# **Paymaster & Ironclad Mine Claims**

## **Preliminary Assessment Report**

Blaine County  
State of Idaho

### **Idaho Department of Environmental Quality**

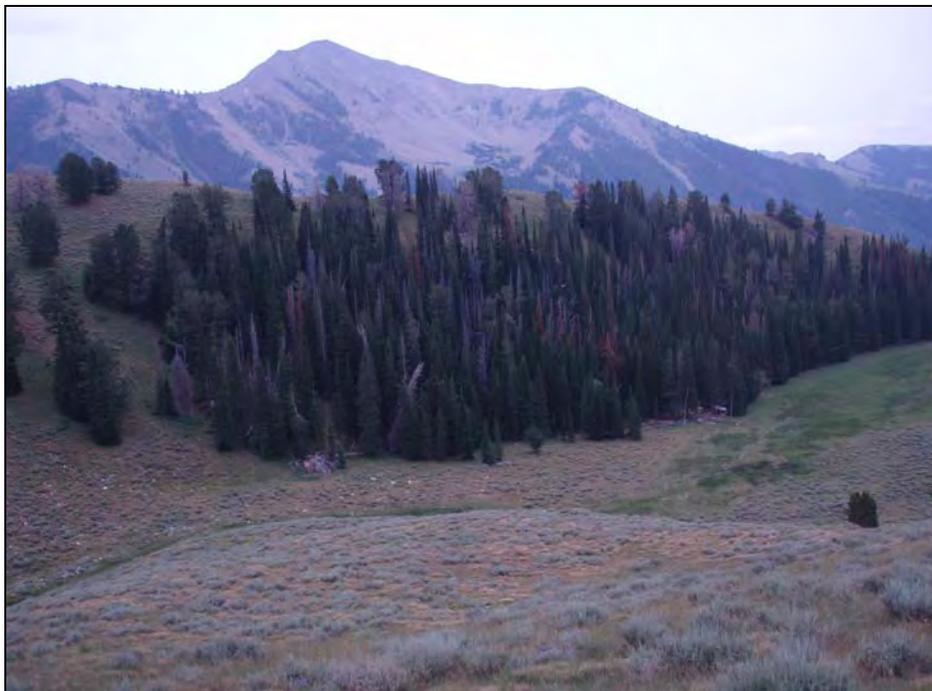
The Paymaster can be accessed from the East Fork Road via a pack trail located at the mouth of Paymaster Gulch. Following the trail for approximately 1.7 miles until it forks. The lower fork continues up the gulch for a short distance before reaching a small meadow situated adjacent to the Paymaster, between the Iron Clad and Mascot claims. A partially built log cabin was noted near the edge of the meadow, possibly located on the Mascot #6 claim. The construction area was not occupied at the time of the site visit (Photo 1).

**Photo 1. View to southeast across Paymaster Gulch; partially constructed cabin (center, right) at lower edge of tree line, workings on crest of the lower ridge above trees.**

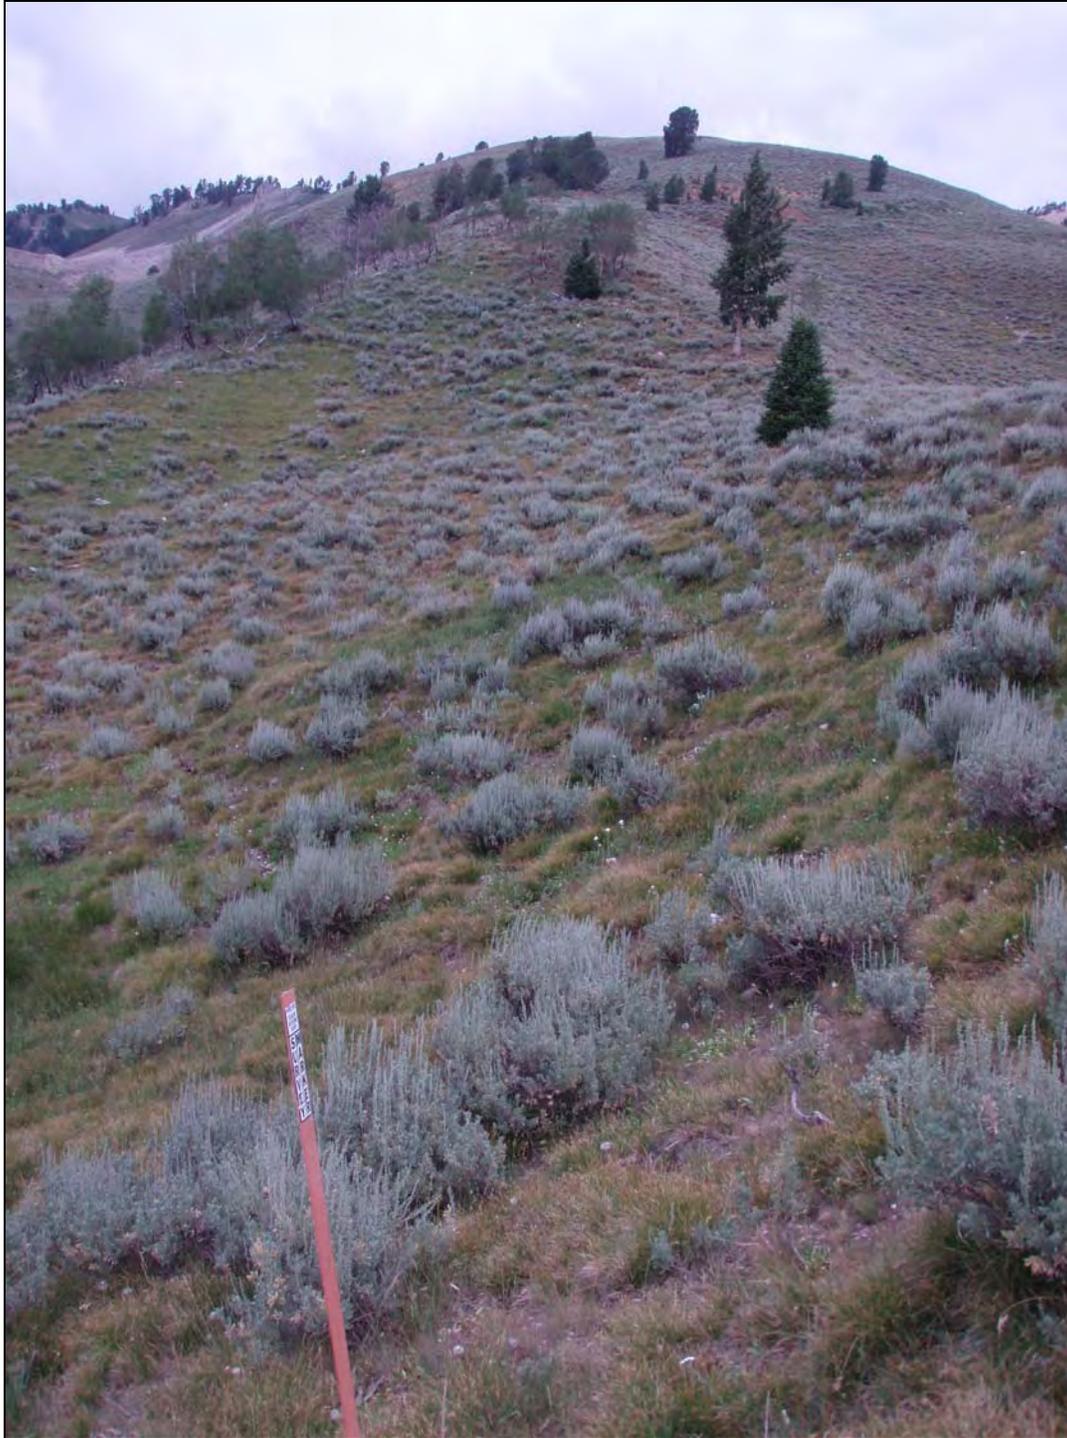
The Iron Clad Mine is located on the north side of Paymaster Gulch, north-northwest of the Paymaster. Prior permission to assess the Iron Clad was not received from the owner, so this property was not accessed. The lower portion of the Iron Clad claim was photographed from adjacent public lands. The working was marginally visible, but did not appear to issue any discharge. Iron staining was extremely evident near the open cut and associated waste rock.

**Photo 2. View to north-northwest from USFS boundary toward Iron Clad; iron oxide (red) staining visible near lower workings.**

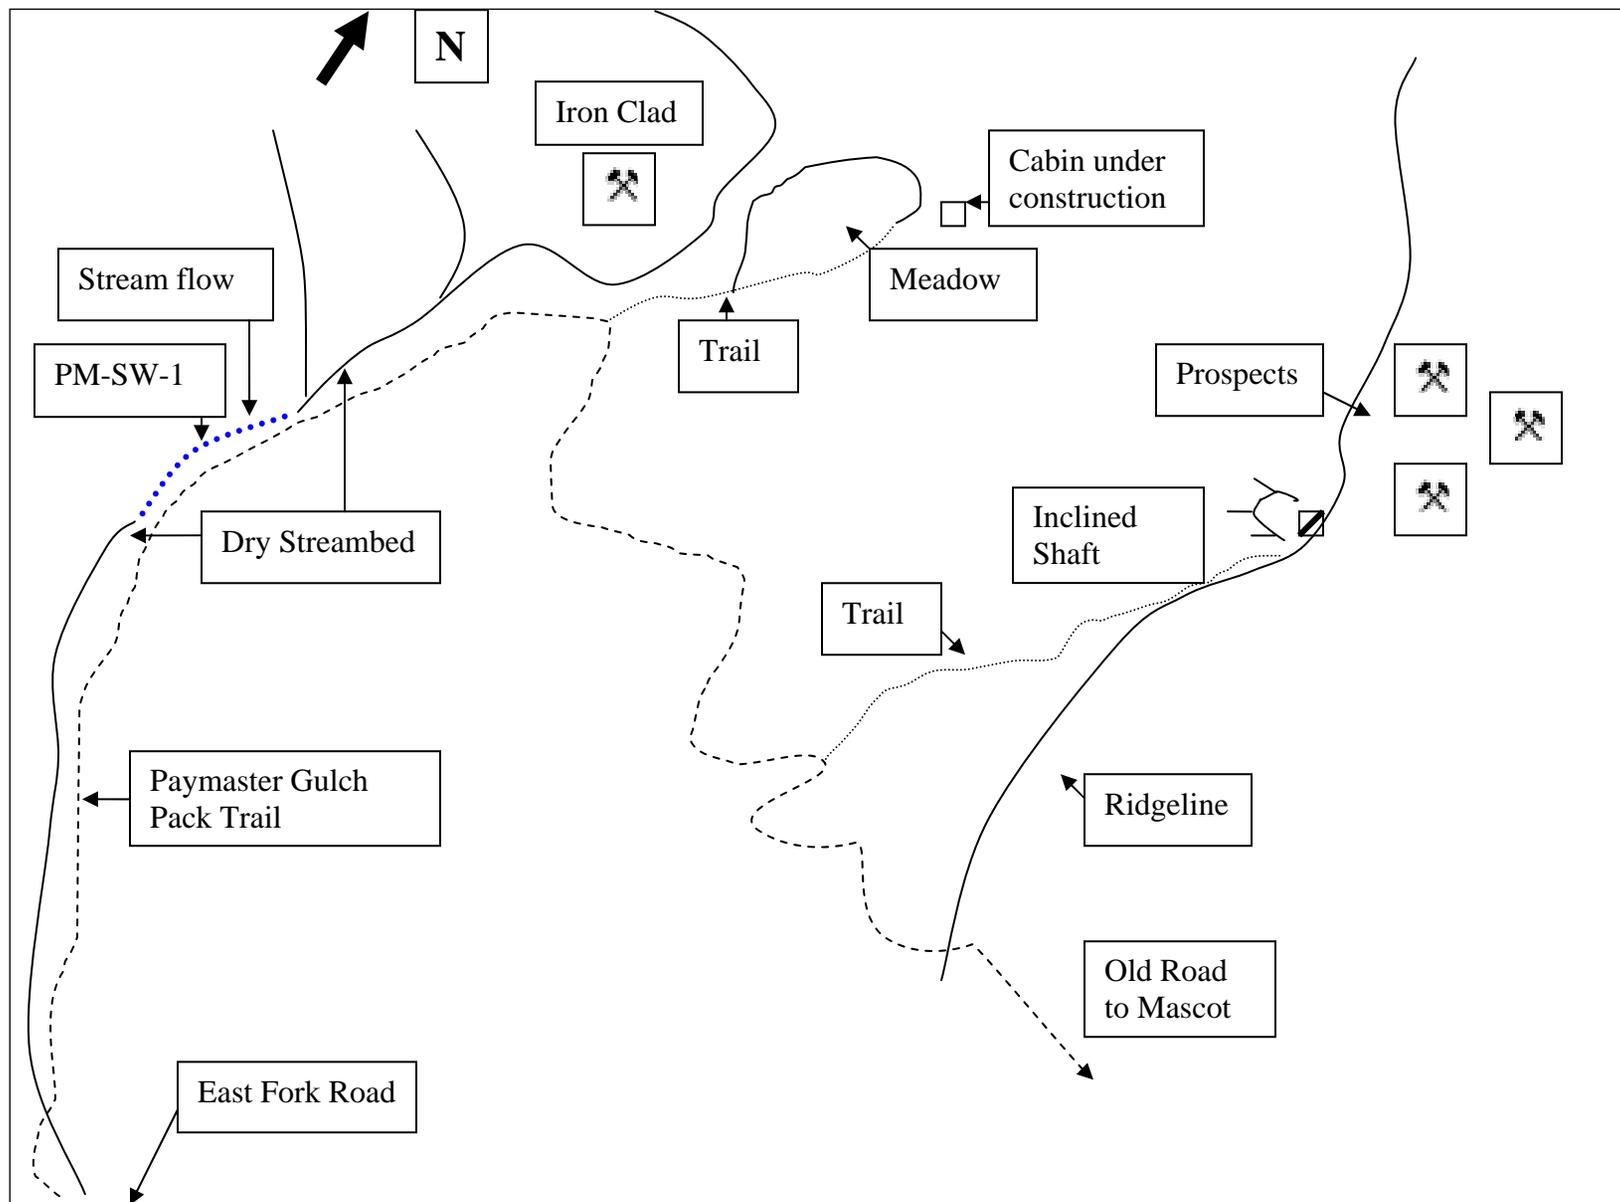
Figure 4: Sketch of site.

The upper fork climbs for another 0.25 miles through the timber to the crest of the ridge. Here, a very narrow trail, little more than a game trail, leads up the ridge to the Paymaster workings. The pack trail continues over the ridge toward the East Fork, possibly connecting to the Sunshine tunnel at the Mascot Mine. A sketch (not to scale) is included to orient the reader with various features on and adjacent to the Paymaster.

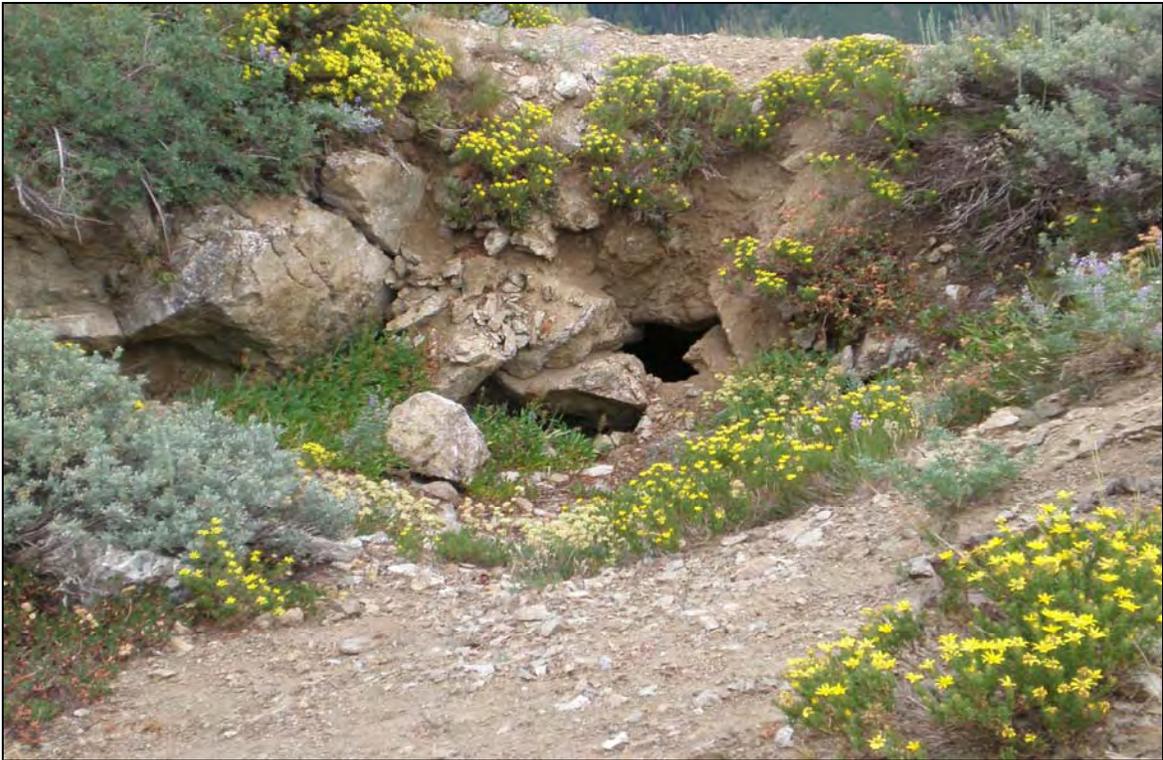
As mentioned by Umpleby (1930), the Paymaster Mine's workings appear to have been located in pockets of mineralization, as evidenced by very small (<100 cubic yards) waste dumps on the steep hillside and ridge. The first working encountered was identified as a collapsed inclined shaft (Photo 2). The waste dump contained less than 100 cubic yards of material and sulfide mineralization was not apparent. Three additional workings were located approximately 90 meters to the northeast, immediately below the ridge (Photo 3). These shallow prospect "holes" were collapsed and the corresponding dump material was spread down the steep slope as veneer. Very minor mineralization was noted, though iron oxide staining was apparent. Owing to the lack of massive sulfide mineralization and the very small volume of waste dump material, no sampling activity was conducted.

**Photo 3. View to southeast; possibly a collapsed inclined shaft. Very small waste dump, no apparent massive sulfide mineralization.**

The Paymaster claim has at least three prospects and one possible inclined shaft, all of which are collapsed. None of these workings are very extensive and sulfide mineralization is not readily apparent.

However, IDEQ recommends that prior to development plans for any residential use; additional site characterization should be conducted to better evaluate potential risk management issues.

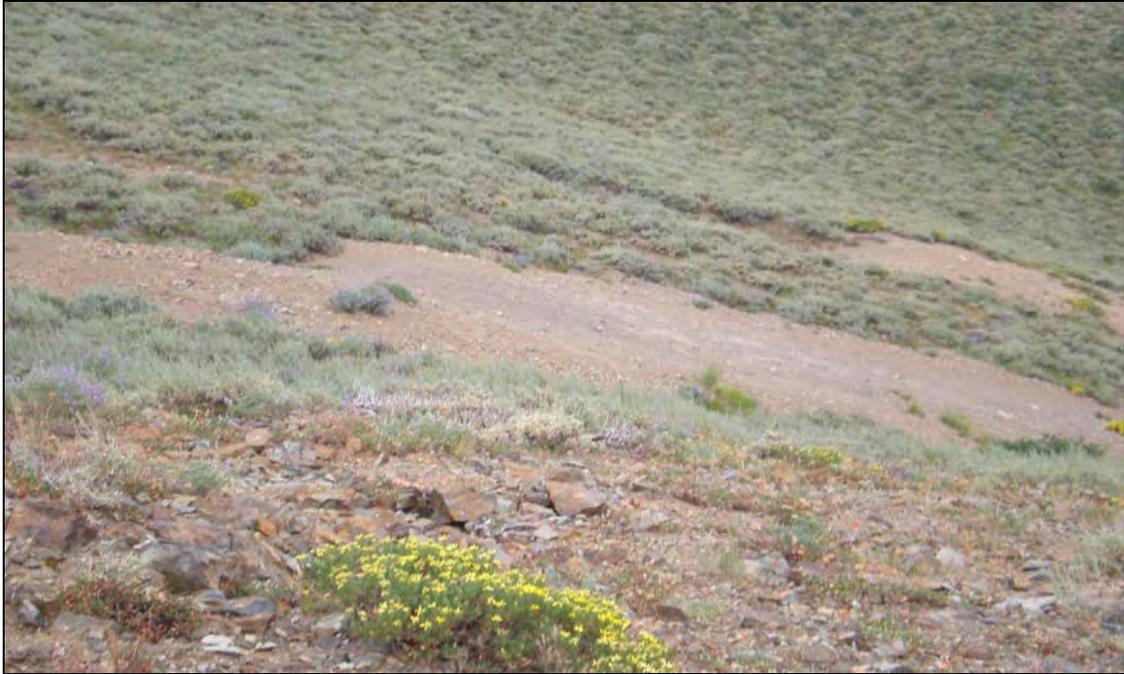
**Photo 4. View to east; three prospects near the crest of the ridge, waste dump volumes appear larger, owing to steepness of slope, iron oxide present.**
