2011 Performance and Progress Report

State of Idaho Nonpoint Source Management Program

**State of Idaho
Department of Environmental Quality**

March 2012

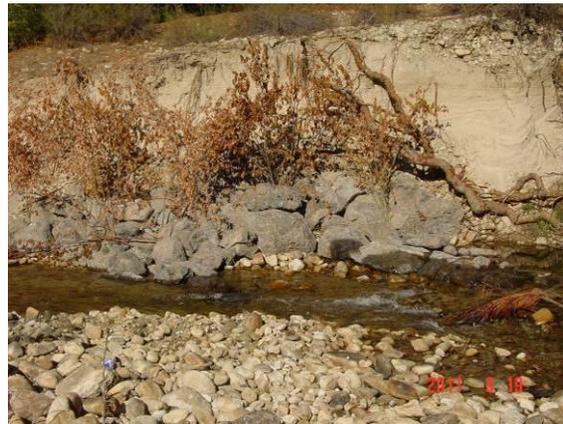
Figure 22. Large rock toe armor was added along this stretch. Most of the planted willows died, but the unstable bank behind the rock will naturally slough to a stable state, allowing vegetation to reestablish on its own.

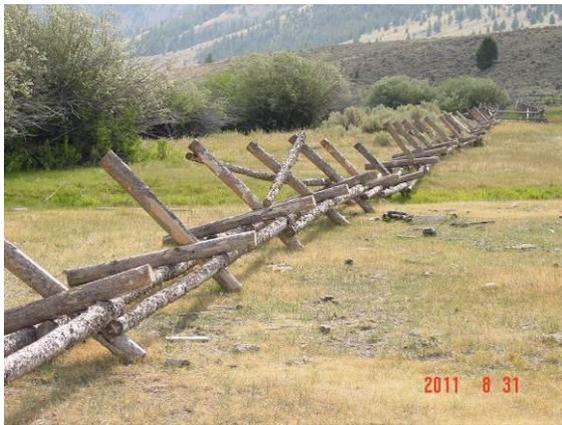
Figure 33. A 300-foot section of jack-pole fencing was toppled last winter by snow buildup and high winds. Although it still functions well enough to exclude cattle, it will soon be repaired.

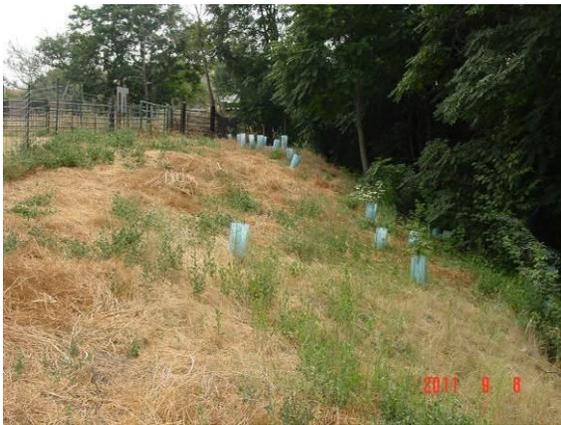
Figure 37. Work on the Walton property was completed in 2009 on a former buffalo corral. Prior to the work, streambanks were barren and badly caving in. Weeds continue to be an issue, but this site is no longer an eyesore or a major contributor of sediment and coliform bacteria to Lindsay Creek.

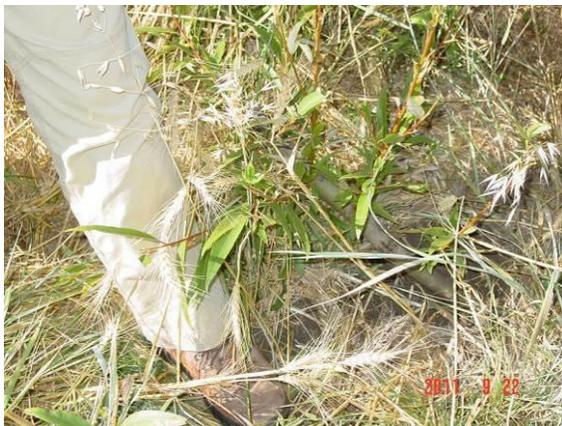
Figure 41. Although some vegetation was damaged last spring, much of it is still growing in place. These willow branches are attached to a willow cane that was planted deep into the streambank using a compressor-powered hydraulic stinger.

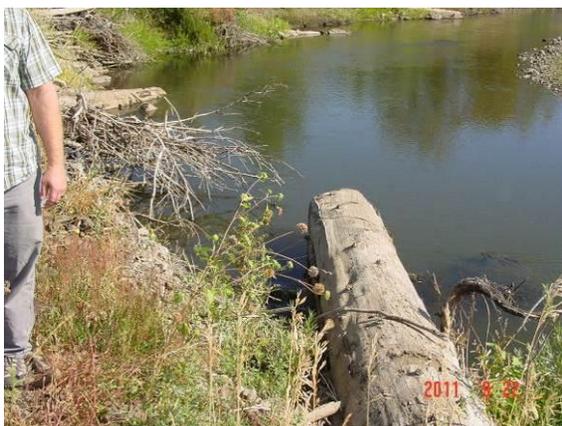
Figure 43. This log barb was keyed into the bank at too shallow of an angle and will be reset in the near future to an angle of about 35–40 degrees.

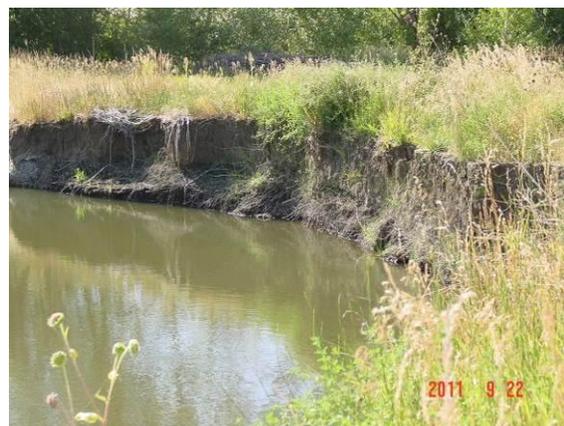
Figure 44. Log barbs installed here were also set incorrectly and were washed out during last spring's very high runoff. This area will be redone with log barbs set at an angle so that the current will be diverted away from the bank instead of towards it.

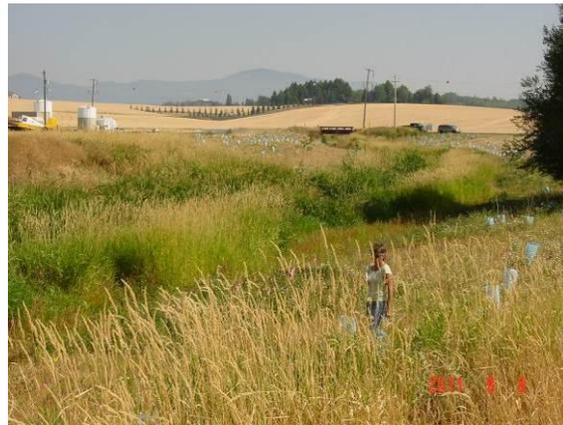
Figure 48. Although some of the woody vegetation was destroyed during spring runoff, most of the grass is coming in very well.

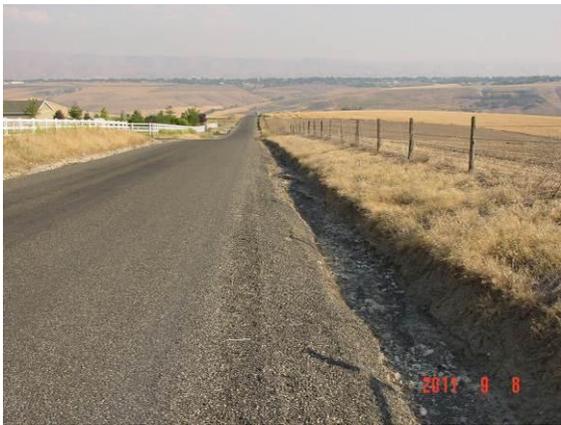
Figure 53. Vollmer Road runs along a section line north and south up a steep hill in highly erosive Palouse soils. The road design exacerbates erosion into Tammany Creek, located at the bottom of the hill.

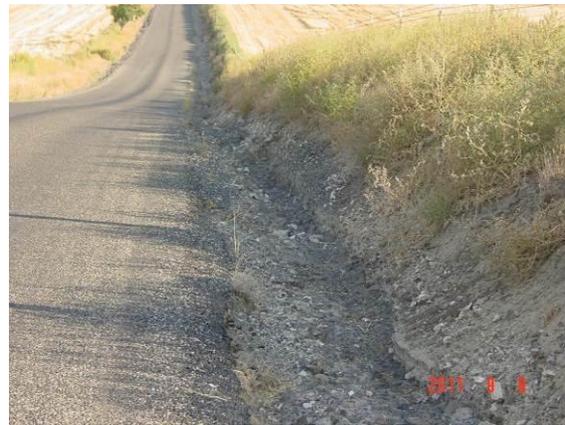
Figure 54. Storm water runoff transports enormous amounts of very fine-grained sediment directly to Tammany Creek.

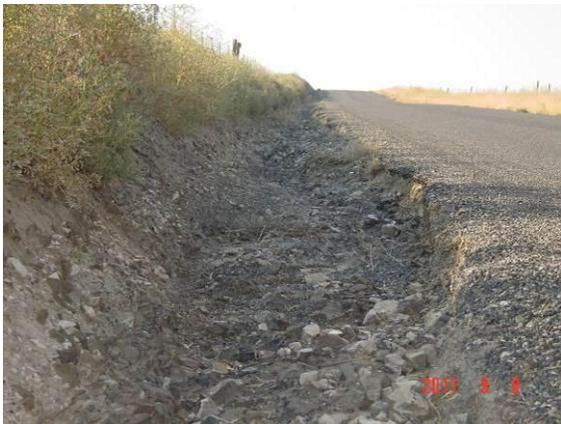
Figure 55. Some sections of the road must be frequently repaired due to the high erosion. The project includes installation of numerous rock check dams, rip-rap, culverts, and settling ponds.

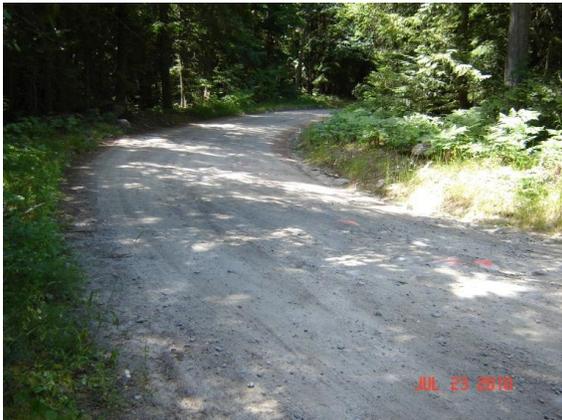
Figure 73. Before the project: this roadbed had numerous large protruding rocks that prohibited proper grading, which caused water to run on the surface.

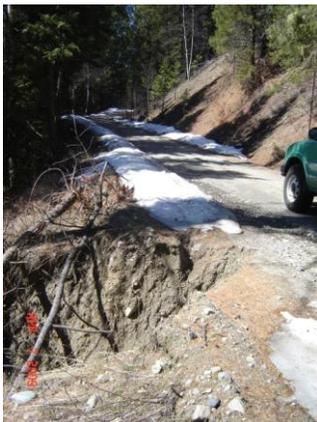
Figure 75. Road failure before this project created unsafe driving conditions and was a major sediment source to Twentymile Creek just below the road in this photograph.

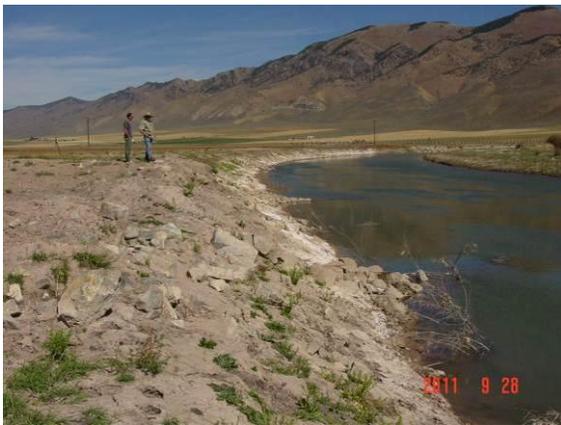
Figure 85. This 1,000-foot section of Bear River had a near vertical bank that was contributing thousands of tons of sediment per year to the river and ultimately to Bear Lake. The resloped and rip-rap-armored bank is now stable and contributes very little sediment.

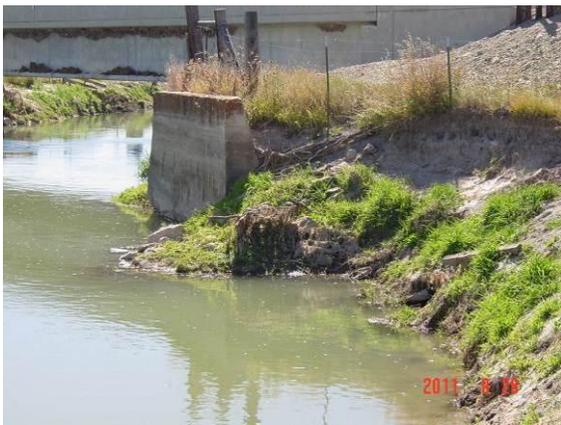
Figure 87. A rock barb installed immediately above this bridge abutment appears to be preventing the abutment, and ultimately the bridge above it, from being undermined.

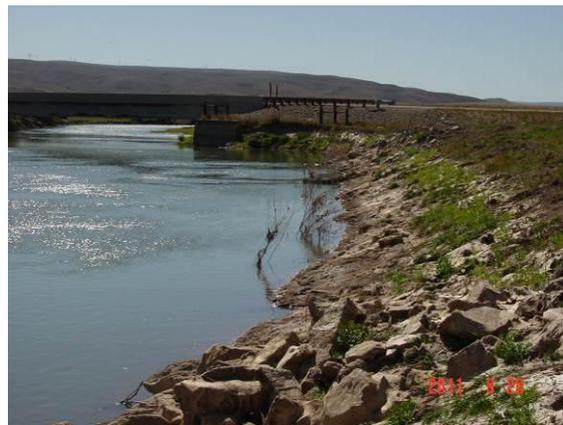
Figure 88. Had the bank continued to erode, the bridge would have been destroyed, resulting in an expensive repair and the deposition of a large volume of sediment into Bear River.

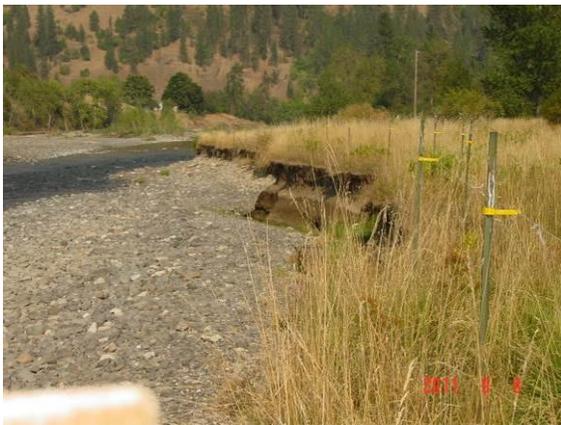
Figure 93. A tributary recently discharged huge volumes of gravel into the river, causing the river channel to shift to the east and erode this bank.

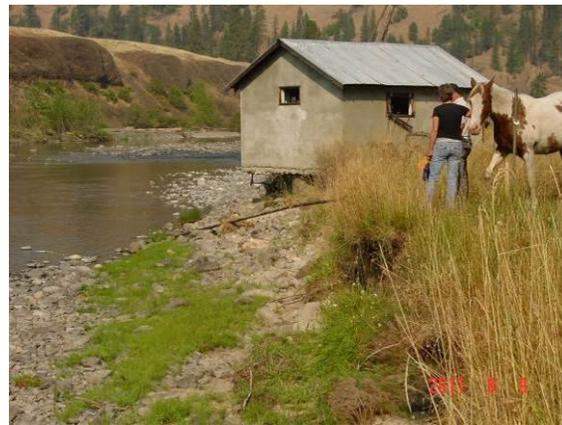
Figure 94. This building will either be moved or destroyed, and the streambank will be resloped and stabilized. Rock barbs will be keyed into the bank to help deflect fast-moving runoff away from the shoreline.

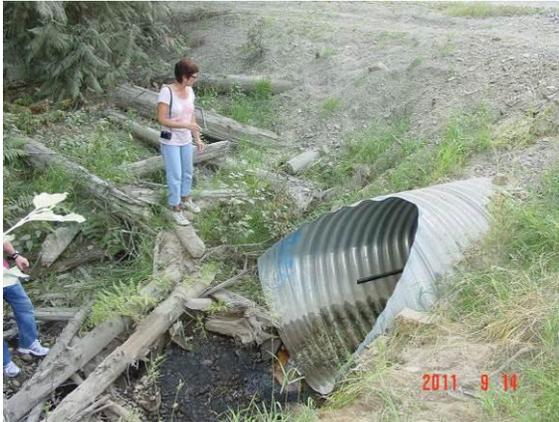
Figure 97. This 60-inch culvert replaced an old, undersized, and damaged culvert that was on the verge of failure, which would have resulted in a major discharge of sediment to Hangman Creek.

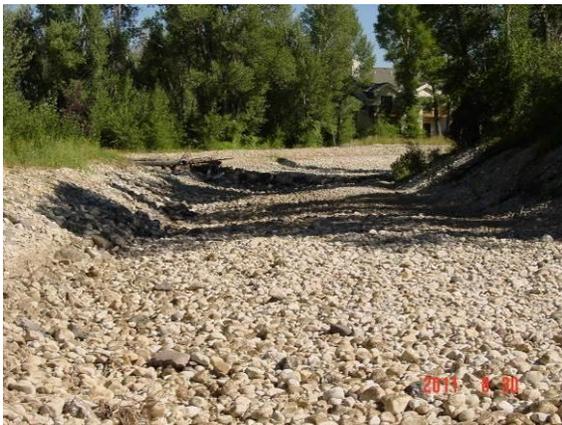
Figure 113. The channel flanks along Teton Creek had to be armored with large basalt boulders to correct down cutting caused by illegal removal of gravel by a developer some years ago.

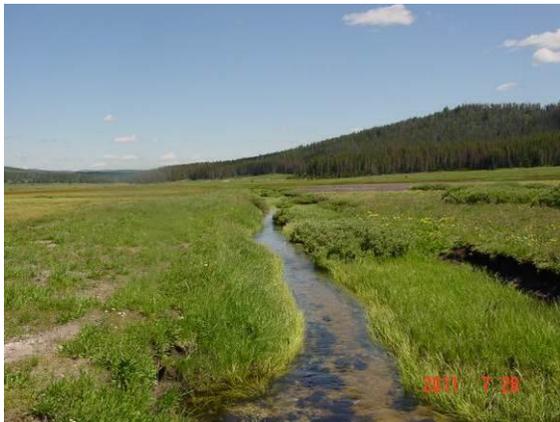
Figure 123. Previously, a berm extended along the left of the excavated and channelized stream. The channelization and heavy grazing resulted in channel down cutting and caving streambanks. The berm was removed, the sod was replaced, and cattle are now excluded.
