2005 Performance and Progress Report

State of Idaho
Nonpoint Source Management Program

January 1 through December 31, 2005

Idaho Department of Environmental Quality

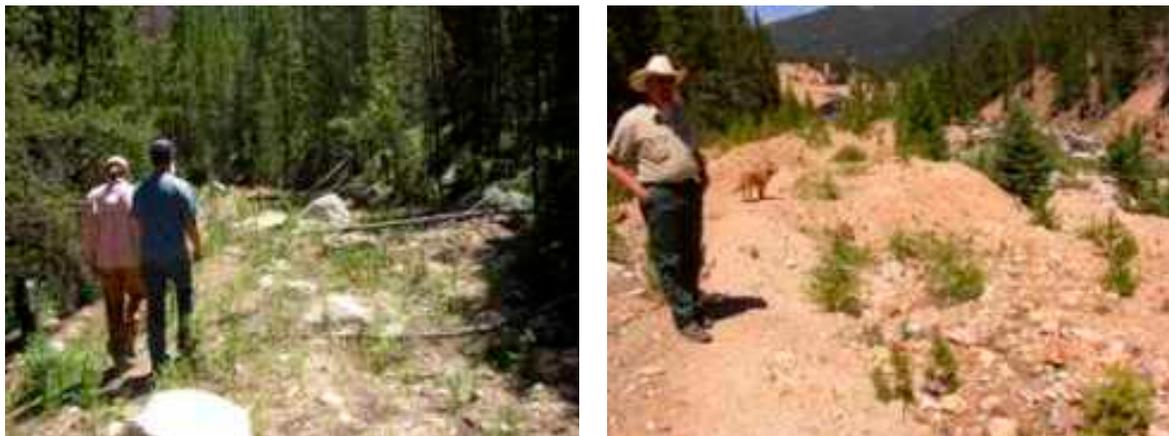
The only access to the Monday Camp was the cause of significant stream bank instability, responsible for production and delivery of in excess of five (5) tons of sediment per year (Figure 3).

Figure 3. Approximately 1.5 miles of access road to the Monday Camp Dump was redeveloped for access to the project. The historic roadway was marred by massive slope failures and deeply incised gullies on fill slopes. The road represented a major eroded surface and source for fine sediment delivery.

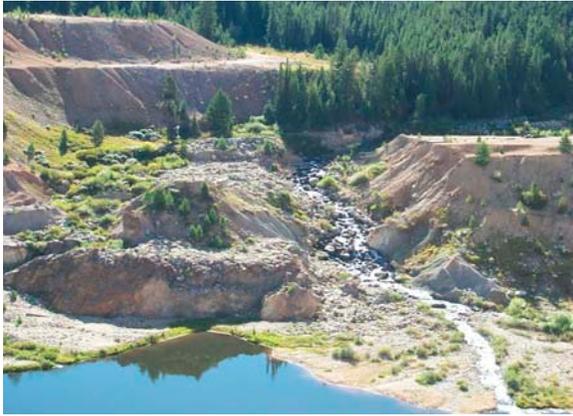
Figure 4. The river cuts through toe of the Monday Camp dump.

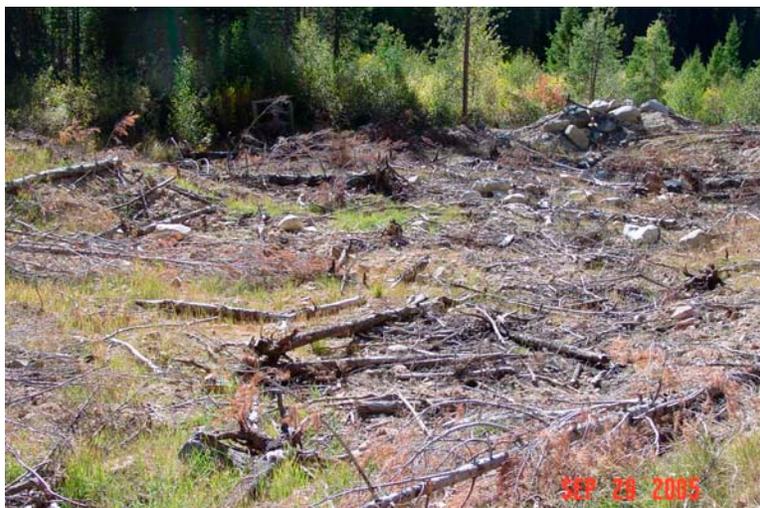
Figure 7. Reclaimed sediment basin alongside of Glory Hole and the public access road was constructed from a top soil borrow source that was developed for the reclamation work in the Meadow Creek Valley.

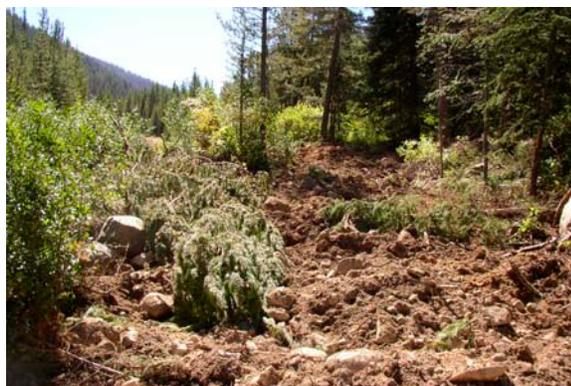
Figure 9. Obliterated Monday Camp Access Road after reclamation of the Monday Camp Dump.

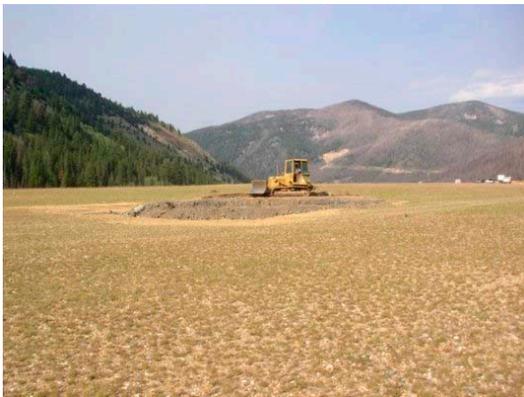
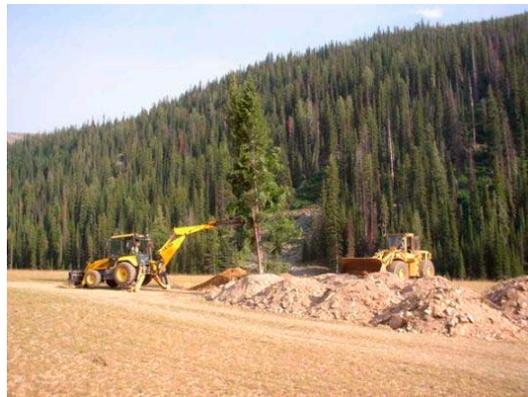
Figure 13. The placement of the backfill mixture created an absorbent island of growing material that would capture and retain surface runoff from the interior of the SODA until the moisture could be evapotranspired, significantly reducing surface runoff that had previously caused most of the erosion on the SODA benches.

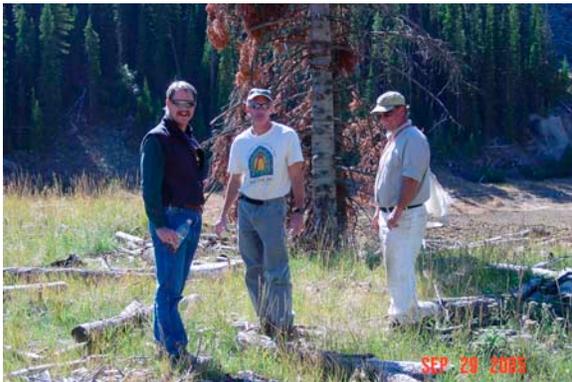
Figure 14. One year after creating the first vegetated islands, lush grassy species and large woody debris hide and shade over 9,000 plantlings of wild roses and lodge pole pines.

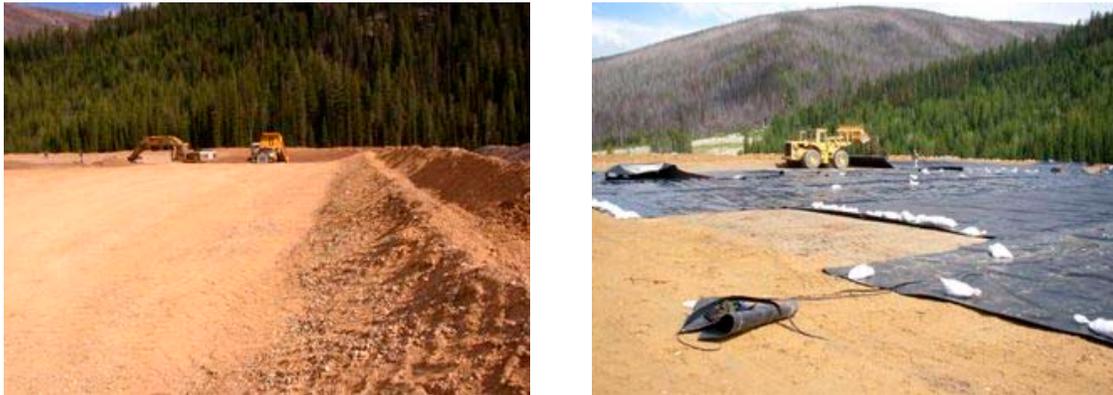
Figure 15. (Left) Excavated spent ore from storm water ponds and placed as berm. (Right) HDPE liner is placed on compacted tailings above repository.

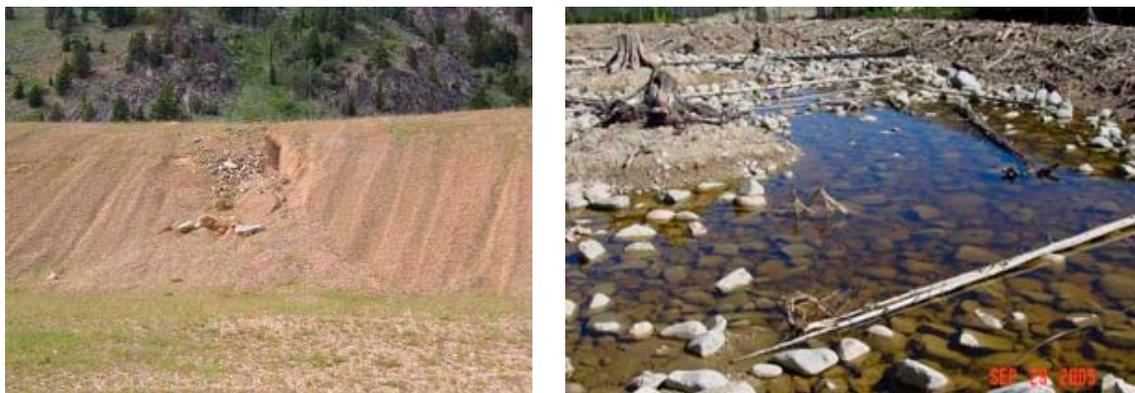
Figure 20. (Left) Surface runoff and mass wasting of upper SODA bench is one of the more significant sources for fine sediment production and delivery. (Right) The storm water catchment pond at the composting facility was developed as a wetland to continue to restrict surface water runoff and utilize it to develop a vegetative cover on top of the SODA.

The slopes of the upper SODA bench prevented vegetation from becoming established and resulted in high velocities of surface water runoff in the spring—the primary cause of 5-10 tons of metals-laden sediment that was carried to Meadow Creek annually, depending on precipitation.

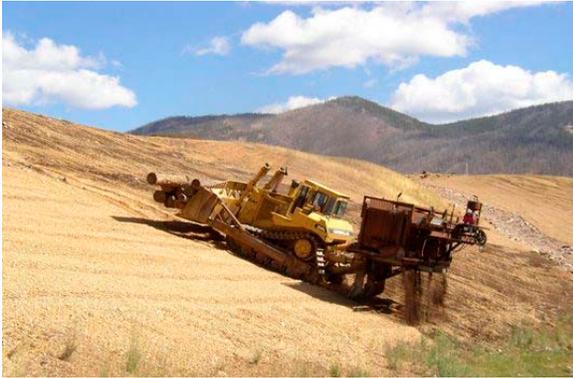
Figure 21. D-8 Caterpillar with apron feed compost spreader applies approximately 0.25 inches (1,800 lbs/acre) of compost to the surface of the re-contoured upper SODA bench. Subsequently a D-3 Caterpillar dozer cross-rippled the bench parallel to the contours to impede overland flows.

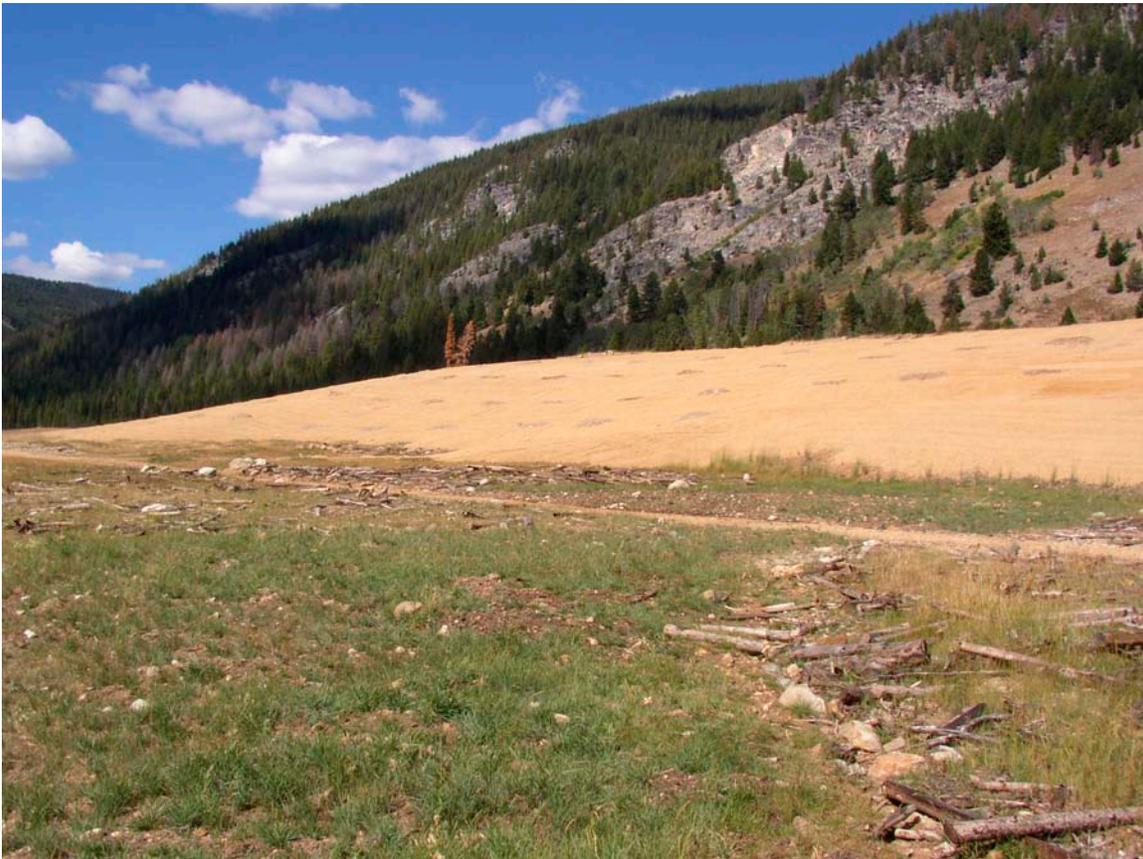
Prior to reseeding the slopes of the upper SODA bench, Thornton Construction dotted the landscapes with micro-islands (Figure 23). Thornton excavated approximately three (3) cubic yards of spent ore and replaced it with topsoil and compost in each of the micro-islands. DEQ then seeded the entire slope and planted four to six ten-inch starts of ponderosa pine and wild roses in each. It is hoped that the lush vegetation that develops on each of these micro-islands will provide long-term seed sources for trees and shrubs and slowly expand outward across the slope.

Figure 23. Micro-islands were constructed on the re-contoured and composted upper SODA bench slope, spaced at approximately 50-foot centers. The micro-islands were constructed by excavating three cubic yards of spent ore, mixing it with two cubic yards of top soil and compost, and then backfilling the excavation. The micro-islands were then seeded and planted with lodgepole pines and wild roses.

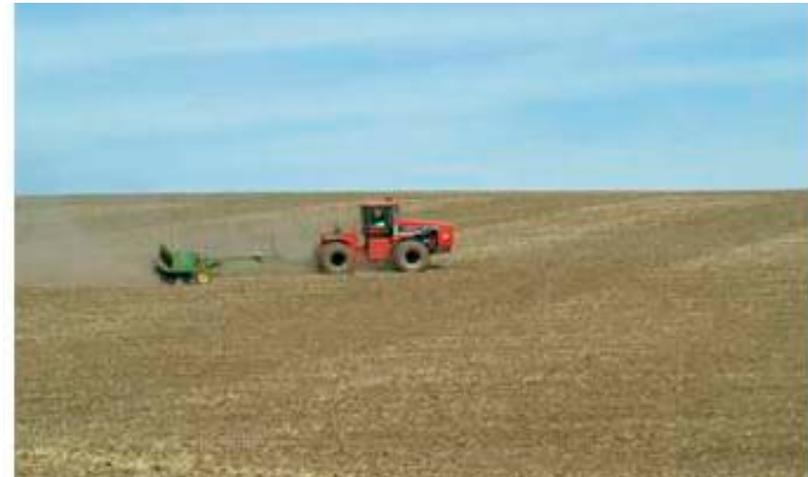
Figure 27. Residue remaining in this minimum tillage field is significantly lower than residue rates in direct seed systems. The additional residue in direct seed systems slows runoff waters allowing infiltration into the soil and lowers sediment losses from the fields.

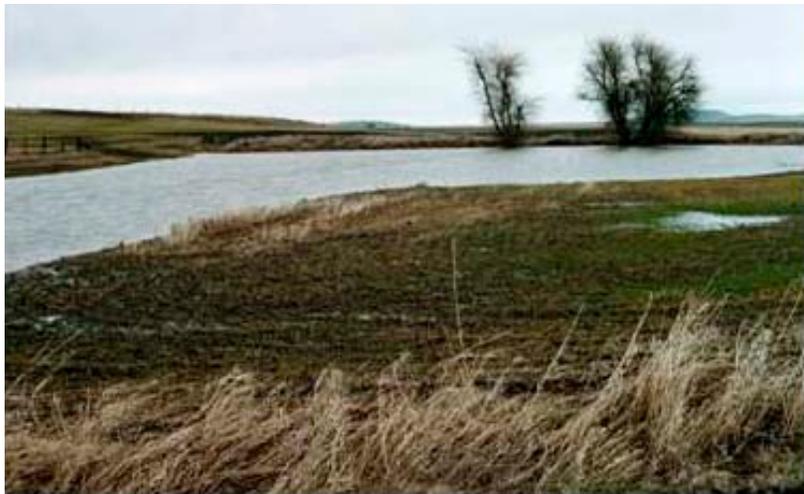
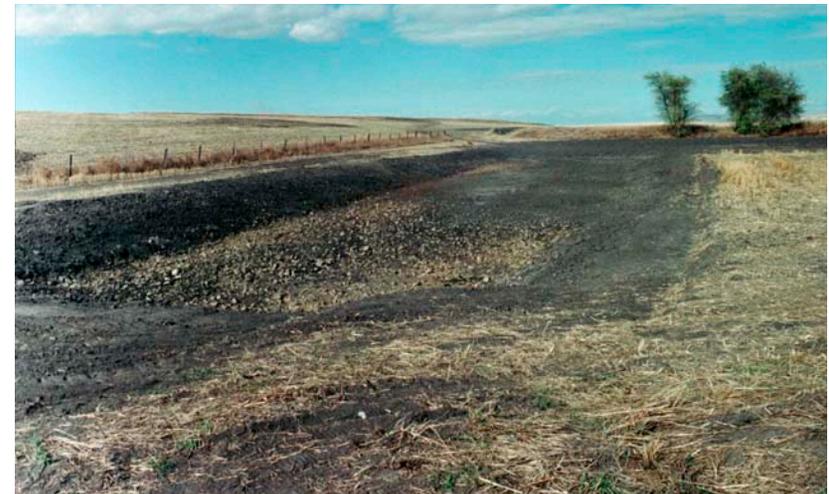
Figure 28. Sediment basins collect sediments and reduce the amount of sediment and nutrients entering streams and other water bodies. This sediment basin is seen completed in the fall (right) and full of water and sediments in the spring (left).

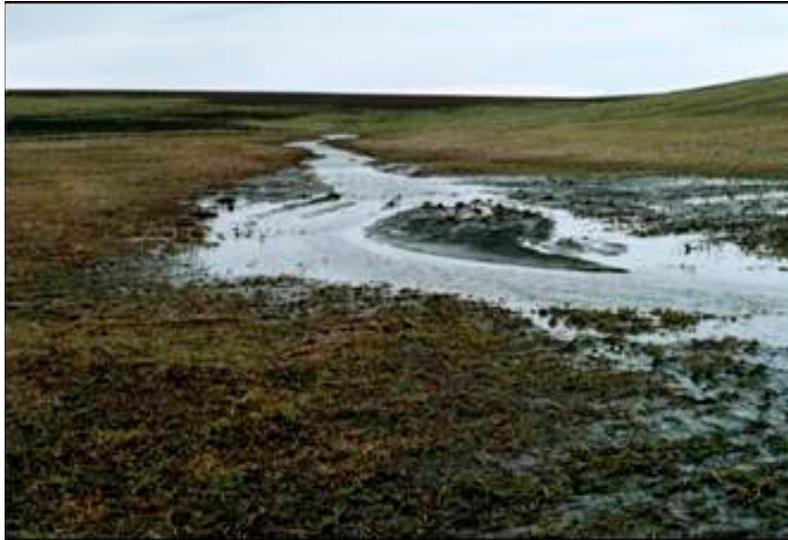
Figure 29. The runoff depicted is typical of summer fallow systems in the Cottonwood area before cooperators converted to direct seed systems. In areas where landowners are not converting to direct seed, some landowners are installing sediment basins to collect sediments.

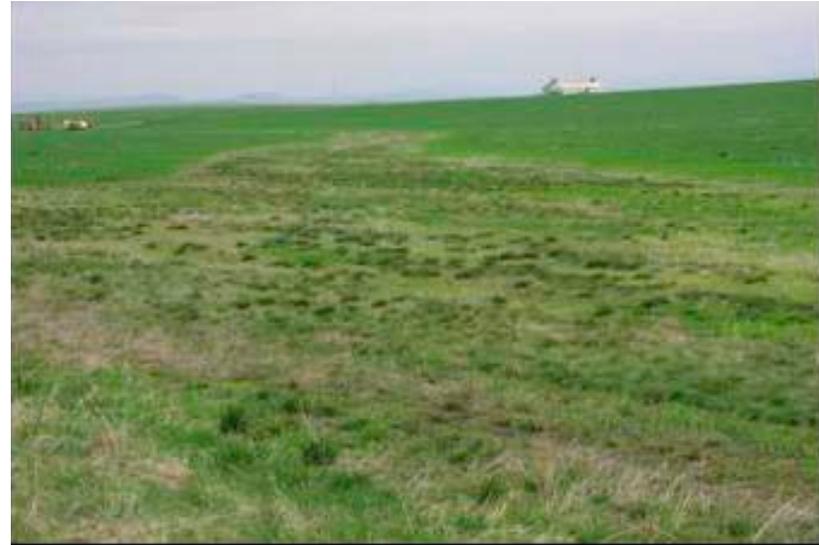
Figure 30. Filter strips, serve to reduce sediment, bacteria, and nutrients entering water bodies. This is accomplished by slowing water velocity, allowing contaminants to settle out of run-off waters.

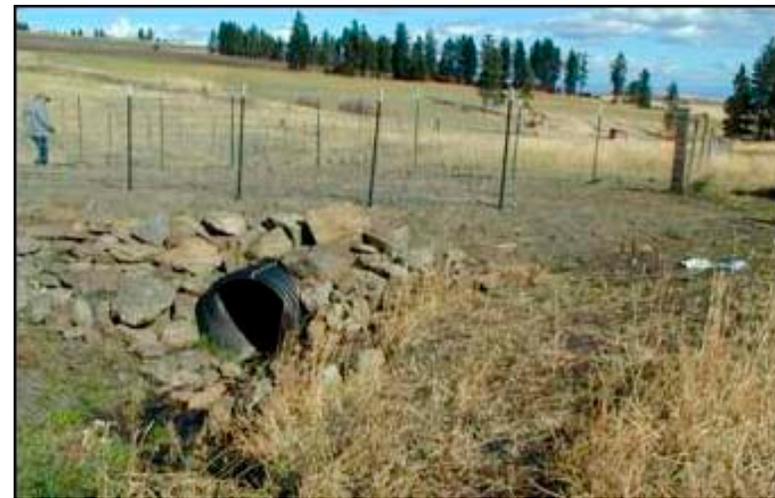
Figure 32. Culvert crossings provide livestock access to additional pasture areas with minimal impacts to stream banks and creek waters.

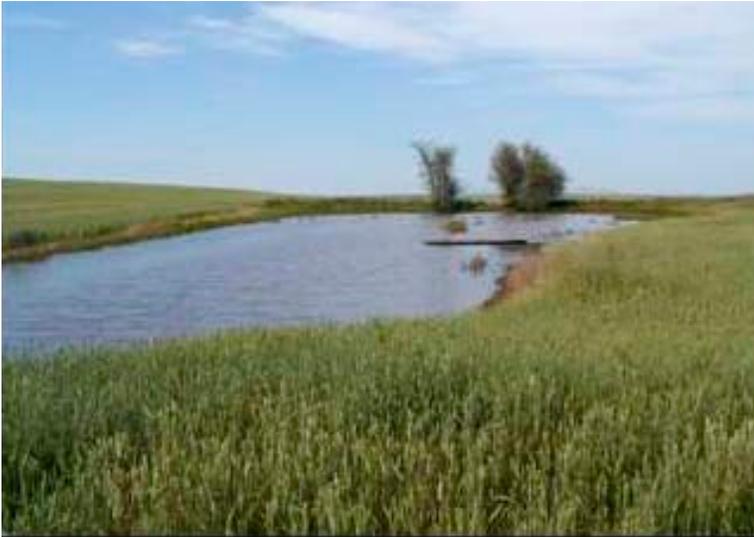
Figure 33. Sediment Basin two years after installation. Fifteen tons of sediment has been removed each year from this basin.

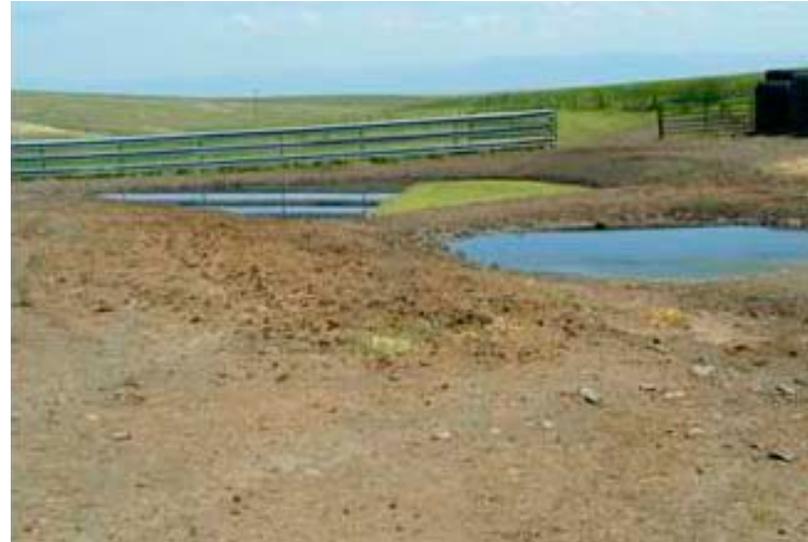
Figure 34. Corral berms help to contain corral water and manure, allowing pollutants to settle and keeping them from entering the creek.

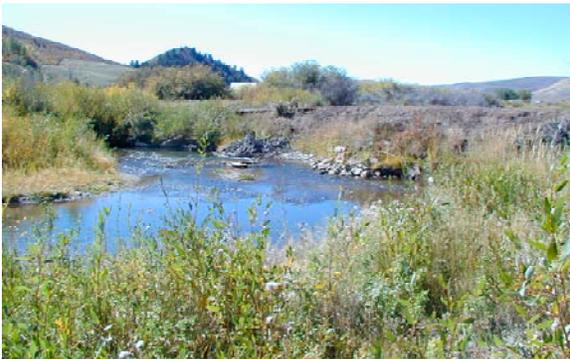
Figure 38. Segment 2 prior to treatment with BMPs.

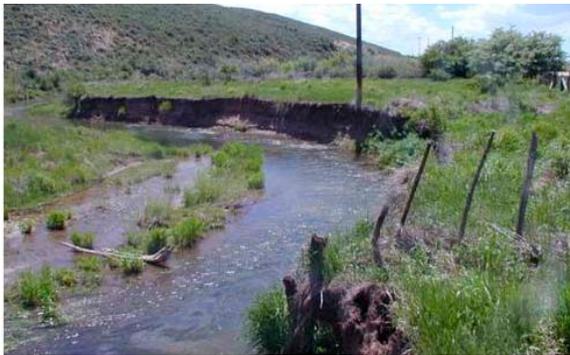
Figure 42. Segment 11 before treatment with BMPs.

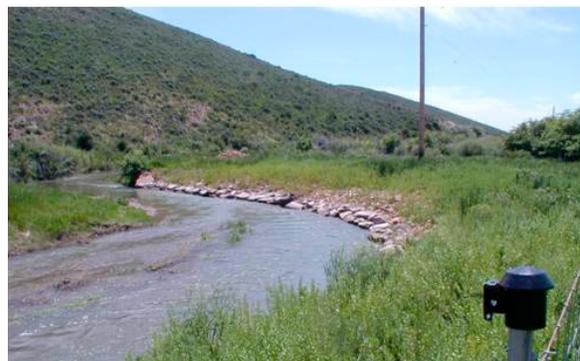
Figure 43. One year after implementation of BMPs, Segment 11.

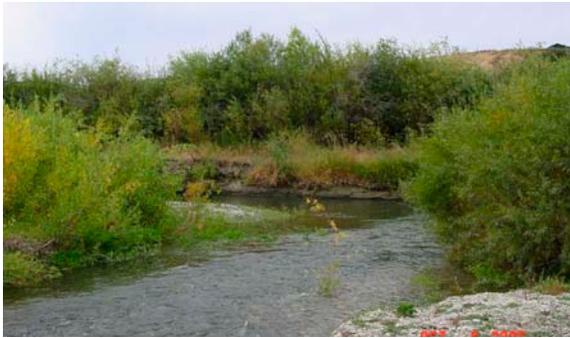
Figure 77. Vegetation in the background was planted in earlier years. The gravel in the foreground is part of a hardened crossing installed as part of this current project.

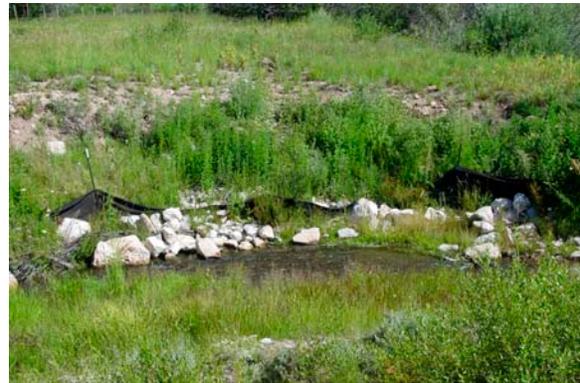
Figure 86. Vegetation is coming in nicely and the biodegradable silt fencing is breaking down.

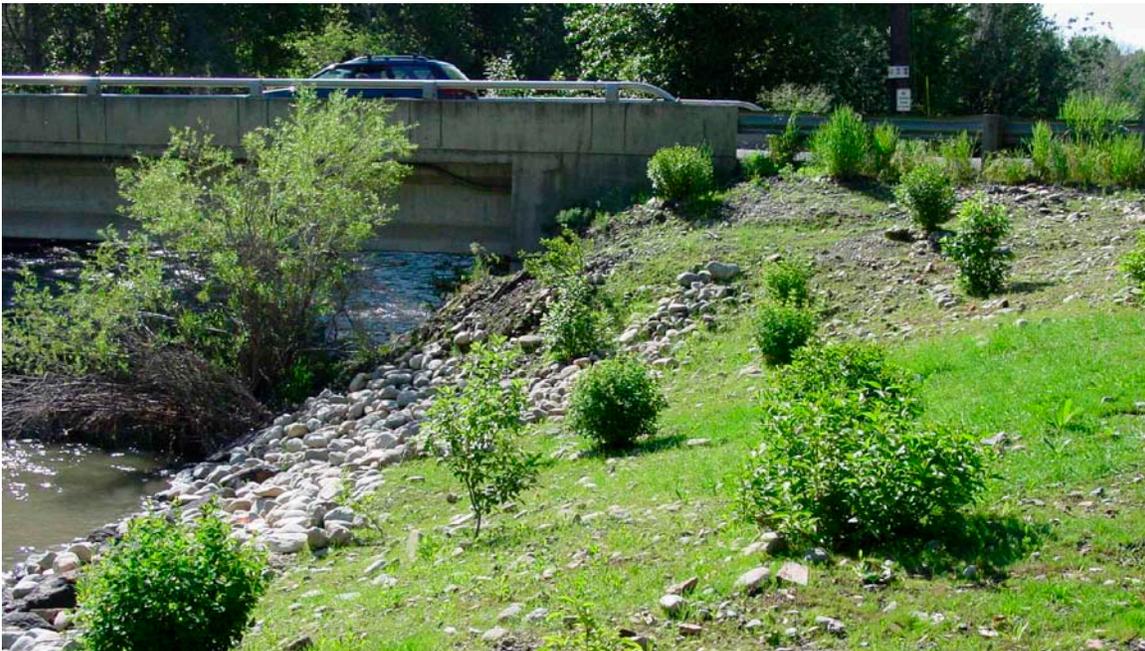
Figure 92. A decades-old abandoned bridge abutment formerly stood from the foreground of this photograph to a point near the existing bridge. The abutment and a large volume of sediment and debris were situated to the right, behind the old abutment.

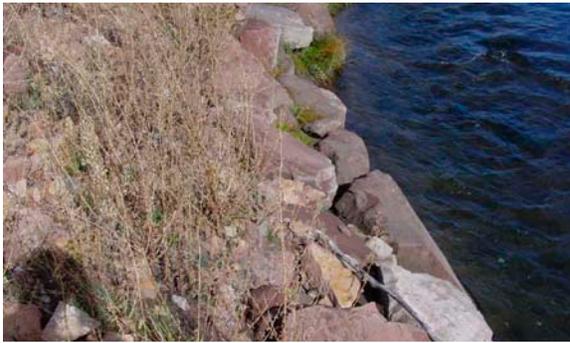
Figure 95. For this subproject and the numerous other subprojects conducted by the Bear Lake Regional Commission along Thomas Fork, re-sloping and the installation of rip-rap creates the foundation for stream bank stabilization.

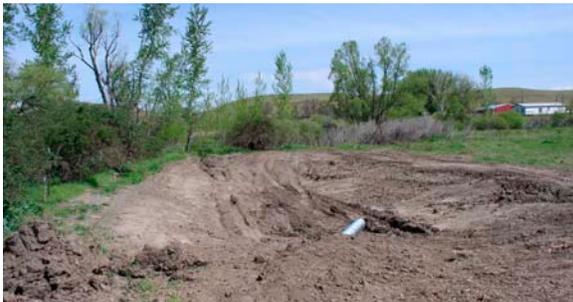
Figure 118. This sediment basin was installed on a 21-acre field with a grain/alfalfa crop rotation. The basin was designed to trap 65% of the sediment load from the field. The sediment load reduction is an estimated 54 tons/year. The banks will be seeded with a low growing, drought tolerant grass, such as crested wheat grass. This will stabilize the banks as well as act as an additional filter.

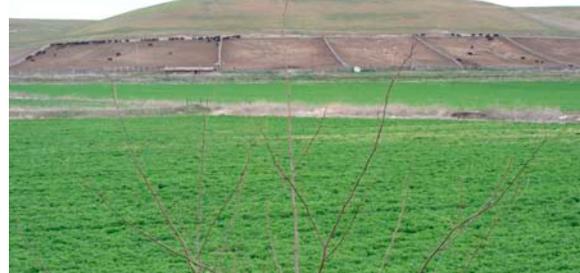
Figure 119. Animal Feeding Operation located in the Bissel Creek area. The owner is going to install an Animal Waste Storage Facility for a feedlot with an approximate capacity of 970 head. The project will consist of two ponds; wastewater will be piped to a small drainage pond above the feedlot that currently drains about 48 acres of rangeland and drains through the feedlot. A pipeline will divert storm water from the upland area underneath the feedlot. A nutrient management plan is also being developed to address current soil conditions and crop uptake to assure that manure is not over applied.

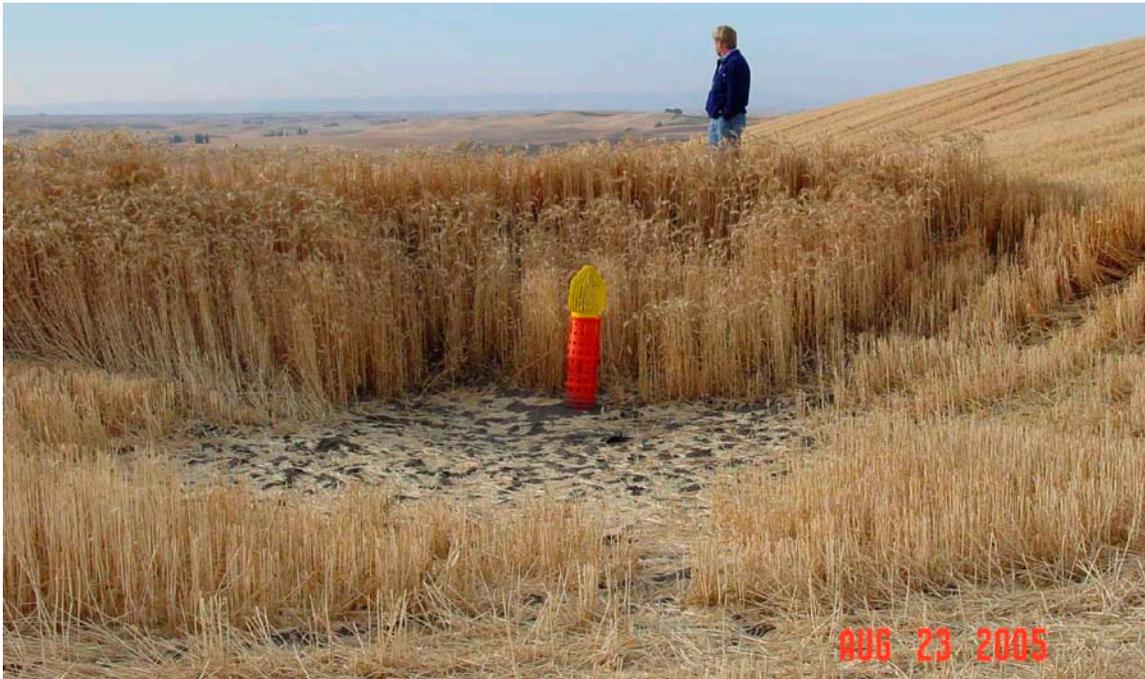
Figure 134. A BMP, known locally as a "gully plug," consists of a sediment basin, stand pipe (above), and a conveyance pipe (below). Scores of gully plugs situated in small swales across cultivated Palouse country capture millions of gallons of storm water and associated pollutants. Relatively clean storm water is then conveyed to the foot of the hill via a pipeline, where it is ultimately discharged to streams.

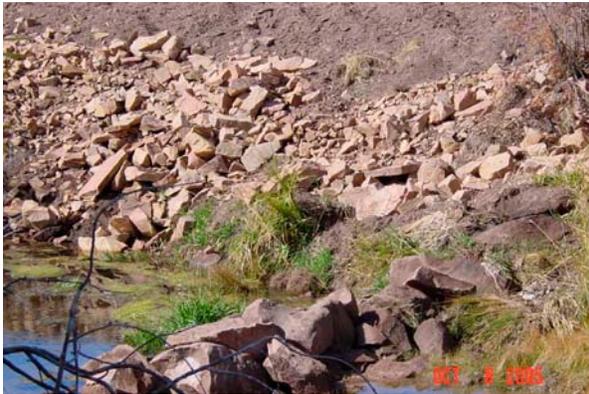
Figure 142 (above and below). What used to be a near vertical unstable head cut has been sloped to a 3 or 4:1 angle and rip-rapped. It does not look very attractive now but will quickly be covered with natural and planted vegetation.

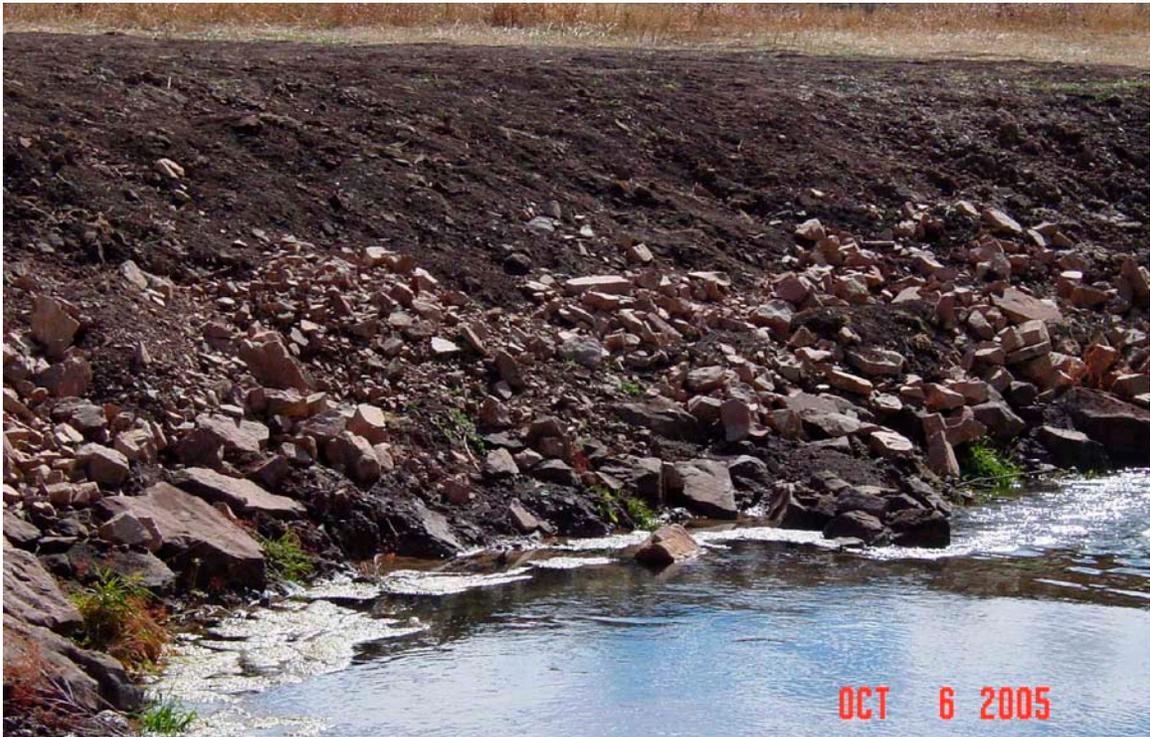
Figure 144. This newly formed bank looks pretty bad now but will soon look much better.

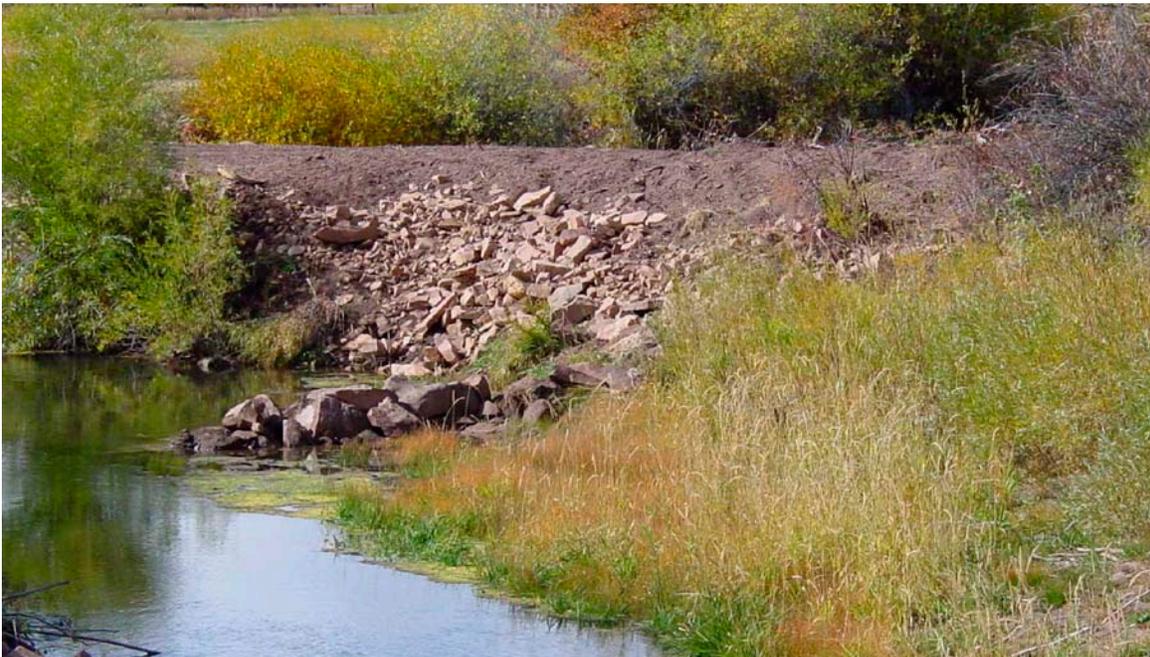
Figure 145. The work in the foreground was completed several years ago. The work in the distance was just completed. Note the rock barb near the middle of the photograph, which will deflect strong water currents away from the stream bank.

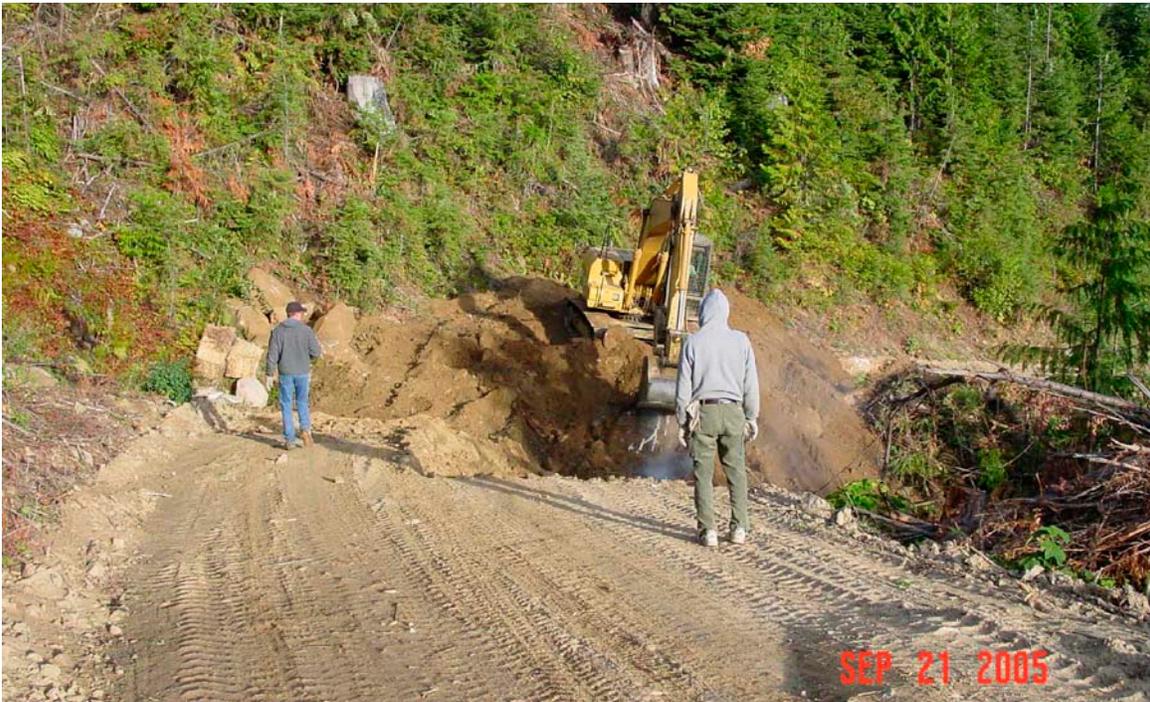
Figure 147. This logging road will be temporarily closed to vehicular travel until timber in the area is ready for harvest in several decades. Culverts are being removed, and drainage will be rip-rapped to allow for high levels of storm water and spring runoff flows.

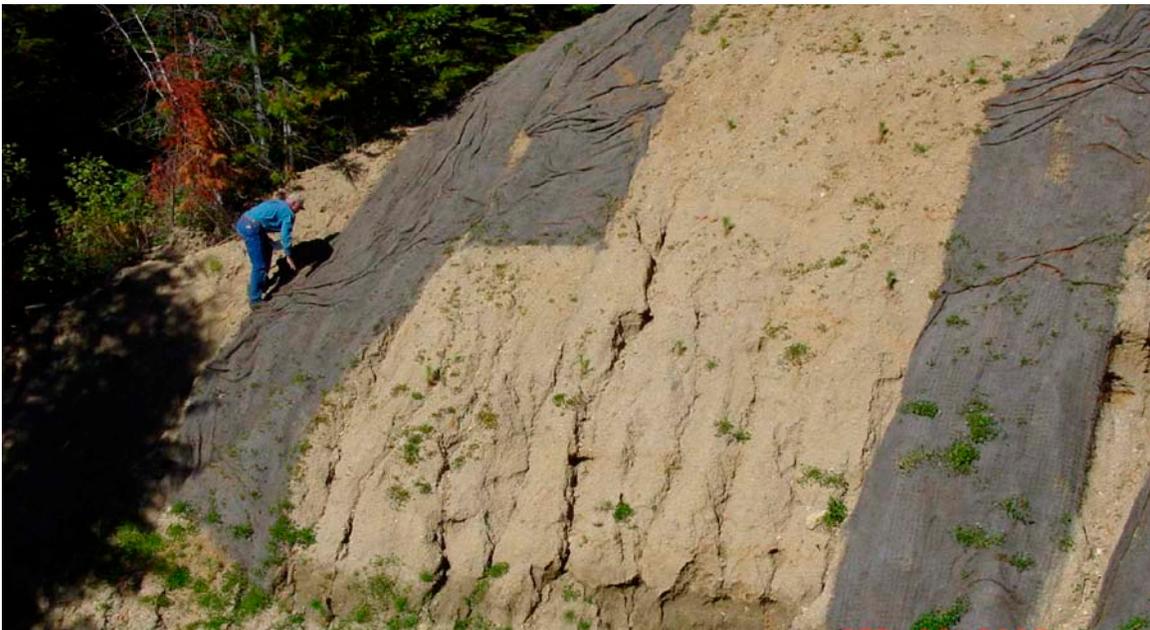
Figure 148. Things can go wrong on projects as large as this one. Here the subcontractor improperly cut the slopes at a 1:1 angle in highly erosive granitic soils and improperly installed the geofabric. The project manager will directly oversee the correction of this problem. The slopes will be recut to an approximate 4:1 slope and the fabric will be properly anchored. This is just one of the many sub-projects within this overall project area. And it was the only problem area we found during our two day long evaluation.

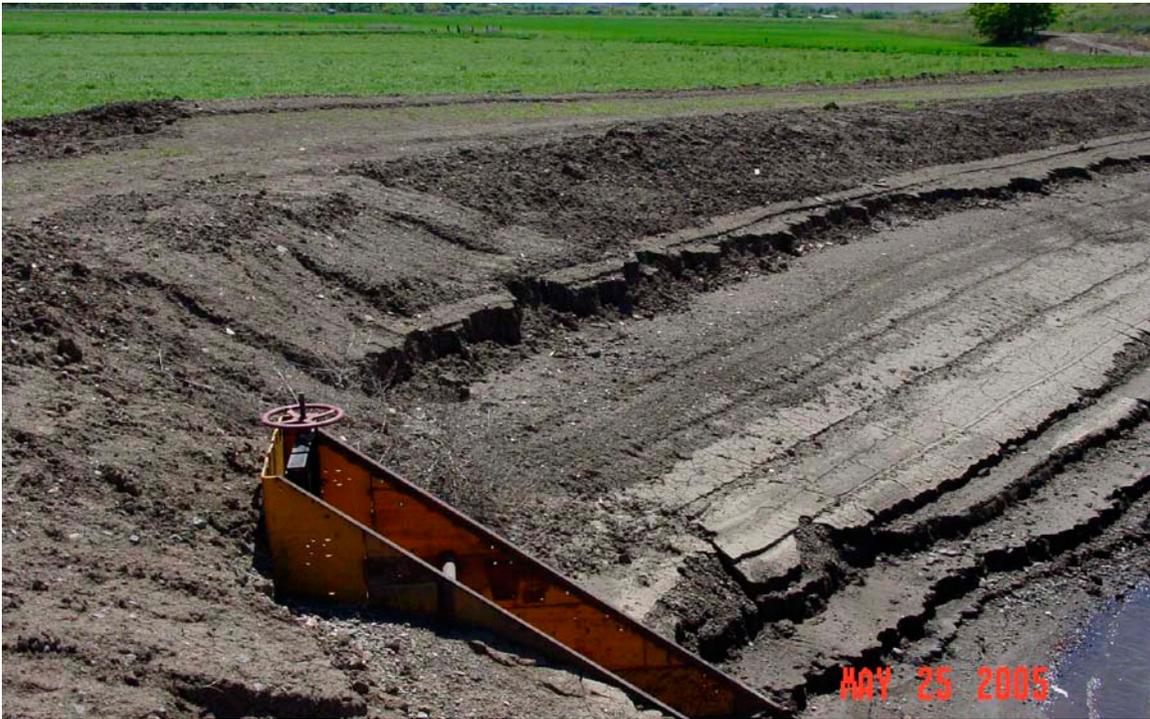
Figure 150. The dam will need to be inspected frequently to assure that wave action does not jeopardize the integrity of the facility. This gate will allow the pond to be emptied for maintenance purposes.

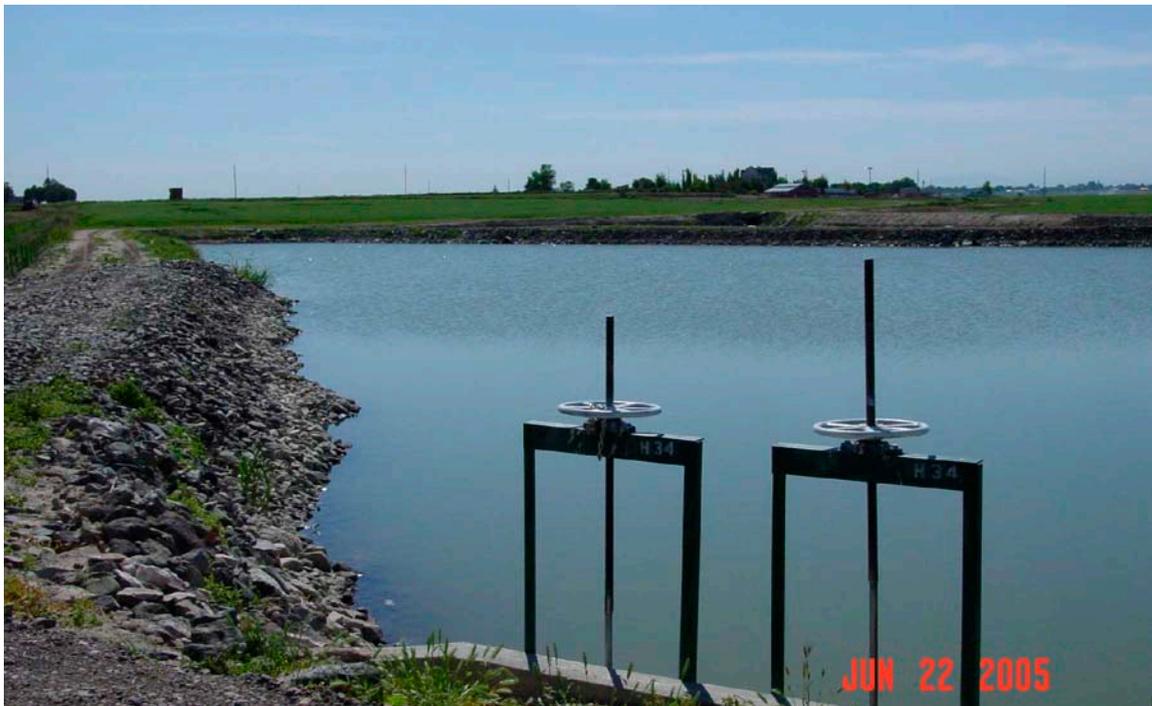
Figure 154. Control valves will assure flow levels in the ponds and wetlands.

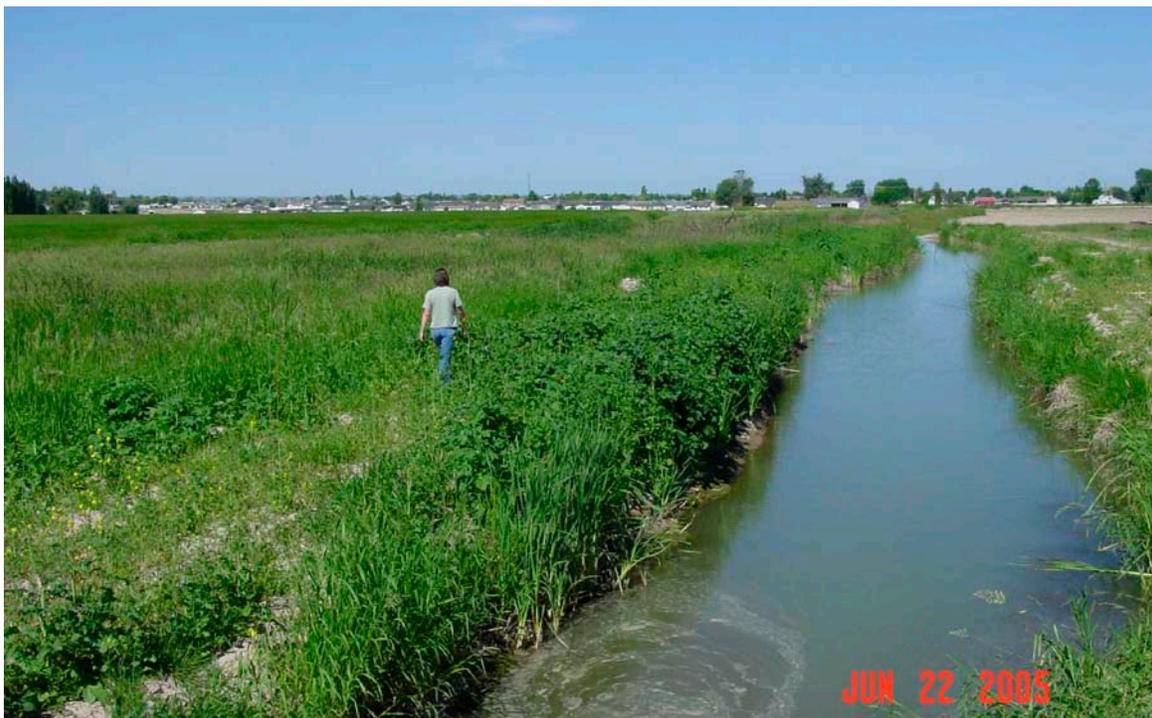
Figure 155. The wetland component of this facility (above and below) will help take up nutrients from irrigation return flow.

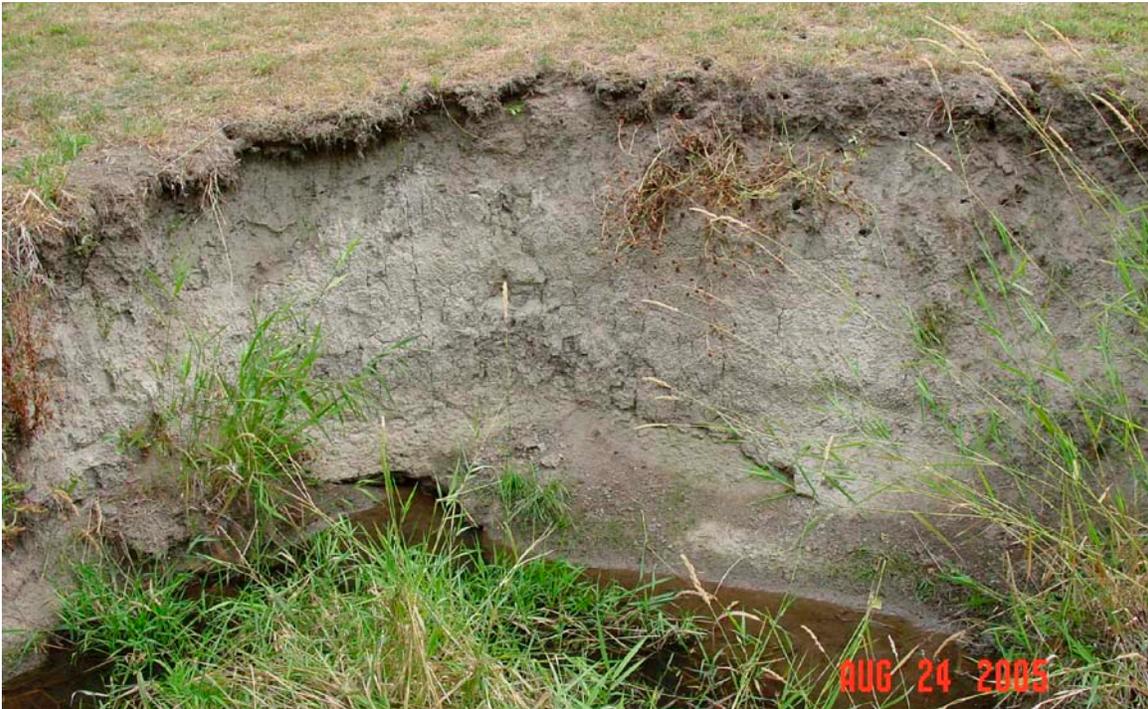
Figure 163. If left alone, the creek will continue to meander across the old reservoir floor until thousands of tons of sediment is re-deposited downstream in low energy areas along the South Fork of the Palouse River.
