Ground Water Quality Report

Chilco Area of the Spokane Valley-Rathdrum Prairie Aquifer

Prepared by Richard Lee
Idaho Department of Environmental Quality
State Office
November 2010

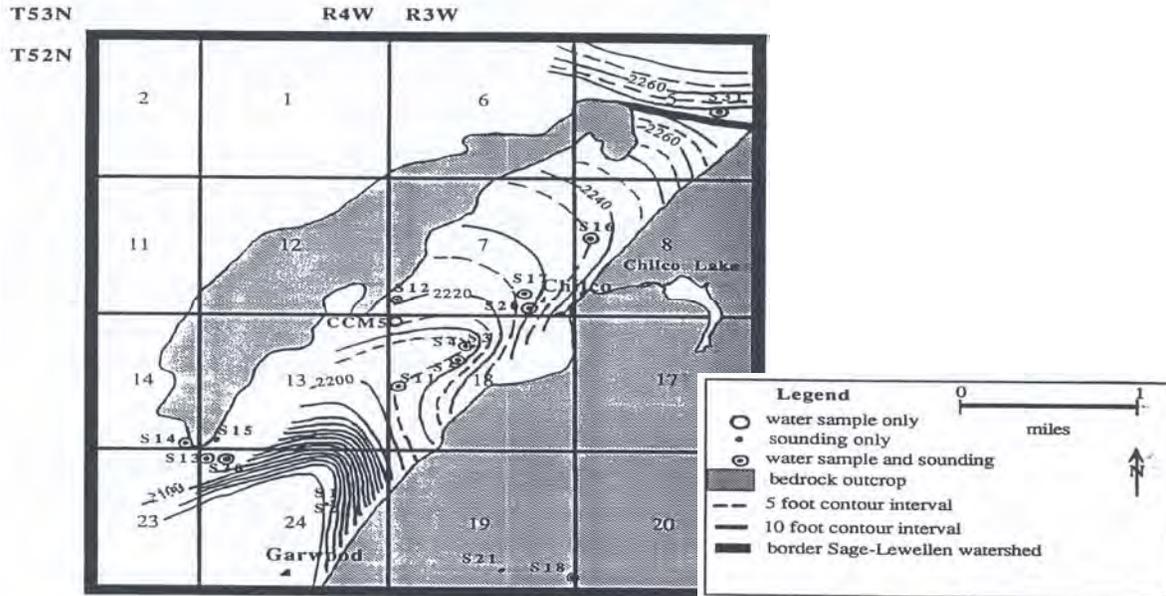
Figure 2. Ground water contour map of the Chilco channel (modified from Graham and Buchanan, 1994).

DEQ projected the information from Graham and Buchanan (1994) onto an aerial photo of the study area and approximated ground water flow paths based upon the potentiometric surface contours. As illustrated, the ground water flows westward from the eastern margins of the channel, then flows southwesterly in the central part of the channel (Figure 3). At the DEQ529 well, ground water flow direction was identified to be almost westerly.

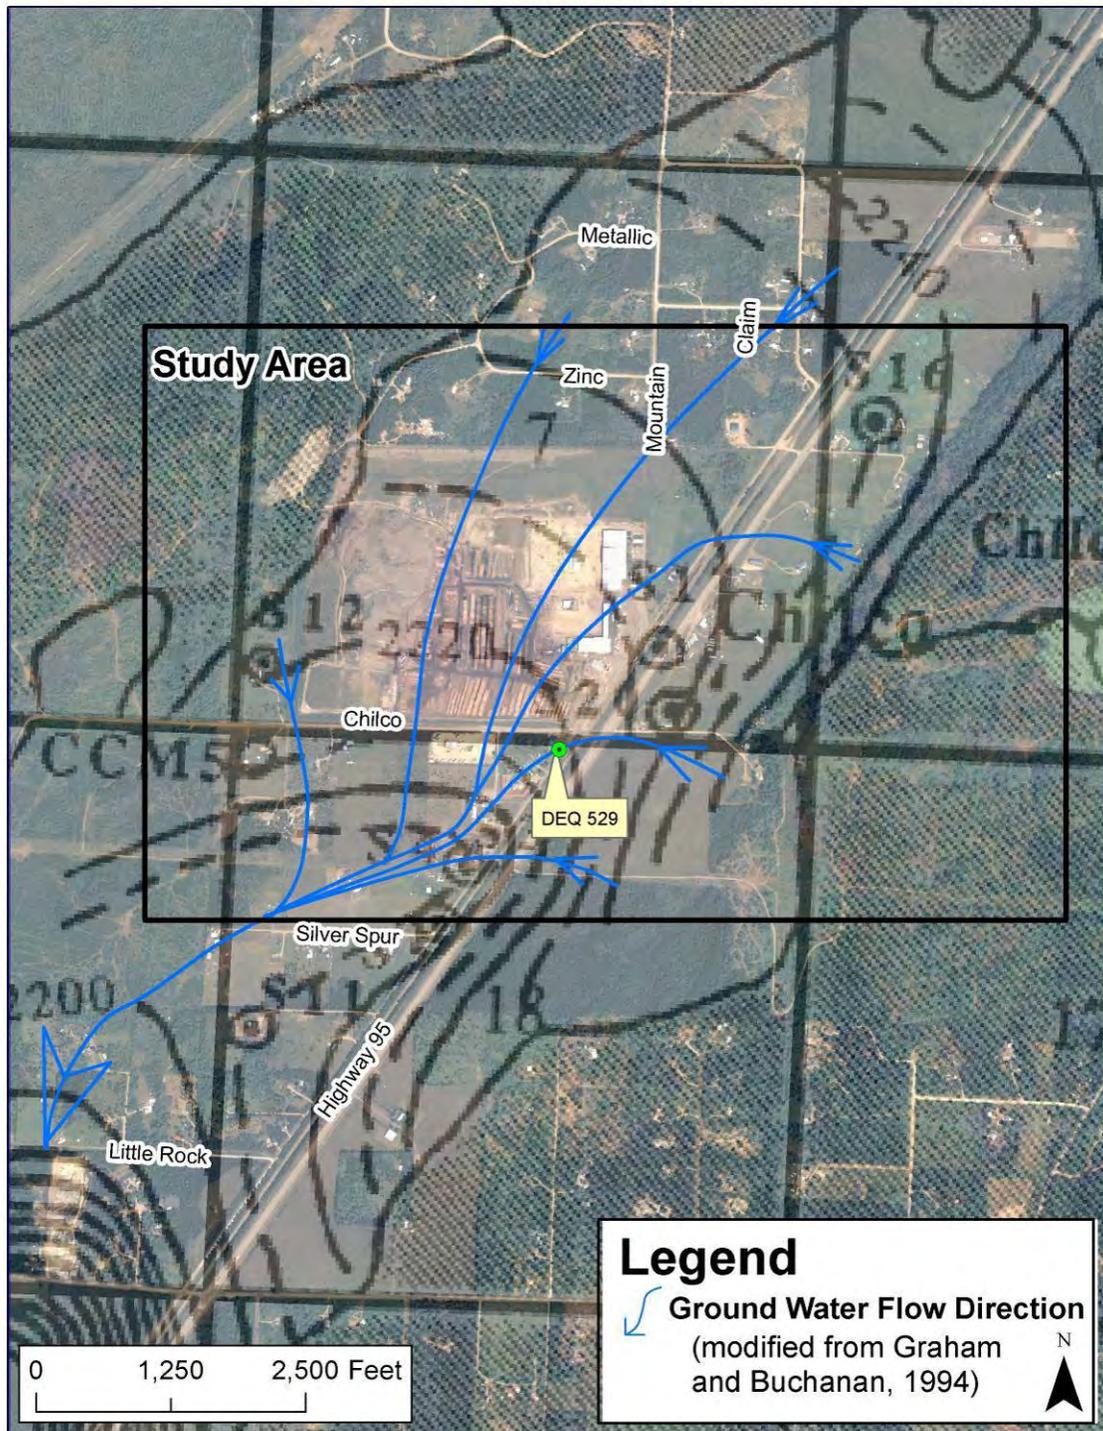
Figure 3. Ground water contours within the study area, from Graham and Buchanan (1994).Ground water flow paths are illustrated as blue lines. Street names have white backgrounds.

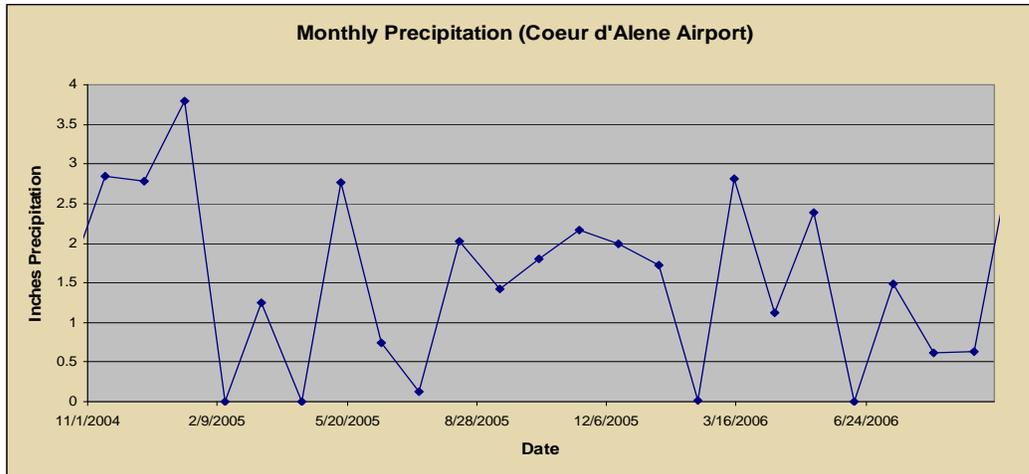
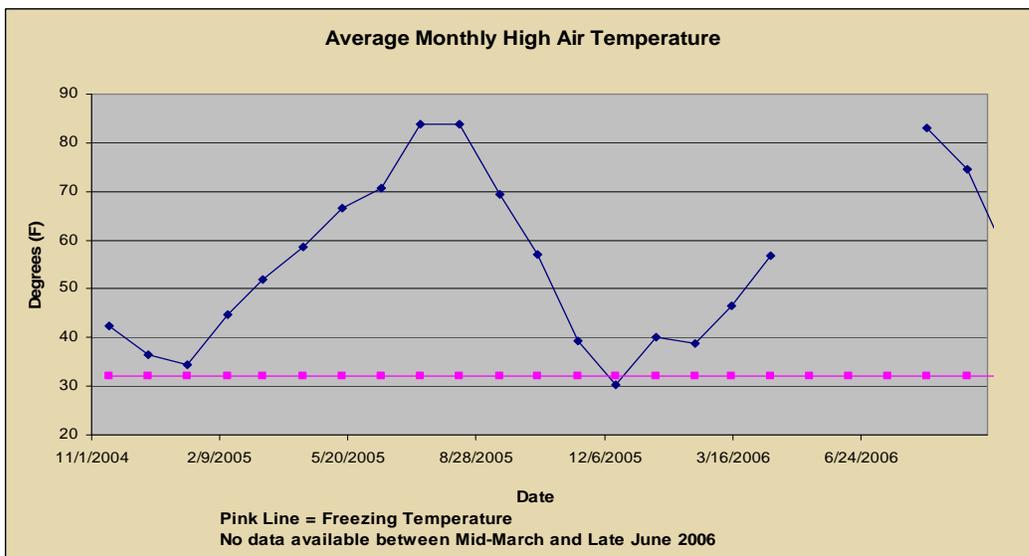
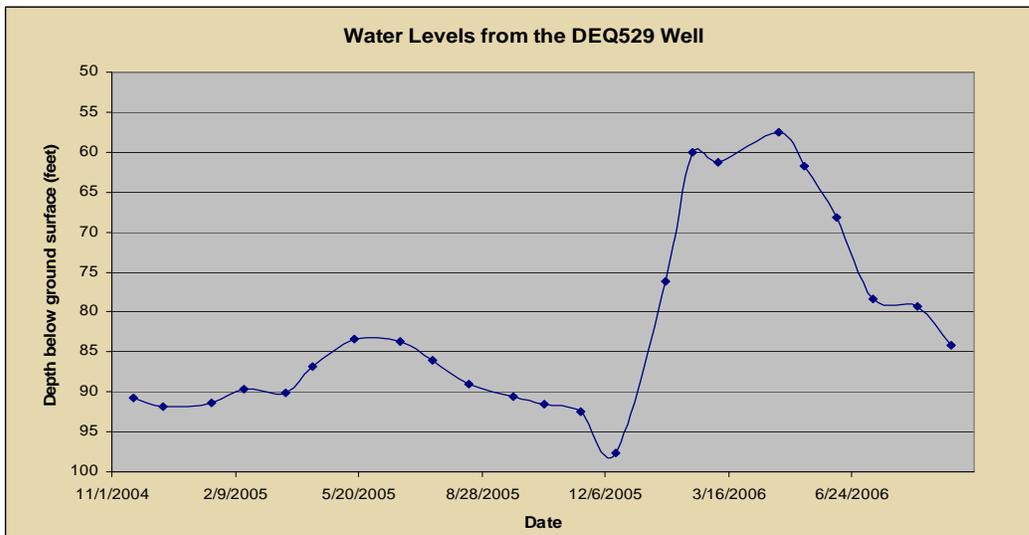
Figure 4. Monthly graphs of precipitation, average monthly high temperatures, and water levels from 11/1/2004 to 6/24/2006, illustrating short time response fluctuations in ground water levels due to precipitation/snowmelt events.

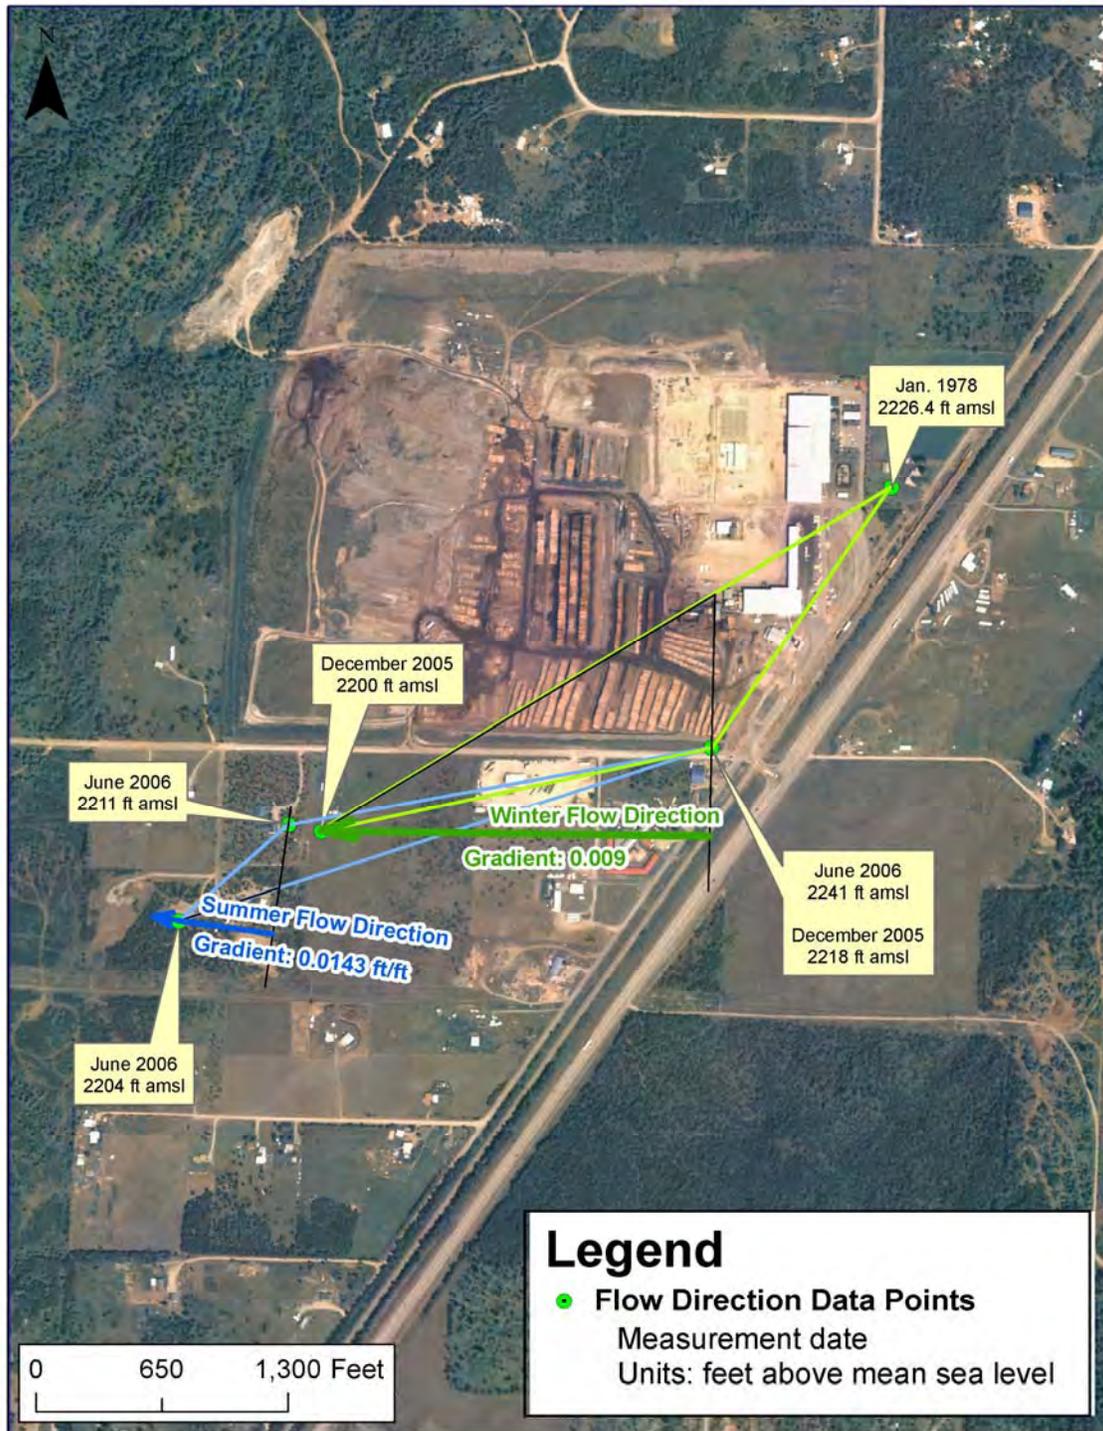
In an effort to identify site-specific seasonal flow directions, ground water flow direction was calculated using three-point diagrams with summer data from June 2006 and winter data from December 2005 (Figure 5). Only two December 2005 measurements were available, so another winter measurement—from January 1978—was used. As seen in Figure 3, the ground water flow direction in the vicinity of the DEQ529 well appears to be consistently in a westerly direction, with very little seasonal variation. DEQ’s findings therefore agree with the ground water flow direction described by Graham and Buchanan (1994).

Figure 5. Calculated ground water flow direction based upon water levels measured at three sample sites in the summer (June 2006) and three in the winter (two December 2005 and one January 1978).

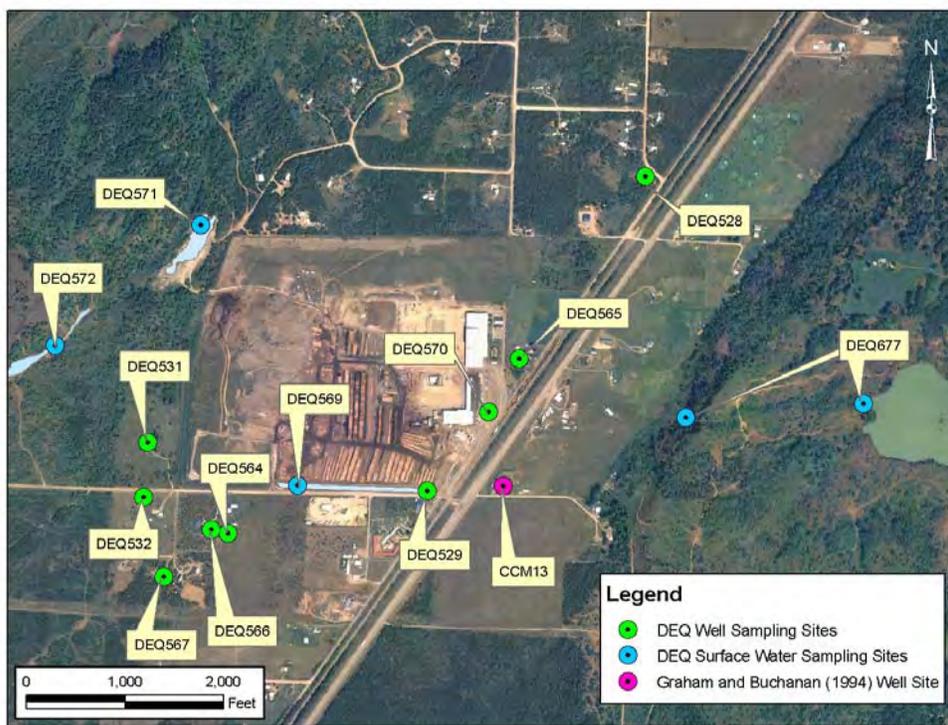
Figure 6. Sampling locations within the study area. Wells are identified with green circles, and surface water sites with blue circles. The pink circle shows the location of a well sampled in a 1994 study (Graham and Buchanan) that is referenced in this report.

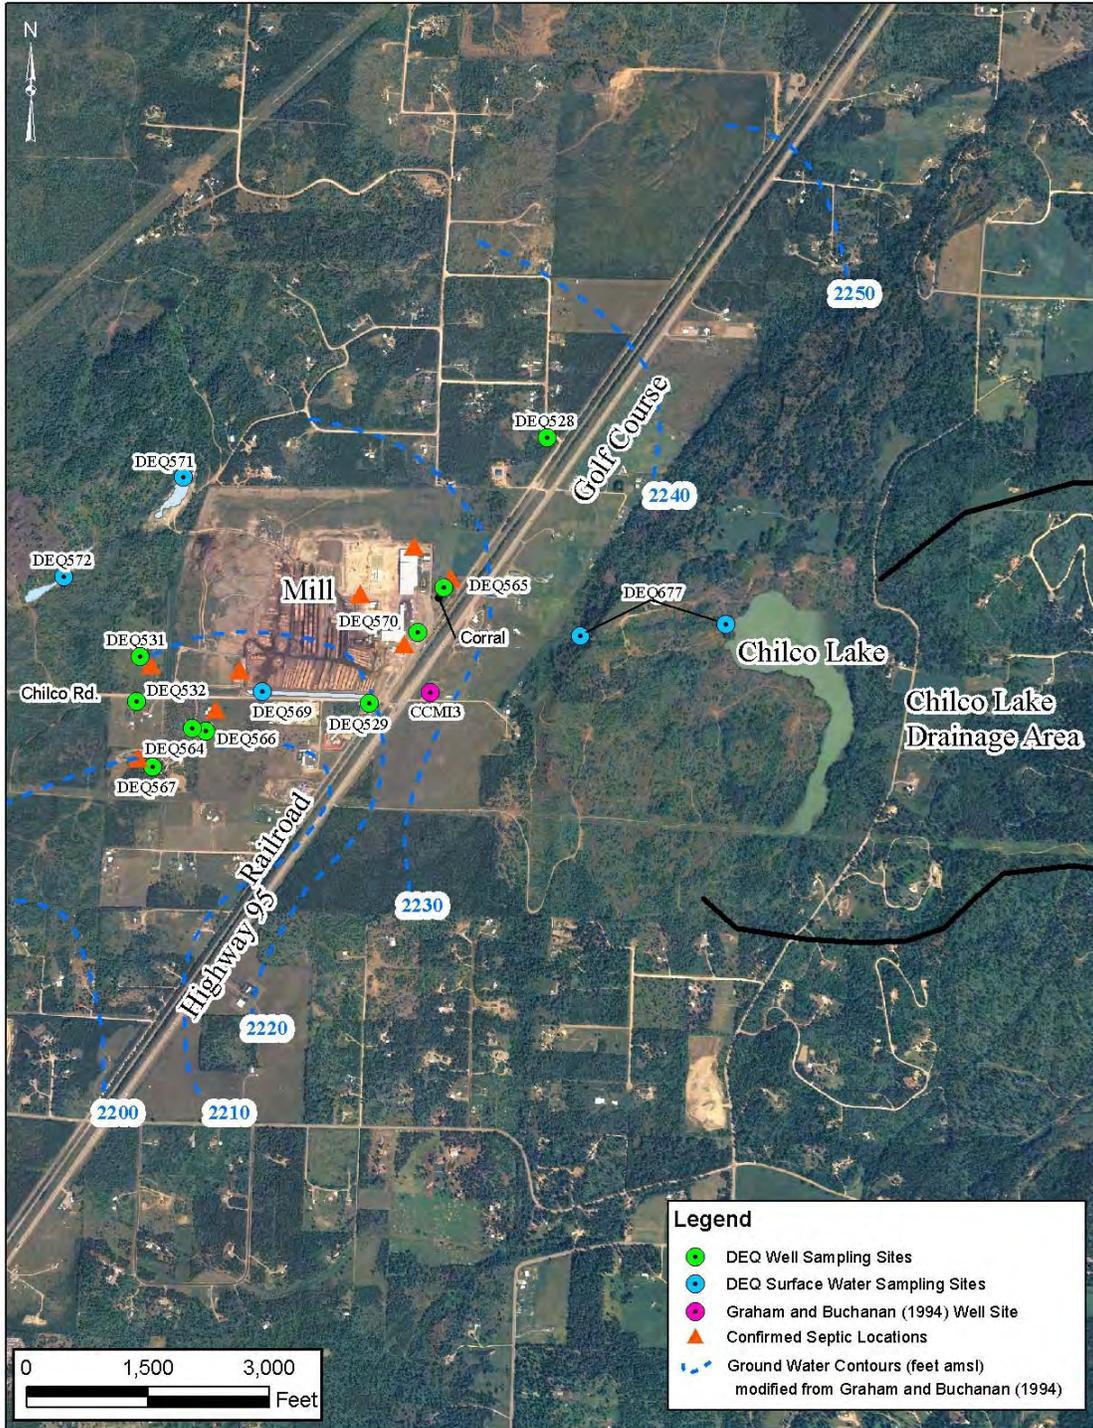
Figure 7. Locations of potential contaminant sources in the Chilco area. The LP Mill, golf course, Highway 95, Chilco Road, railroad, confirmed septic tank locations, Chilco Lake, and Chilco Lake’s drainage area (bound by black lines) are specifically identified. For reference, DEQ sampling locations and ground water surface contours (modified from Graham and Buchan, 1994) are illustrated.

The orange triangles in Figure 7 are locations of confirmed septic drainfields. The investigator talked with resident occupants and confirmed the presence of a septic tank at each residence noted on the map. Septic tanks and drainfields are the most widely used form of sewage disposal in the Chilco area. A septic drainfield can be assumed to be present at the other houses in the mapped area even though their locations were not confirmed during this study.

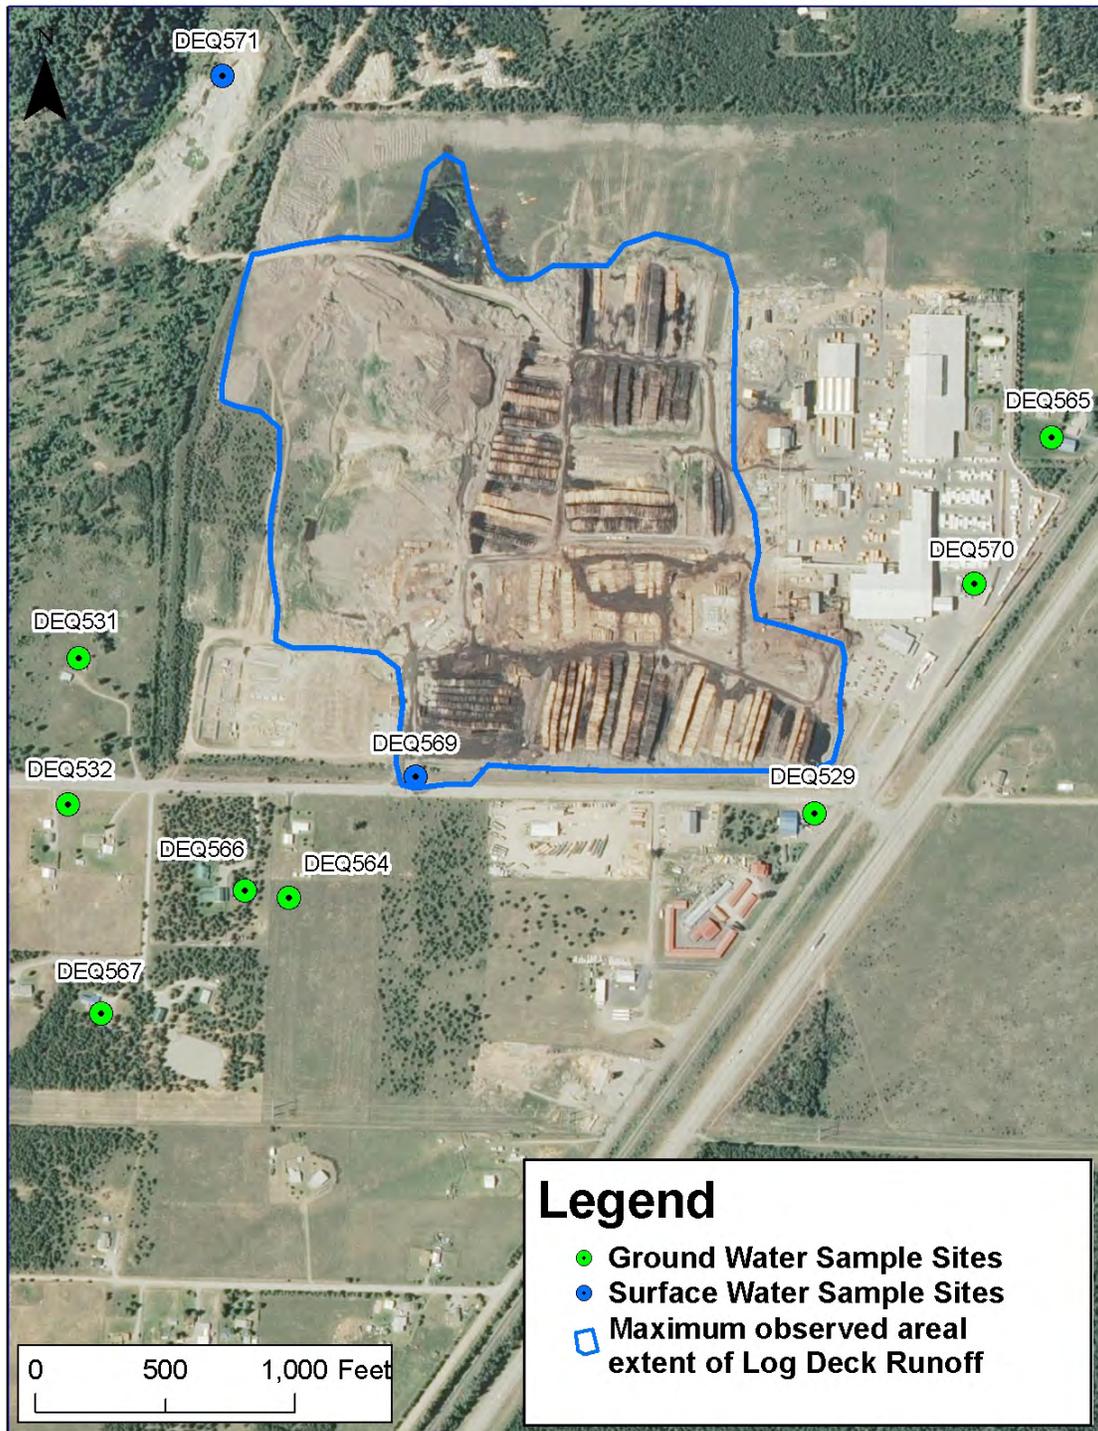
Runoff from the log decks appears to drain to the west and north, and to a ditch on the southern boundary of the site (Figure 8). The amount of surface area affected by log deck runoff appears to be directly related to overall mill production. In 2006, before the housing market downturn (and presumed accompanying reduction in lumber sales) that started in 2008, runoff could be seen in most of the blue-outlined area in Figure 8. In 2009, reduced production resulted in less surface area being affected by log deck runoff, which can be seen as the darker areas surrounding the log deck in Figure 8.

Figure 8. 2009 image (USDA) of LP Mill site. Runoff from the logs is visible as the darker areas between and around the log decks (inside the blue outlined area). The blue perimeter represents the maximum aerial extent of log deck runoff as observed from Google Earth historical imagery. When the mill is in full operation, water drains to the west and the north, and to a ditch on the southern boundary of the site.

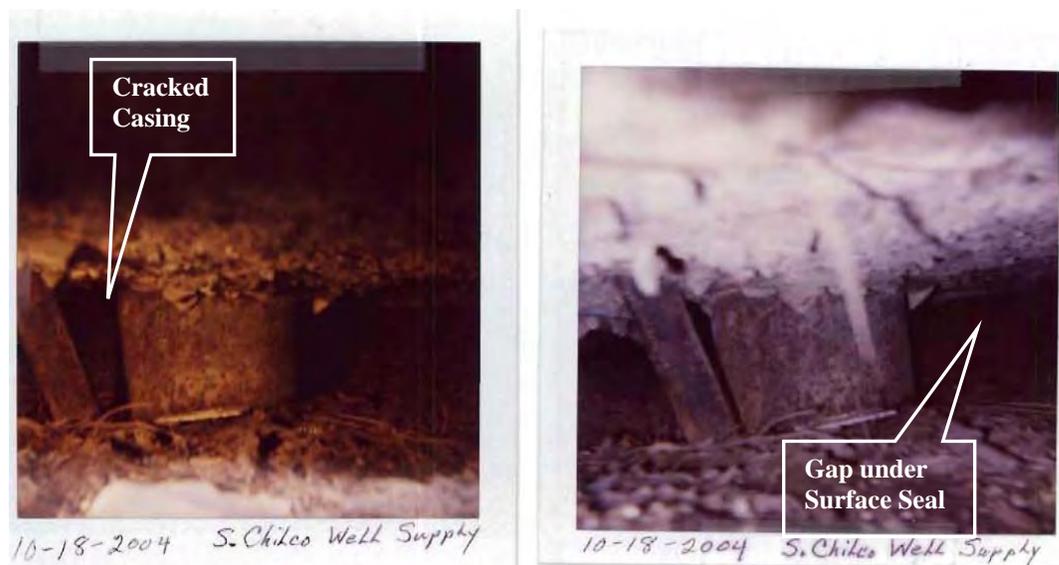
An apparent contamination pathway exists at the DEQ529 well, which was constructed in 1970 and appears to have been compromised at an unknown date. Routine testing of this well detected total coliform and *E. coli* contamination. In October 2004, a local resident took two photos, which illustrated a crack in the **casing** and a gap between the bottom of the concrete surface seal and the ground surface (Figure 9). The pictured damage may establish a direct contamination pathway to the aquifer, as evidenced by discoloration in drinking water after rainy weather, and by elevated turbidity levels in the well (DEQ, 2005).

Figure 9. Photos of the DEQ529 well casing in October 2004, illustrating the cracked casing and the gap between the surface seal's underside and the ground surface.

In an effort to address this contamination, local residents reportedly packed dirt back under the surface seal and regraded the ground slope adjacent to the well in 2005 so surface water would drain away. DEQ is not aware of the depth to which the crack in the casing extends or of any efforts to fix the casing.

- Effectively repair or properly abandon the DEQ529 well so potential surface-related contamination does not enter the aquifer.
- Extract and analyze DNA samples from bacteria in ground water and surface water to help determine the origins of bacterial contamination.

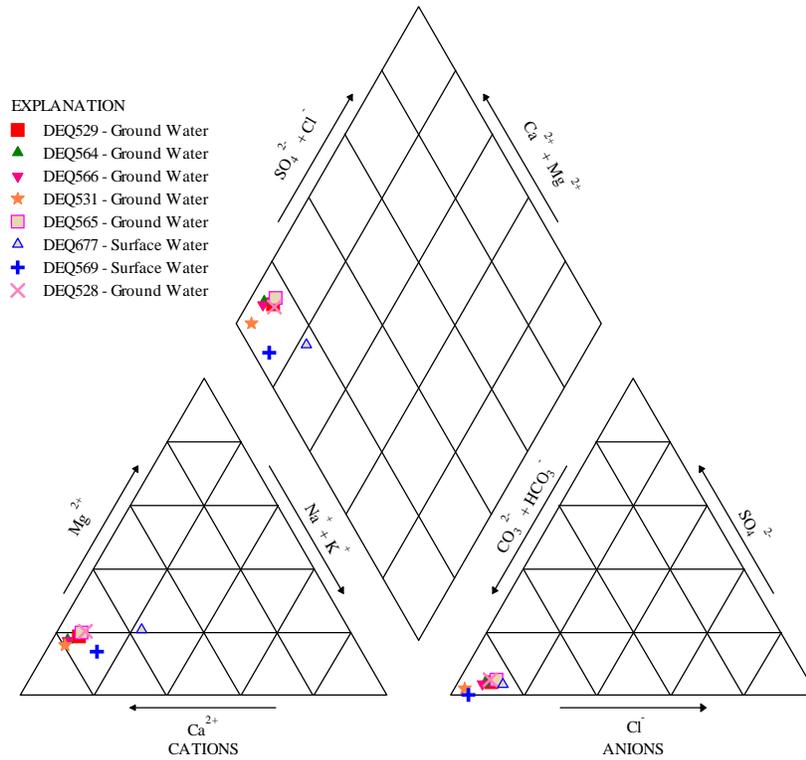
Chilco Area Piper Diagram for Samples Collected on September 6, 2006

Figure 10. Piper trilinear diagram for water samples from selected wells within the Chilco study area (September 2006). Chemical symbols are defined in Appendix A.

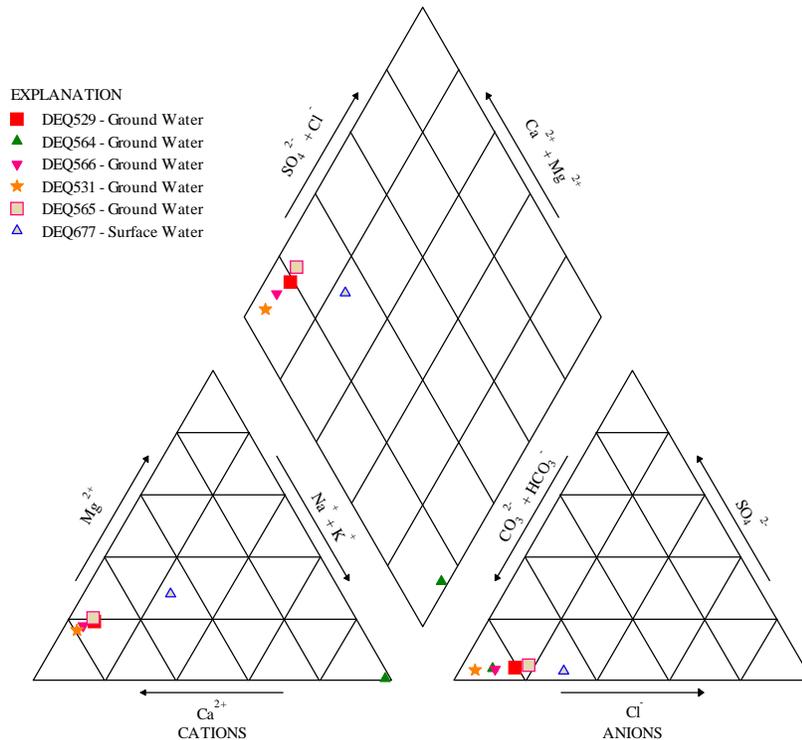
Chilco Area Piper Diagram for Samples Collected on May 20, 2009

Figure 11. Piper trilinear diagram for water samples from selected wells within the Chilco study area (May 2009). Chemical symbols are defined in Appendix A.

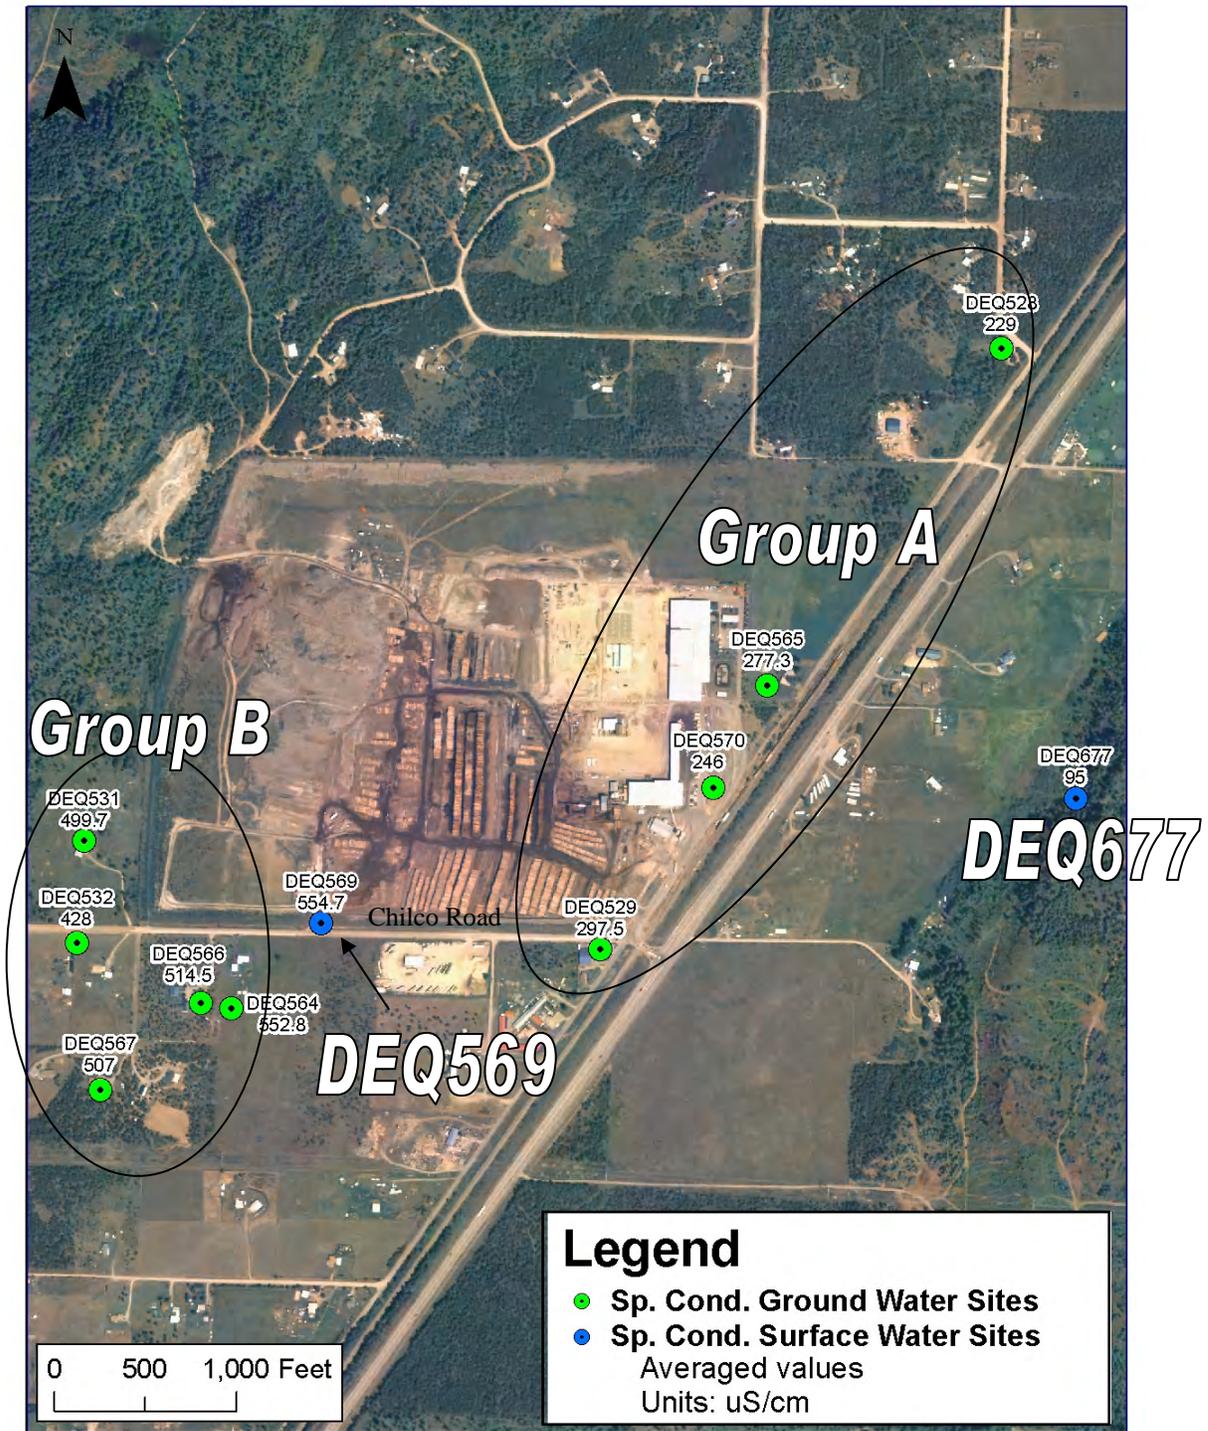
Within Group A, water samples from the DEQ529 well had an average specific conductivity of 297.5 $\mu\text{S}/\text{cm}$ (Figure 12) measured from September 2006 to February 2009. That value is approximately 7% greater than the specific conductivity average from a well that is up-gradient approximately 0.3 miles to the northeast (DEQ565), and 29% greater than the specific conductivity average from another up-gradient well approximately 0.75 miles to the northeast (DEQ528). The implication of the data within Group A is that specific conductivity is slightly increasing in the down-gradient direction.

Figure 12. Averaged specific conductivity values for selected sampled wells and surface water sites. The specific conductivity values measured along Highway 95 (Group A sites) were almost one-half of those measured along Chilco Road (Group B sites). In a surface water sample taken along Chilco Road (DEQ569), specific conductivity measured only slightly higher than in nearby ground water samples.

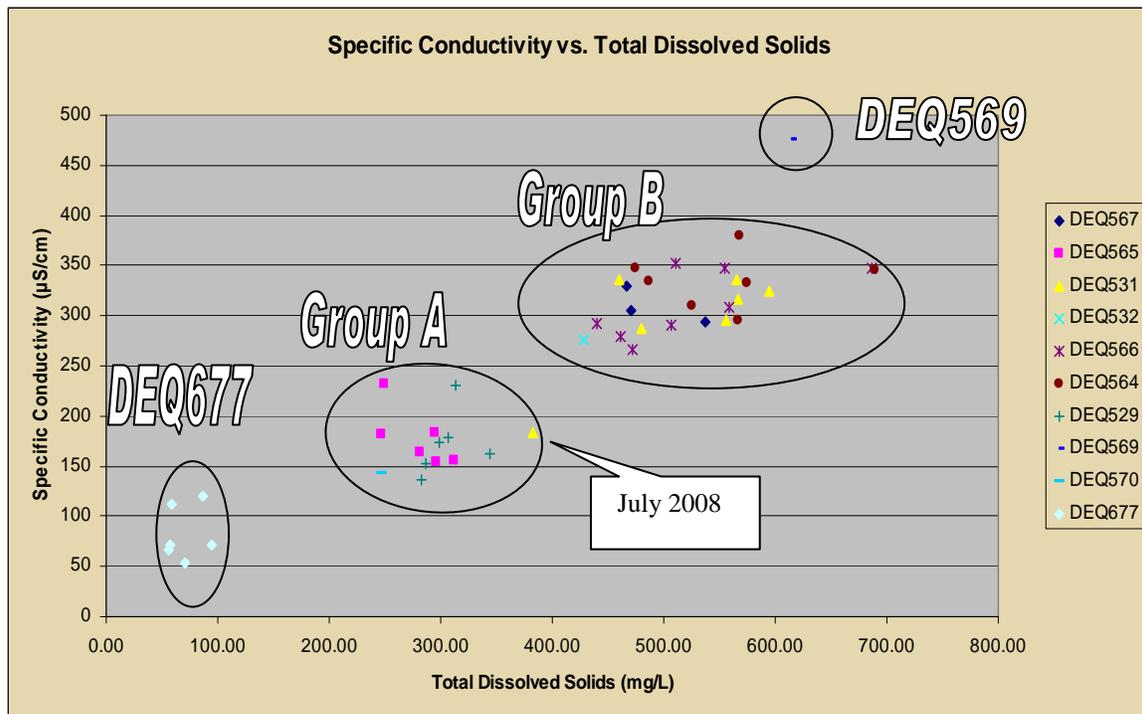
Figure 13. Specific conductivity and total dissolved solids sample results for each sampling event. The four groups of data represent distinct water chemistries. The July 2008 results for the DEQ531 well plotted near the Group A wells, suggesting a change in water chemistry as compared to all other results for that well.

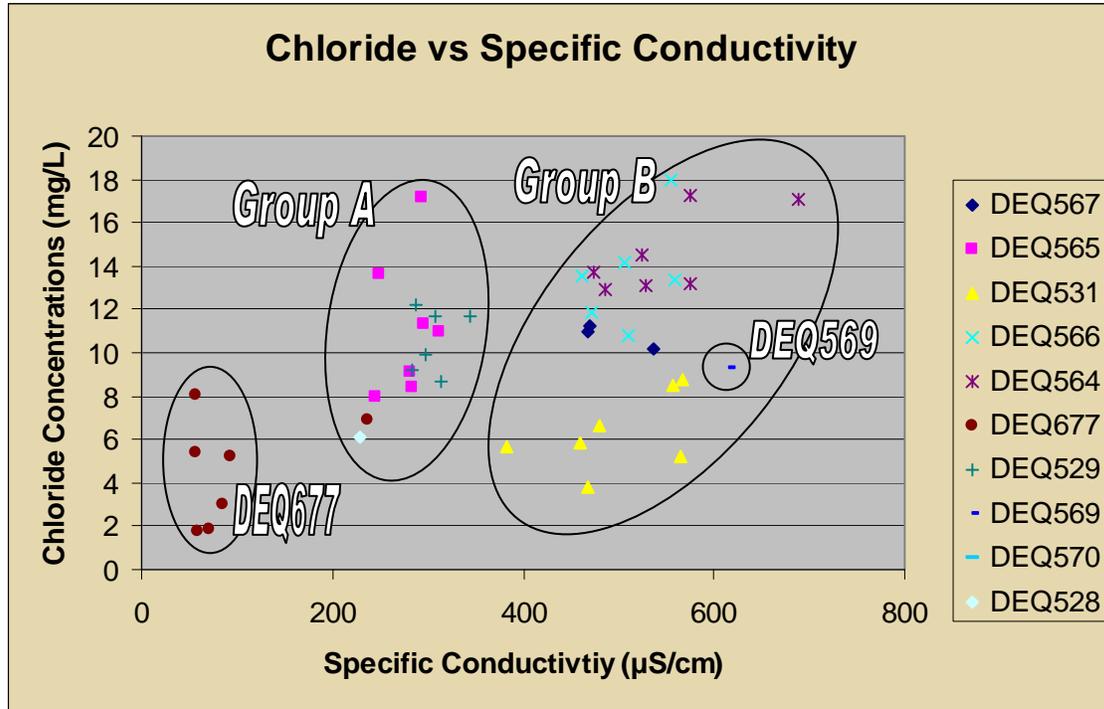
Figure 14. Graph comparing chloride concentrations (mg/L) to specific conductivity measurements (µS/cm) of selected wells for sampling events between September 2006 and May 2009.

Not included in Figure 14 are results for two samples from the DEQ569 sample site which contained chloride concentrations of 284 mg/L (December 2006) and 87 mg/L (March 2007). The two highest chloride measurements for both the DEQ564 well and the DEQ566 well were recorded in late spring or early summer, a timeframe when aquifer recharge from snow melt would have been the greatest (Figure 4). The time frame in which chloride concentrations are greatest in the DEQ569 well and also in the down-gradient wells suggests that de-icers may be the source of elevated chloride concentrations. In addition to the potential use of de-icer at the mill, road de-icer is only applied to Chilco Road where it crosses the train tracks, a location approximately 1,700 feet east of the DEQ569 site (Lakes Highway District, personal communication, September 2010).

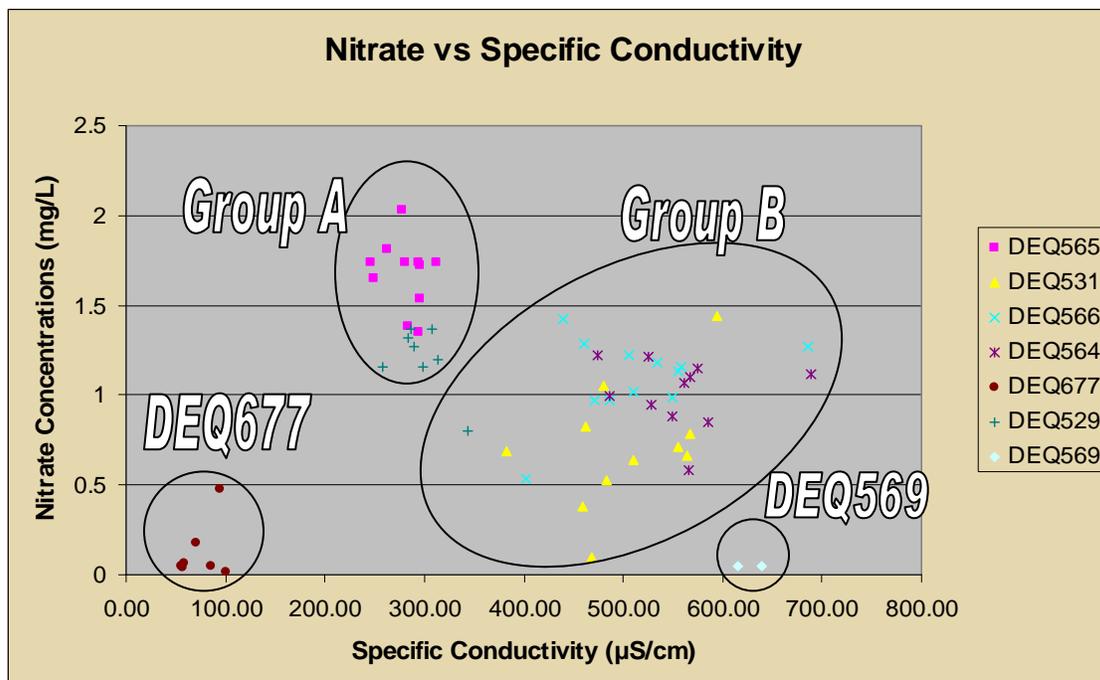
The nitrate-specific conductivity graph in Figure 15 shows the relationship between nitrate concentration and specific conductivity.

Figure 15. Graph illustrating the relationship between nitrate concentration and specific conductivity in selected wells.
