***Watershed Overview & History  
North Fork Coeur d'Alene River Subbasin***

***Little North Fork - Road 209 Stream Restoration Project***

***Submitted to:  
Glen Rothrock  
Idaho Department of Environmental Quality***

***Completed by;  
Watershed Professionals Network  
Boise, ID***

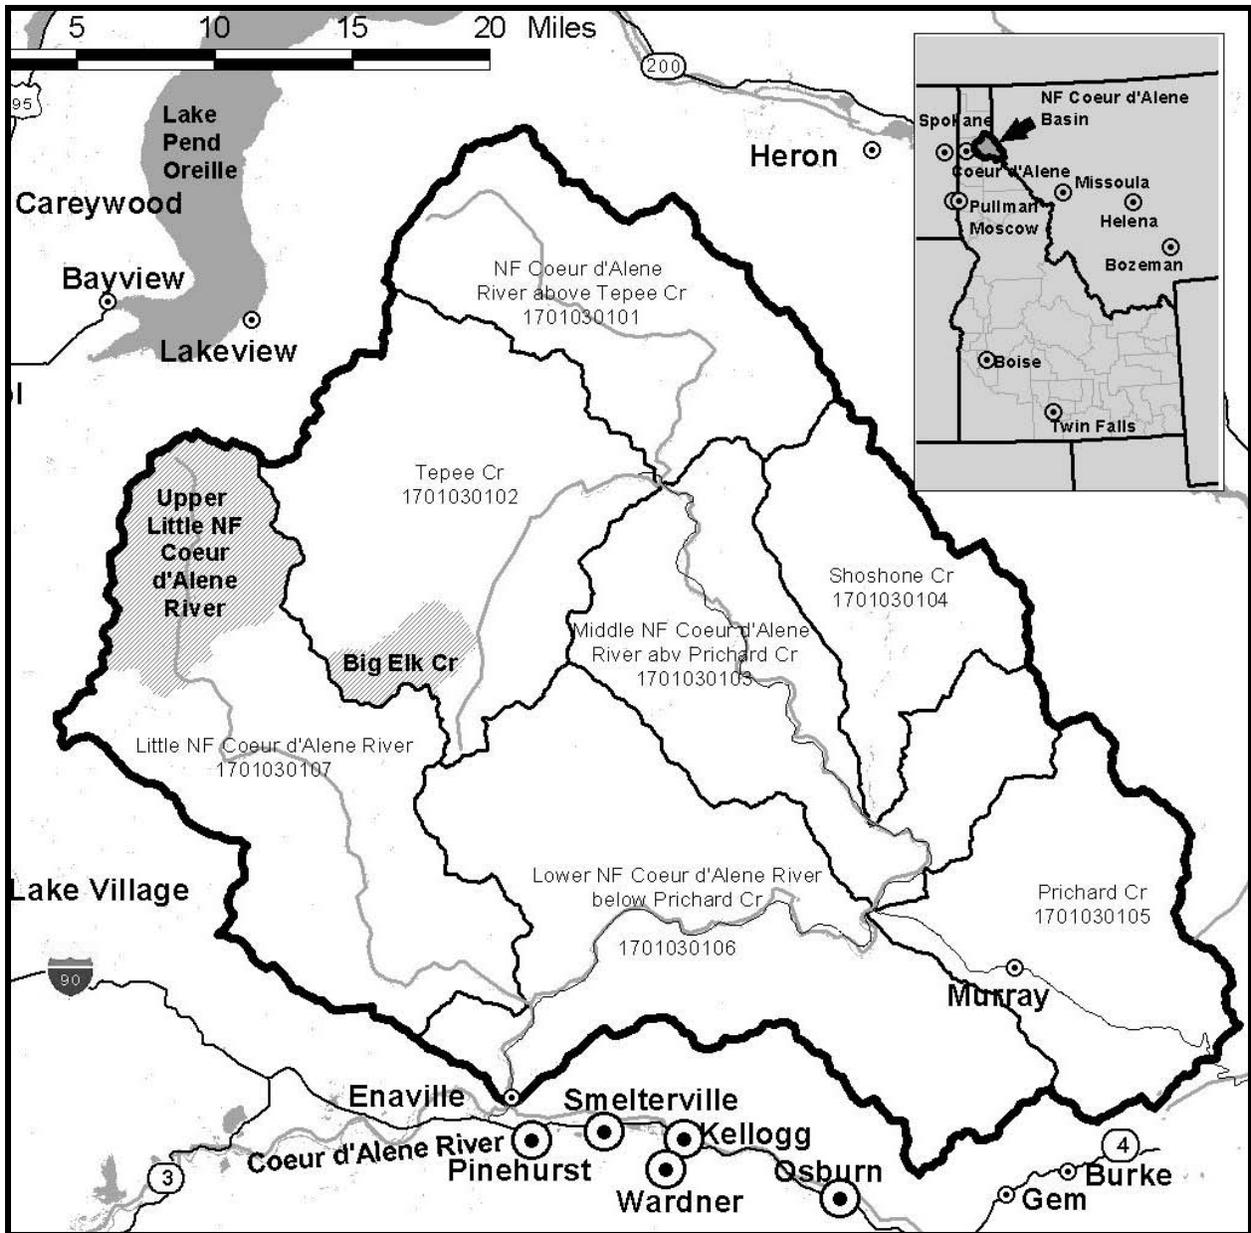
Figure 1: North Fork Coeur d'Alene subbasin location and 5th code HUC boundaries.

The hydrologic and sediment source modeling for roads and tributary streams was focused on two sub-basins, the upper Little North Fork CDA River and Big Elk Creek (tributary of Tepee Creek) (Figure 1) which represented the range of the past management actions in the watershed. These subbasins were selected because stream segments in both of these basins were listed in the TMDL for sediment and there are several currently-operating stream gages which were critical to the hydrologic modeling.

The entire North Fork drainage basin is classified as a 4th field hydrologic unit (or cataloging unit) by the US Geological Survey (USGS). This drainage basin is assigned the 8 digit Hydrologic Unit Code (HUC)<sup>1</sup> 17010301. The Technical Appendix (Appendix A) provides an overview of the numbering and delineation of the HUCs. It is important to note IDEQ used somewhat different boundaries and divisions for their seven, 5th field HUCs used in the *North Fork Subbasin Assessment and TMDL* document (IDEQ, 2001) than the boundaries used by the Forest Service. Unless explicitly specified, this report uses the HUC divisions delineated by the USFS (Figure 1, Table 1).

The two subwatersheds selected for analysis were the upper Little North Fork Coeur d'Alene River, upstream of the confluence with Burnt Cabin Creek (hereafter referred to as the ULNF), and Big Elk Creek (Figure 1). These subwatersheds had continuous stream flow data (for model calibration purposes), and had experienced moderate to high levels of forest harvest and road construction. The ULNF has a drainage area of 44 mi<sup>2</sup>, and the period of record for the stream gage at the subwatershed outlet is from 2001 to present. Big Elk Creek is a tributary to Teepee Creek, draining an area 11.6 mi<sup>2</sup> in size, and the gage period of record is from 1988 to present.

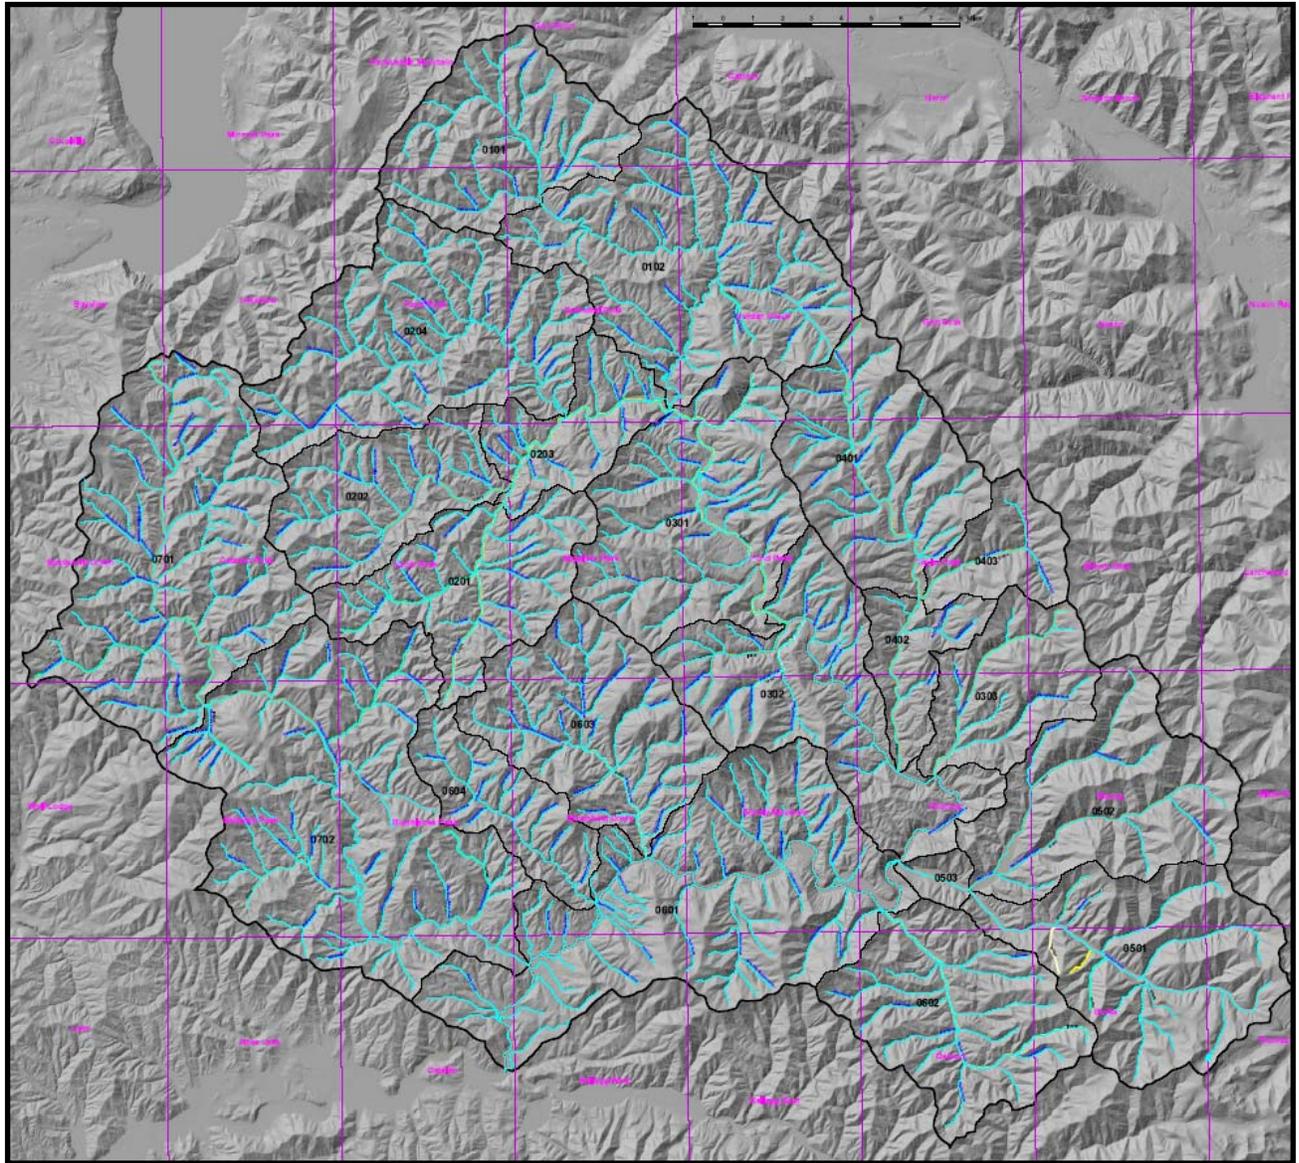
Figure 2 : North Fork Coeur d'Alene shaded relief topography.

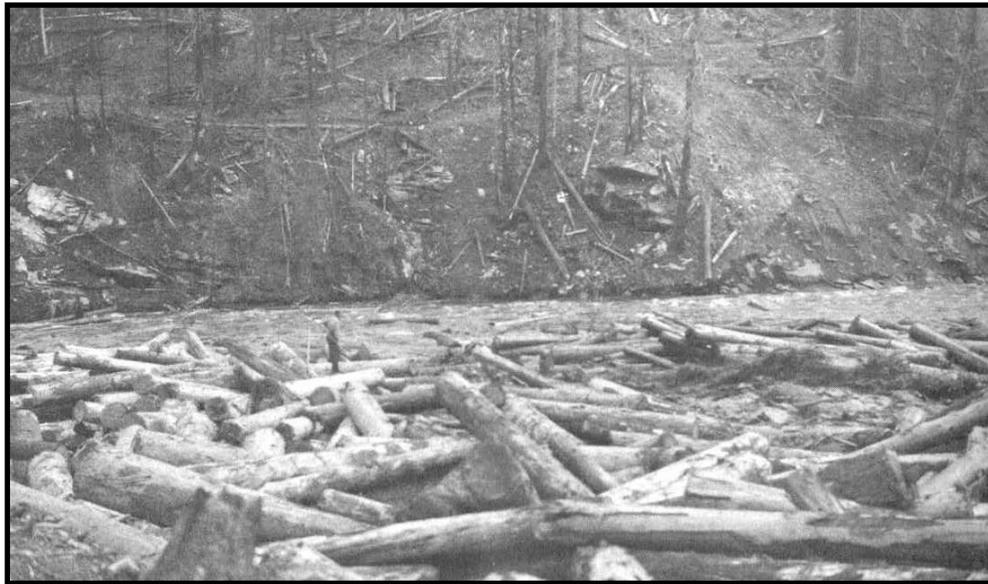
Figure 3. Logs ready for log drive. Note lack of riparian buffer, and bare soil on hillside where logs were slid into river (University of Idaho).

Each mile of log chute or flume built required over a quarter-million board feet of timber. There were hundreds of miles of chutes built in the Coeur d'Alene Basin. In the North Fork, 35 flume projects were built with a total mileage probably exceeding 150 miles (Strong and Webb, 1970). With the completion of the Brunt Cabin railroad in 1923, heavy harvest began in the Burnt Cabin Creek area of the Little North Fork HUC. Over 250 billion board feet were harvested between 1923 and 1944. The peak of this logging activity occurred in 1929, and the last log drive occurred in 1943 (Strong & Webb, 1970).

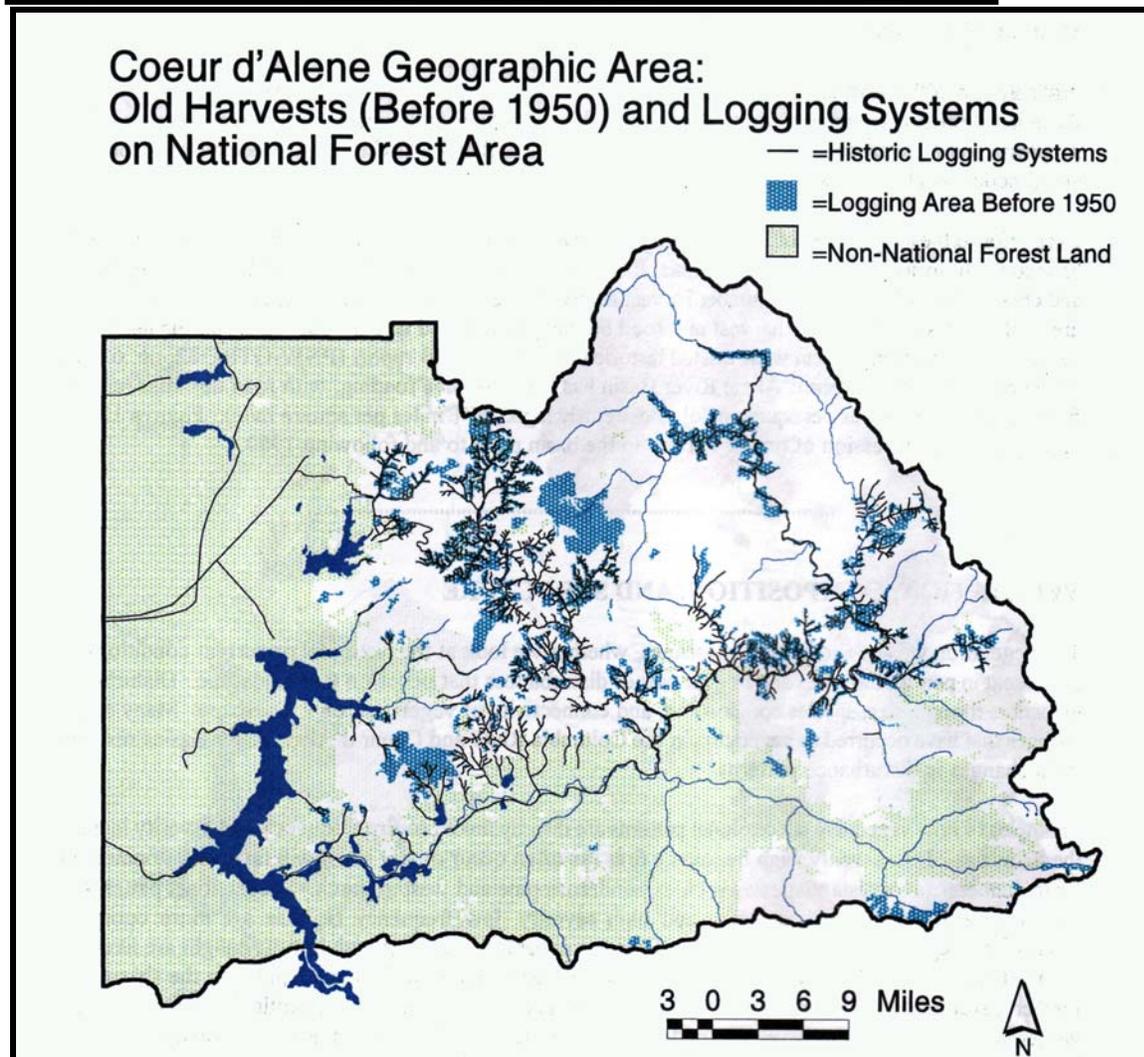
Figure 4. Map of Historic logging systems and harvest within National Forest lands of the Coeur d'Alene River Basin (USFS 1998).

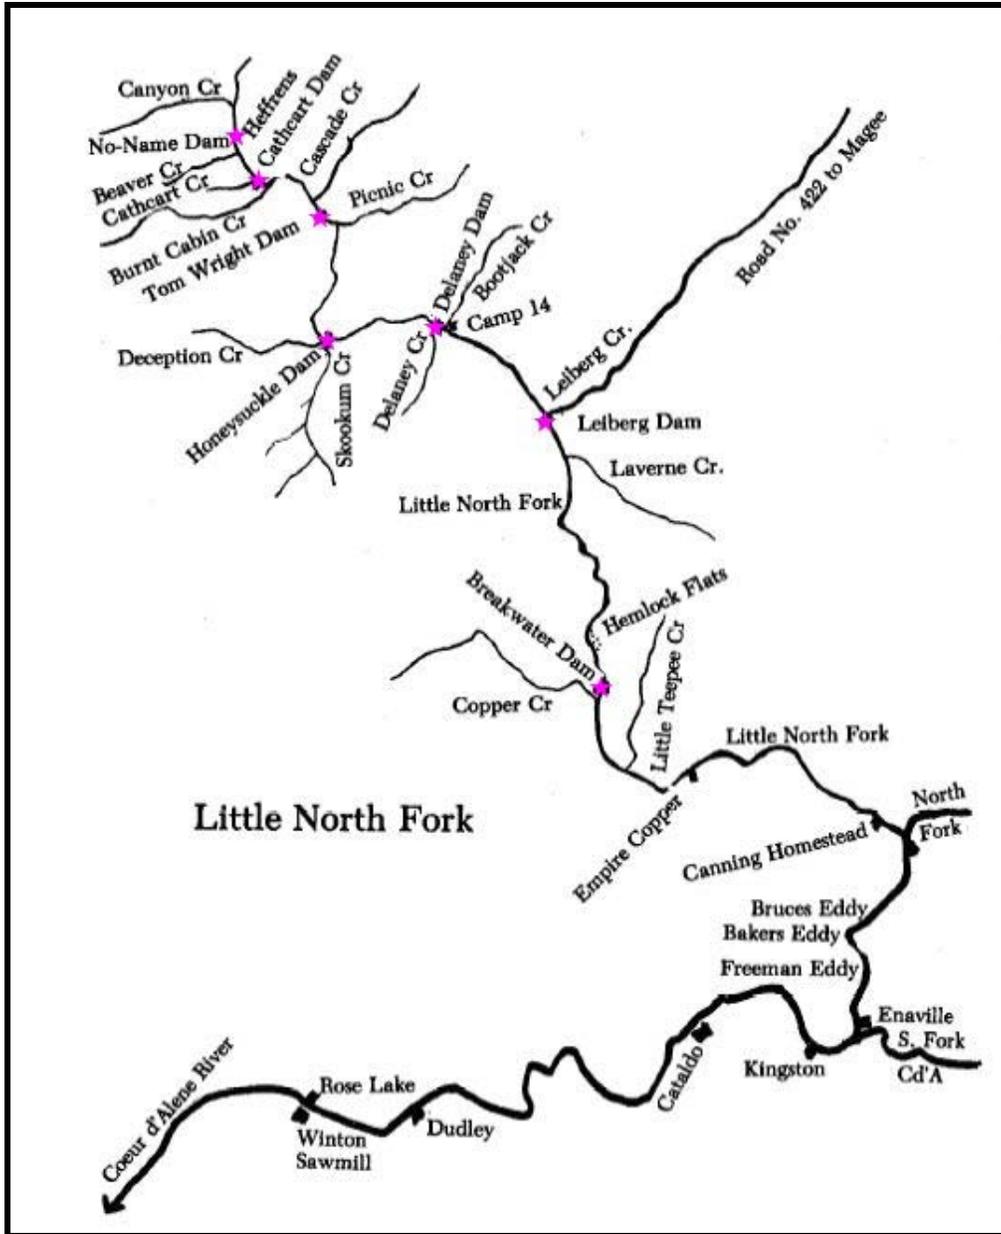
Figure 5. Locations of splash dams on the Little North Fork Coeur d'Alene River (Russell 1984).

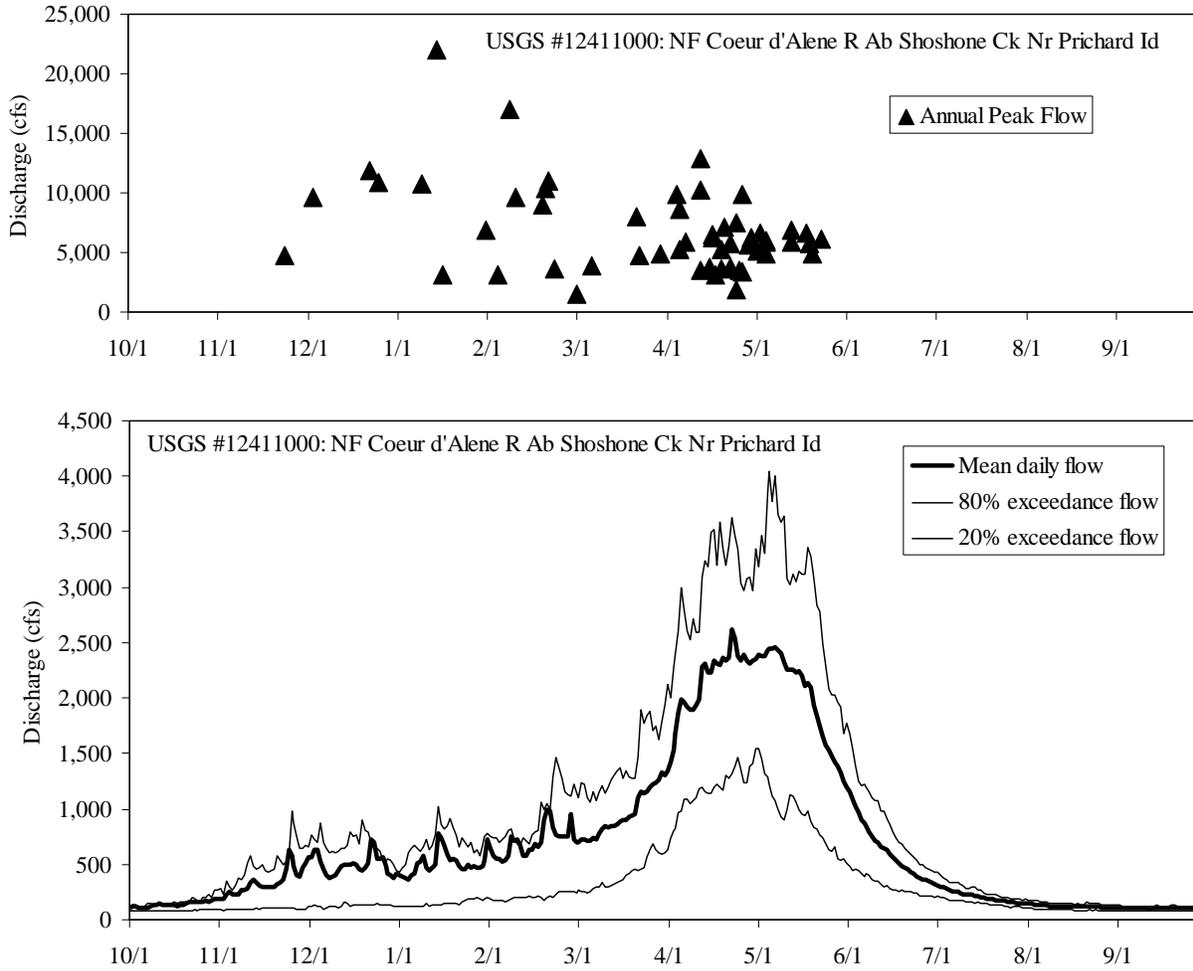
**Figure 7. Mean daily flow (bottom) and annual peak flows (top) at USGS gage # 12411000, North Fork Coeur d'Alene River above Shoshone Creek near Prichard Idaho (mean daily flows are averaged over the period December 1950 to September 2006). 20% and 80% exceedance flow are mean daily flows that have been exceeded 20% and 80% of the time for the designated period.**

The mean daily flow record at the USGS gage site, North Fork Coeur d'Alene River above Shoshone Creek (Figure 7; bottom graph), illustrates overall hydrologic conditions within the North Fork subbasin. Mean daily flows fluctuate early in the winter in response to ROS events, however, the highest mean daily flows occur during the spring snowmelt season (April-June). Flows steadily decline with diminishing snowpack during the late spring and early summer, reaching their lowest levels prior to the beginning of fall rains. An examination of annual peak flows at the gage (Figure 7; top graph) indicates that approximately half of the annual peaks occur during the spring snowmelt season, and the remainder during the winter ROS season. The two largest events at the gage (1/15/1974 and 2/9/1996) were regionally significant ROS events. The pattern appears to be similar in the tributary streams.

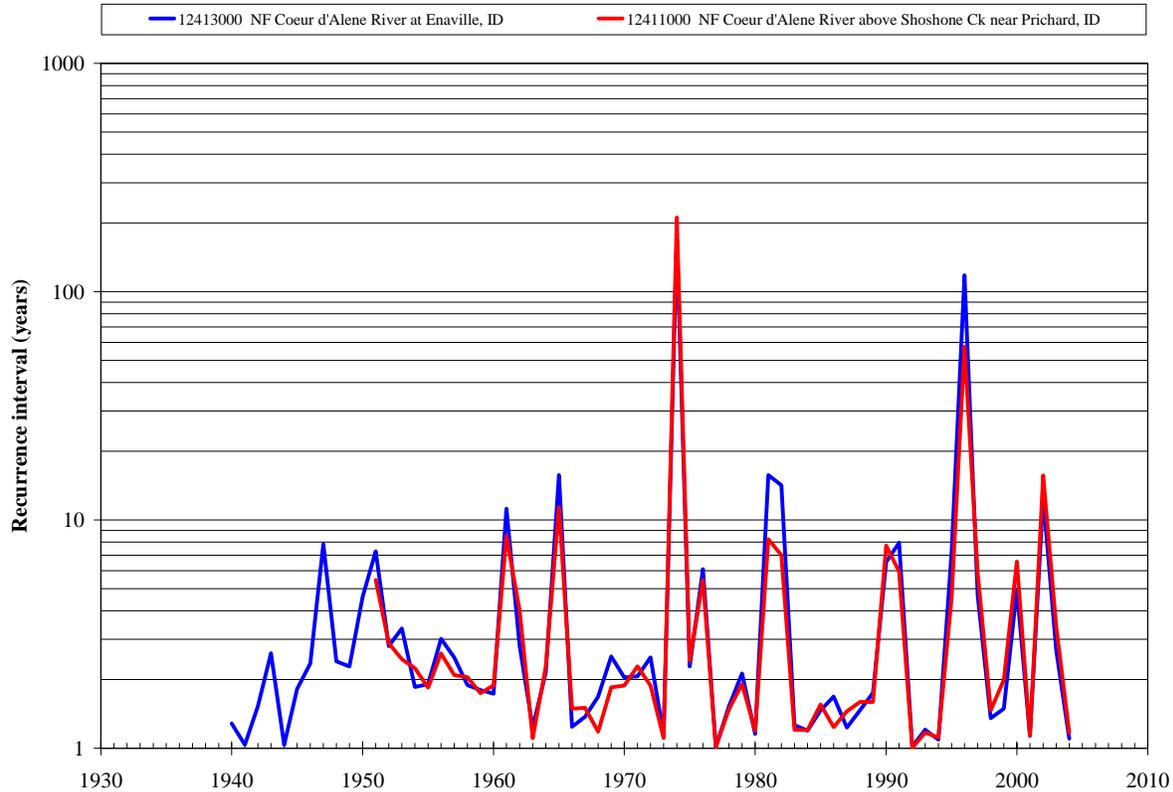
**Figure 8. Recurrence interval associated with annual peak flow events at two stream gages in the North Fork Subbasin (USGS, 2005).**

A time series of annual flood peaks was assembled for the two long-term USGS gages within the North Fork subbasin. The long-term annual peak flow history provides context to recent channel disturbances (or lack thereof) observed throughout the area. For purposes of comparison, the data are presented as a time series showing the recurrence interval of the annual flow event (Figure 8). This approach allows for a comparison of events from a wide variety of watershed sizes. Recurrence intervals were calculated for the period of record at each gage station using techniques described by the Interagency Advisory Committee on Water Data (1982). Peak flow magnitude was next plotted against probability (i.e., 1/recurrence interval) on log-probability paper. Recurrence interval was then interpolated for each event from the plotted values.

The two gages presented in Figure 8 both present a similar peak flow response. This is not surprising given that both are located on the mainstem of the North Fork River. Based on the record presented in Figure 8, it appears that the later half of the record (from the early 1970s to present) saw many larger peak flow events than the earlier half of the record. Note that this period of greater peak flow activity coincides with the cool/wet PDO cycle that began in the North Fork area in ~1973 and continues to present.

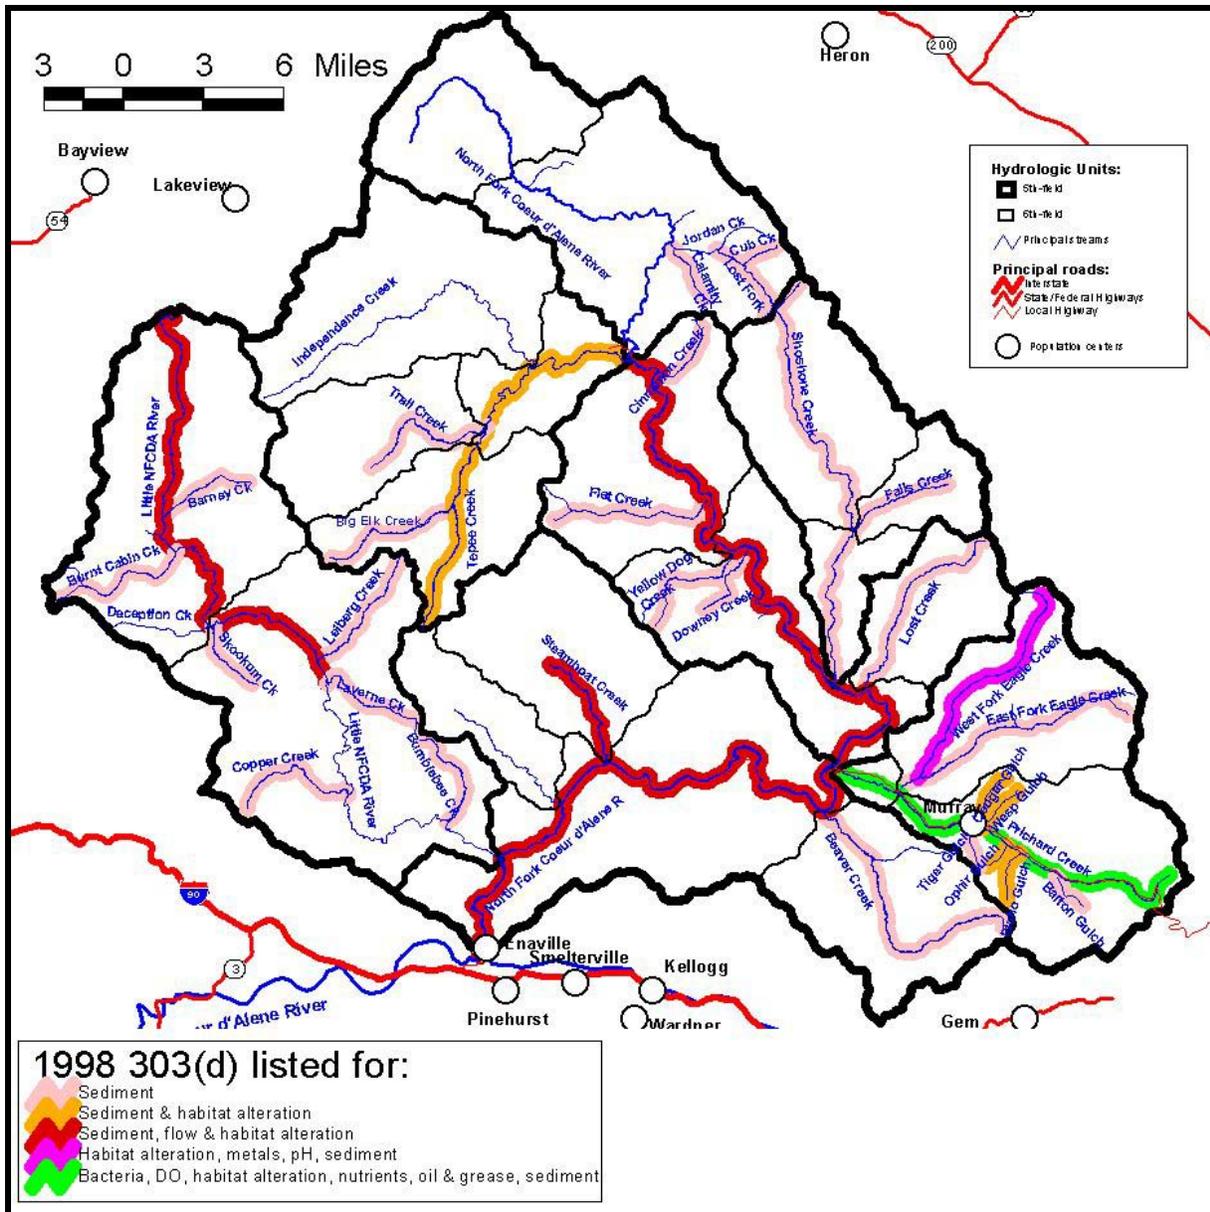
Figure 9. Water quality limited streams in the NFCDA Subbasin.

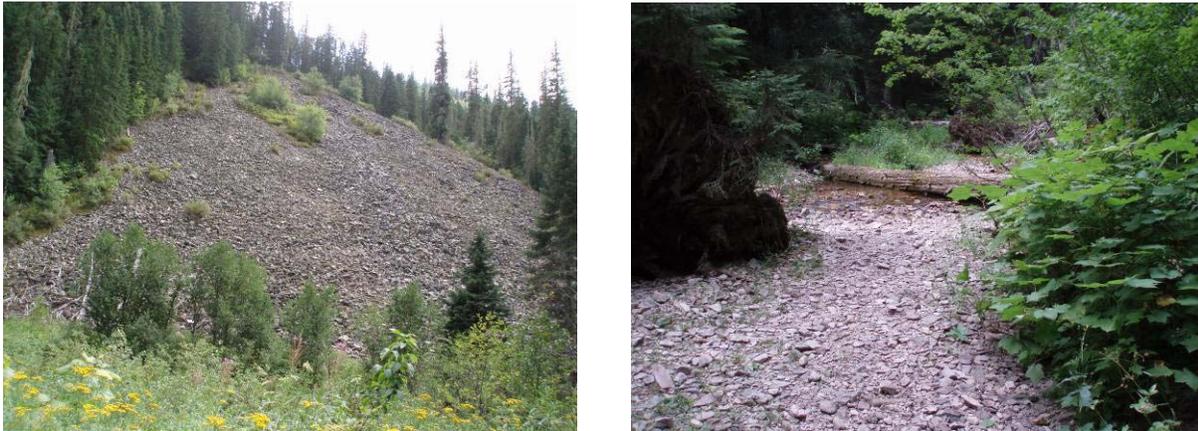
**Figure 10. Talus slopes in the West Fork Eagle drainage and similar angular sediment choking the stream**

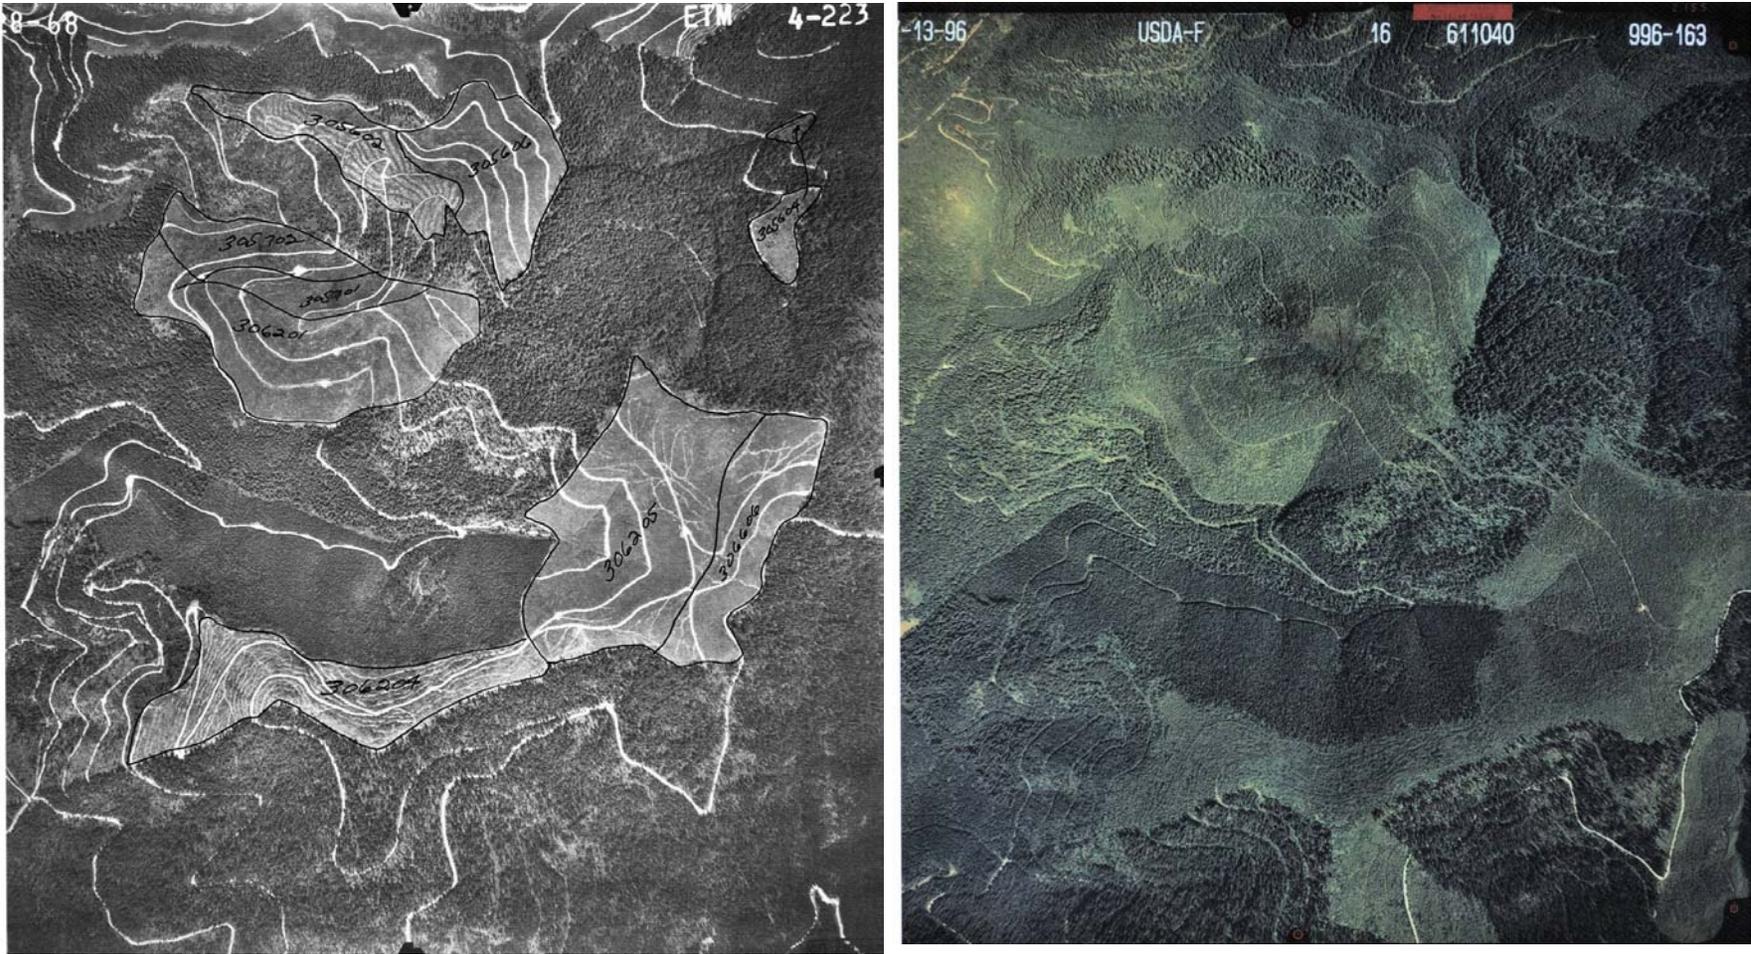
Figure 11. Aerial Photographs of Barney Creek. Left photo showing timber harvest and road building practices in 1968. Right photo, showing revegetation on past harvest units and non-system (inactive/closed) roads taken in 1996.

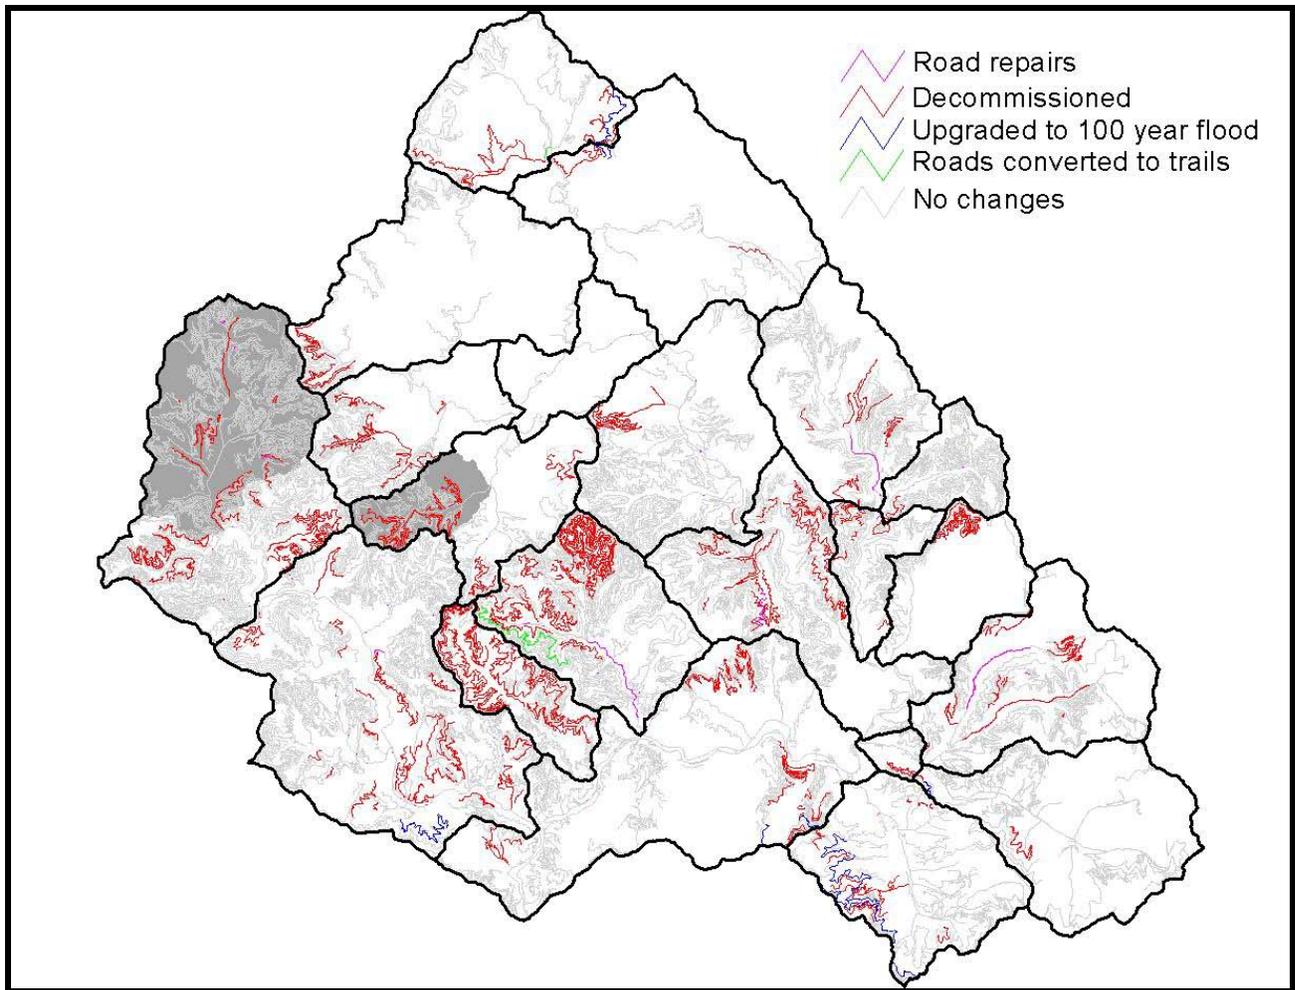
**Figure 12. Location and Status of Roads used in Analysis (note intensive study basins shaded in gray).**

Road surface erosion can occur on all unvegetated roads. Surface erosion is generally higher on native surfaced roads, steeper roads, and on roads that receive high traffic use. Good gravel surfacing, gentler slopes, less traffic, and more frequent cross drains can all reduce surface erosion. Sediment produced from road surface erosion generally does not travel farther than 200 feet from the outlet of a culvert on an insloped road, and only about 10-15 feet from the edge of a road on outsloped roads (Haupt 1959, Megahan and Ketcheson 1996). Open roads in the Upper Little North Fork and Big Elk Creek drainages were inventoried to determine delivery from

hydrologically connected segments as well as road attributes that control surface erosion (road width, length delivering, surfacing, gradient, tread drainage configuration, and outslope height and cover.) The inventory results were used to model road surface erosion and to extrapolate results to roads in the rest of the subbasin that were not inventoried.

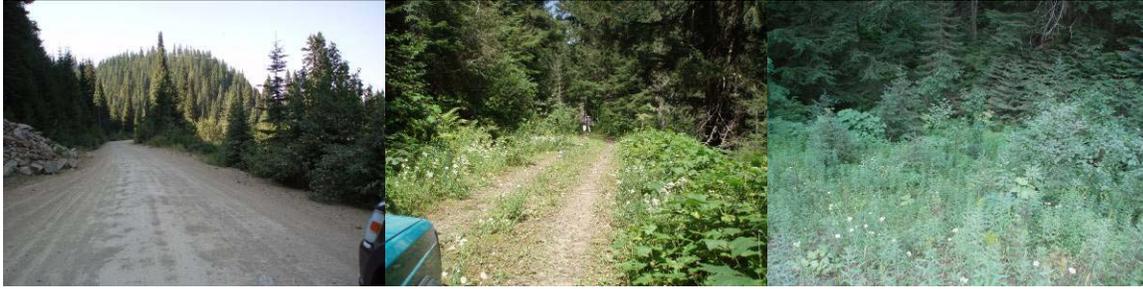
**Figure 13. Examples of main roads, secondary open roads, and closed/overgrown non-system roads**

The majority of open major forest roads in the North Fork subbasin are gravel surfaced with a 15-20 foot wide tread, and receive primarily administrative and recreational traffic. Open secondary roads are narrower, with a 10-15 foot wide tread and receive light recreational use. Secondary roads often have some vegetation growth on the tread. Closed roads are generally revegetated after 1-2 years of closure.

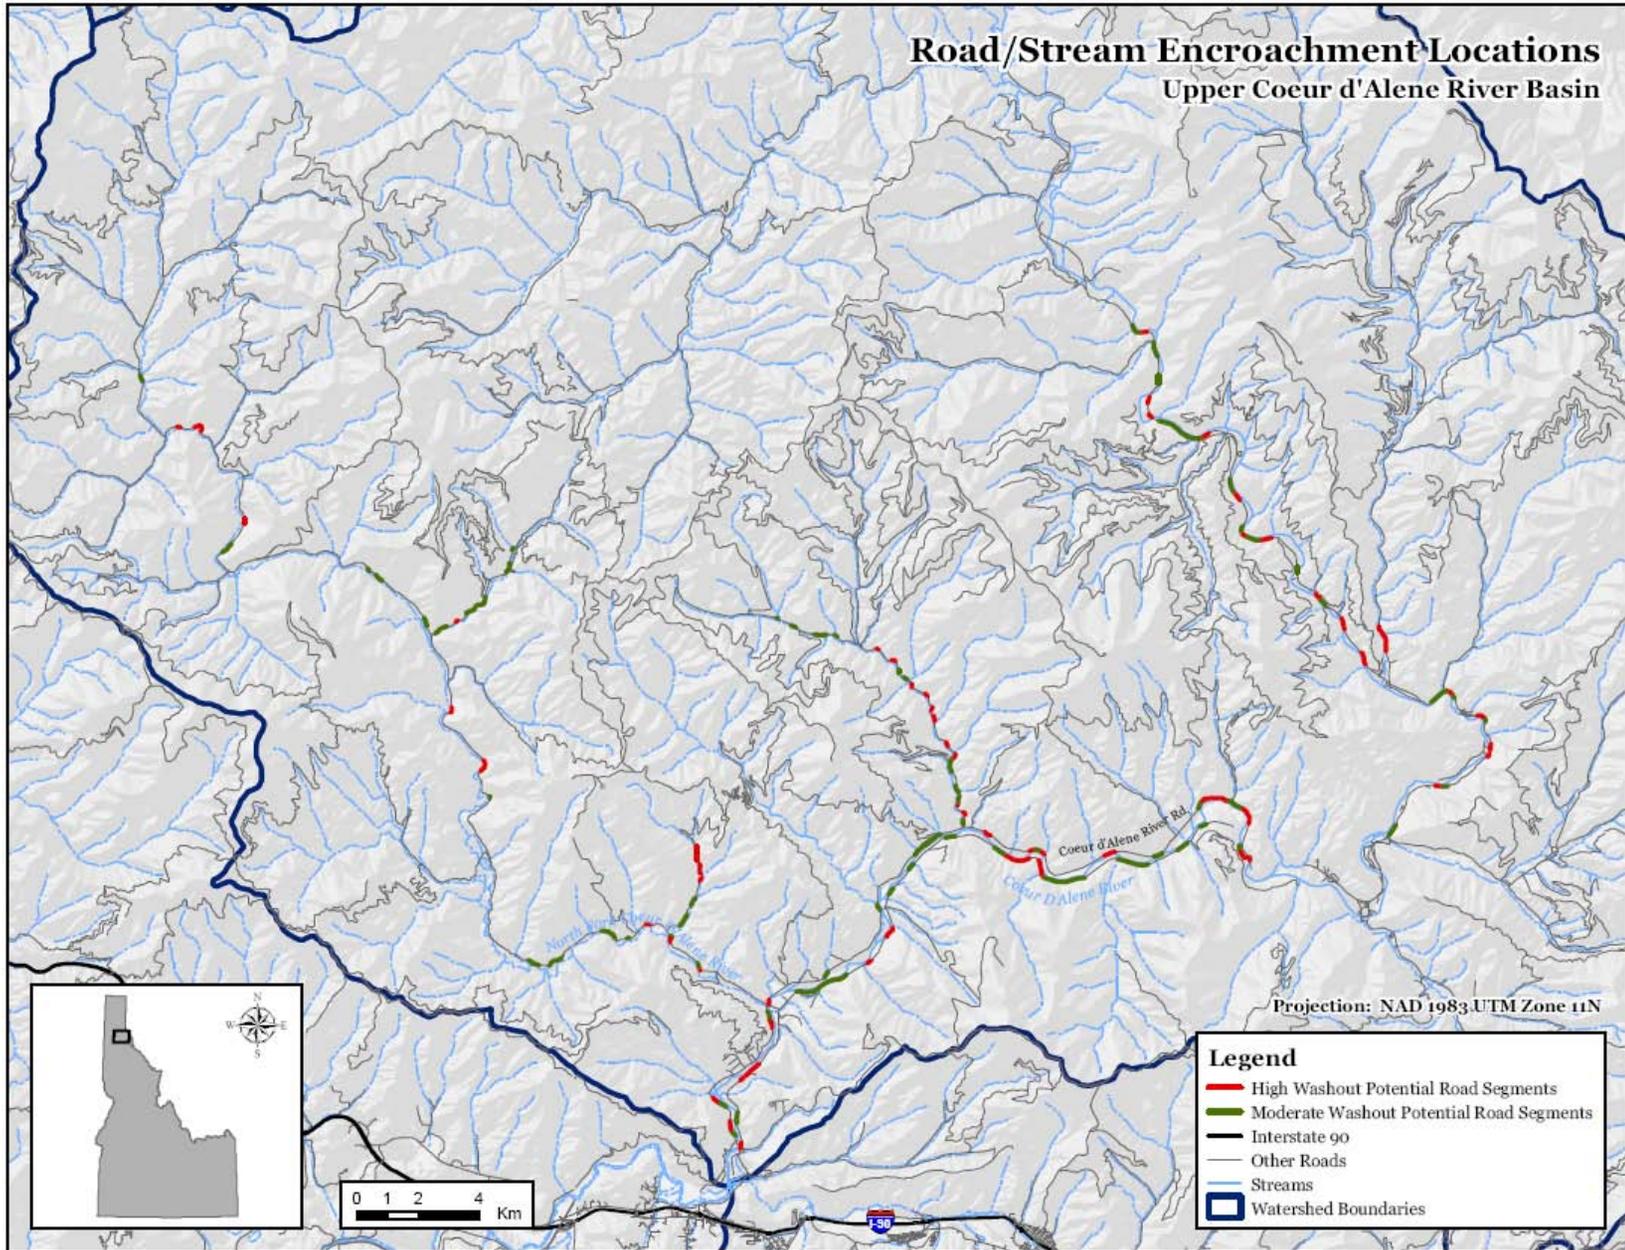
Figure 14: North Fork Coeur d'Alene Road Encroachment locations.

All areas with potential stream encroachment concerns were identified on the 1996 aerial photographs of the subbasin. Areas were identified where a stream impinged upon the road fill. Many of these areas were field checked for evidence of past stream encroachment erosion in August 2006, and road fill lengths, widths, and heights subject to erosion were estimated in the field. In addition, each site was rated as having a High, Medium, or Low susceptibility to road encroachment erosion based on the location of the road relative to the stream and the angle that the stream impinged upon the road fill (e.g., generally roads at the outside of meanders were rated as having a High potential; roads that paralleled the streamflow at straight sections were rated as Moderate).

Sections of roads identified as having potential road encroachment concerns on the aerial photographs, with some of the roads field checked, are listed in the *Sediment Source Analysis* Technical Report (page 36). Figure 14 maps the locations of encroaching roads.

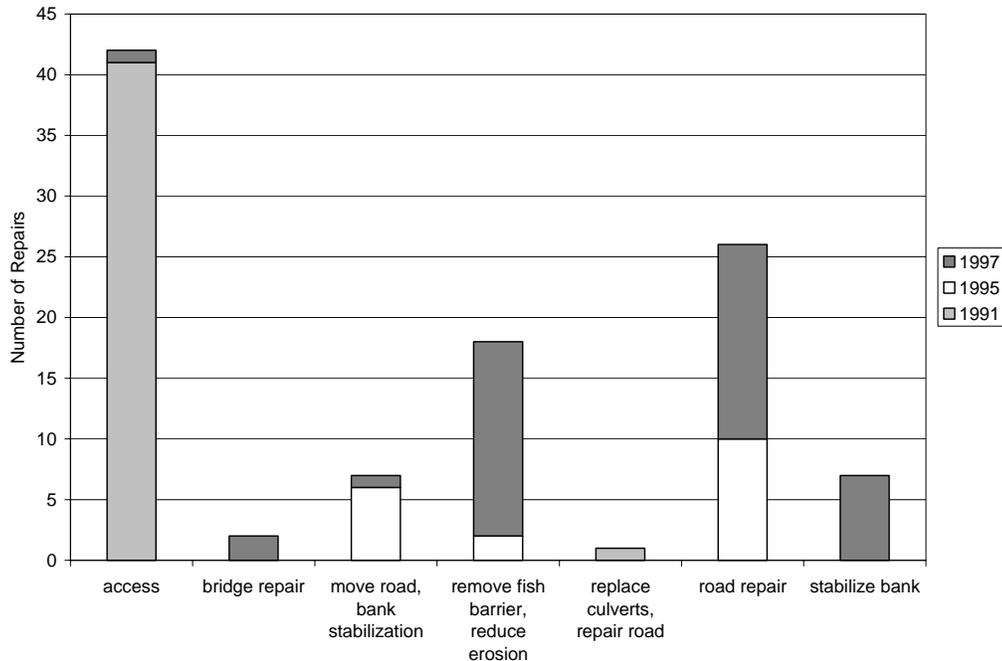
**Figure 15. Number of road repairs by year and reason for repair.**

Reason for Repair	1991	1995	1997	Total Miles
Access	12.47	0	0.47	12.93
Bridge repair	0	0	0.18	0.18
Move road, bank stabilization	0	1.18	0.35	1.53
Remove fish barrier, reduce erosion	0	0.84	4.08	4.92
Replace culverts, repair road	0.22	0	0	0.22
Road repair	0	2.90	6.55	9.45
Stabilize bank	0	0	2.72	2.72
Total Miles	12.68	4.92	14.34	31.95

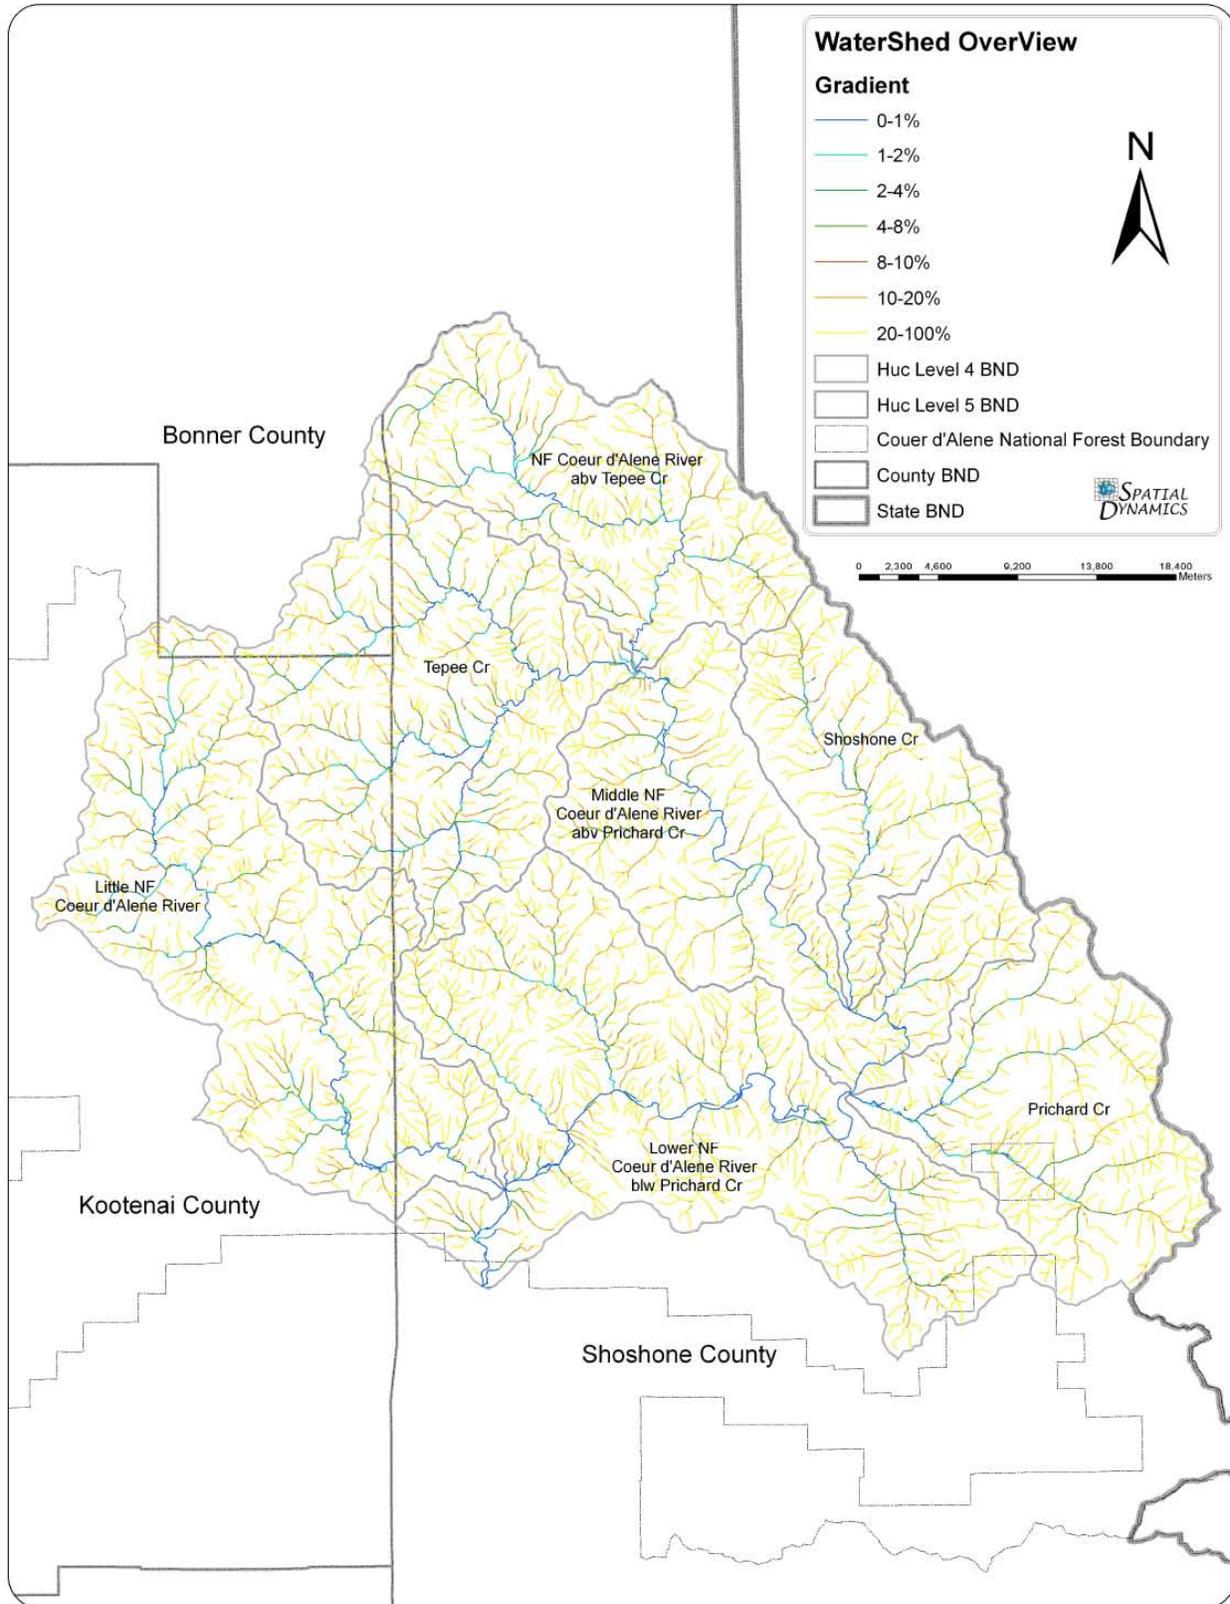
Figure 16. North Fork Coeur d'Alene stream channel gradients.

The gradient of a stream channel reflects the ability of that channel to transport water and sediment. Channels with gradients below 1% and moderately-confined to unconfined valleys are the most likely to respond to excess coarse sediment supply by depositing sediment, becoming wider, and sometimes braiding. Channels in the 1 to 2% range are also sensitive to coarse sediment but the impacts are less likely to be visible on air photos. As an initial indicator of likely channel response, GIS-generated maps showing channel gradient class were generated. Figure 16 shows gradients of stream segments in the study area (USFS GIS). The channel gradient maps were used to select locations for historic air photo analysis, and to select channel segments in a variety of gradient classes for field work.

The North Fork gradually steepens upstream with a concave profile. The river gradient is less than 0.5% on the mainstem of major rivers and gradients increase in the upper headwaters. The major tributaries are steeper than the North Fork with the exception of Tepee Creek, which occupies a flatter valley that is a continuation of the middle North Fork valley. The Little North Fork River and Tepee Creek have average gradients of less than 0.5%. Beaver, Prichard, and Shoshone Creeks have average gradients above 0.7% but below 1.0% where they join the North Fork, but steepen upstream to above 1%. Short segments of all these larger channels are greater than 1% according to the gradient map (Figure 16). Slightly smaller tributaries (such as Lost Creek and Prichard Creek above Eagle Creek) are steeper than 1% except in the Tepee Creek valley.
