AREA WIDE INVESTIGATION
SOUTHEAST IDAHO PHOSPHATE MINING RESOURCE AREA
DEQ #WST.RMIN.SEAW.6005.67068

**ORPHAN MINE SITE PRELIMINARY
ASSESSMENT SCREENING REPORT**

APRIL 2004

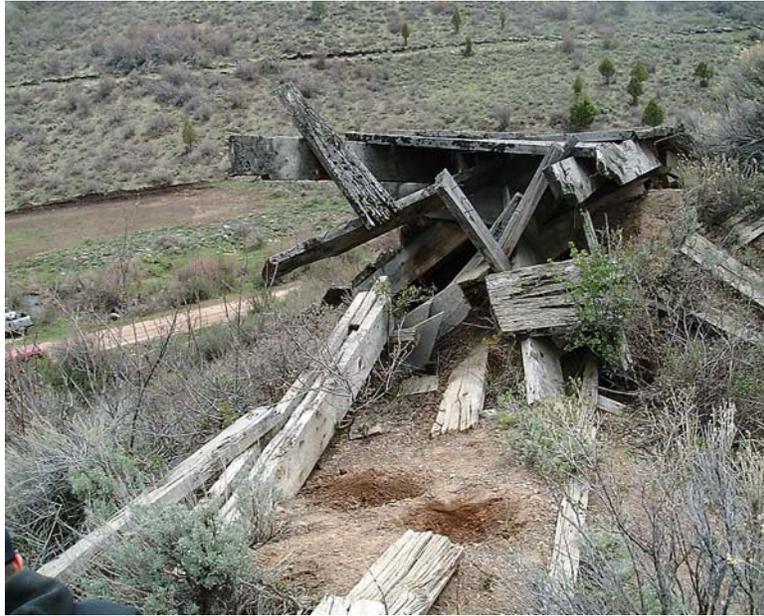
Photo 2.3
Sample site OS-BLM-SO-01-01 on waste dump. View to southwest.

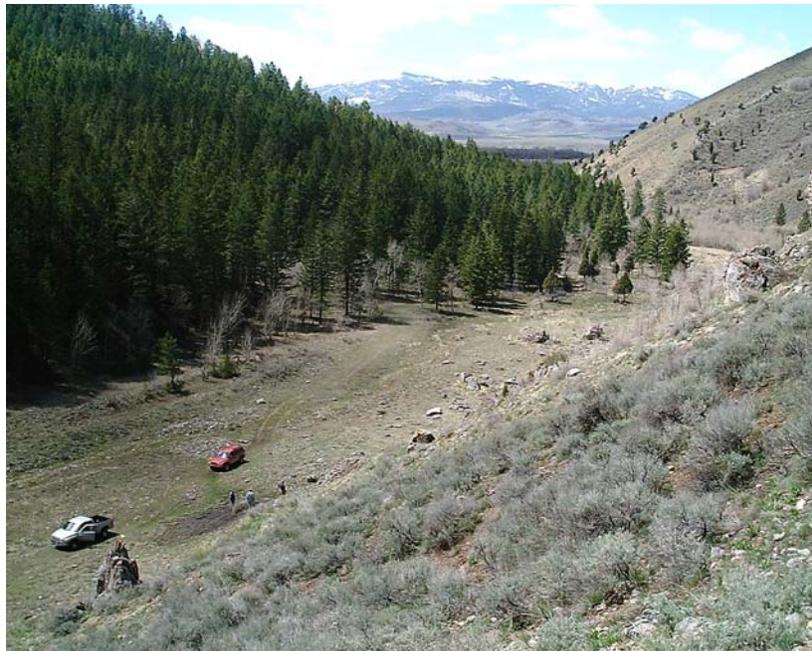
Photo 4.4
“East” Swan Lake Gulch area, view to west. Trench is between the vehicles and the timber, waste dump is between vehicles and sagebrush slope.

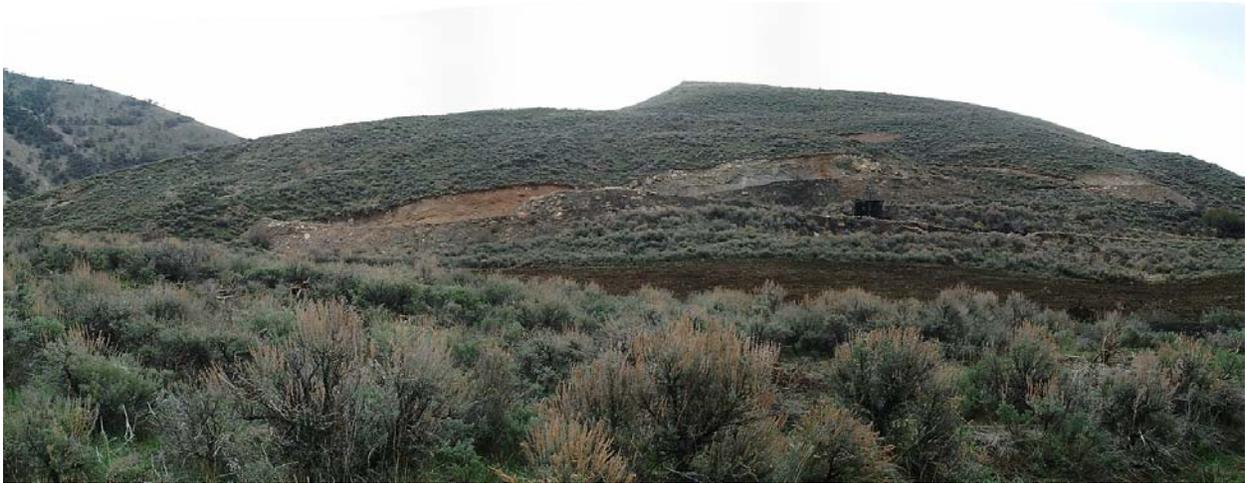
Photo 6.1
Bennington Canyon Mine looking east. Cultivated field in photo center, small pit highwall above field. Building facility on black shale in photo right-center.

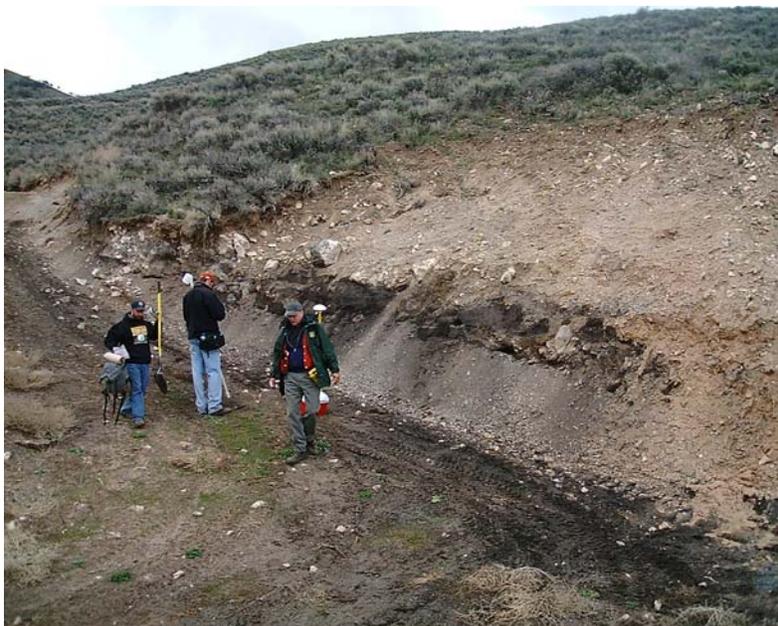
Photo 6.4

Black shale in roadcut on south end of Bennington Canyon Mine. XRF-only sample location.

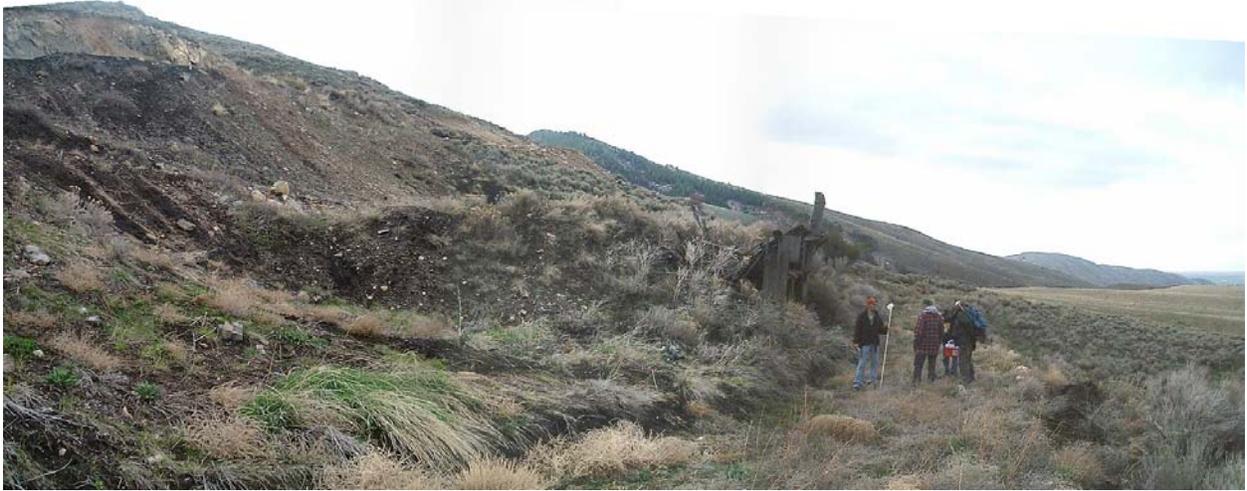
Photo 6.5

View toward south of Bennington Canyon Mine. Location for samples OS-BMS-SO-01-01 and OS-BMS-VE-02-01 in center of photo, left of the building.

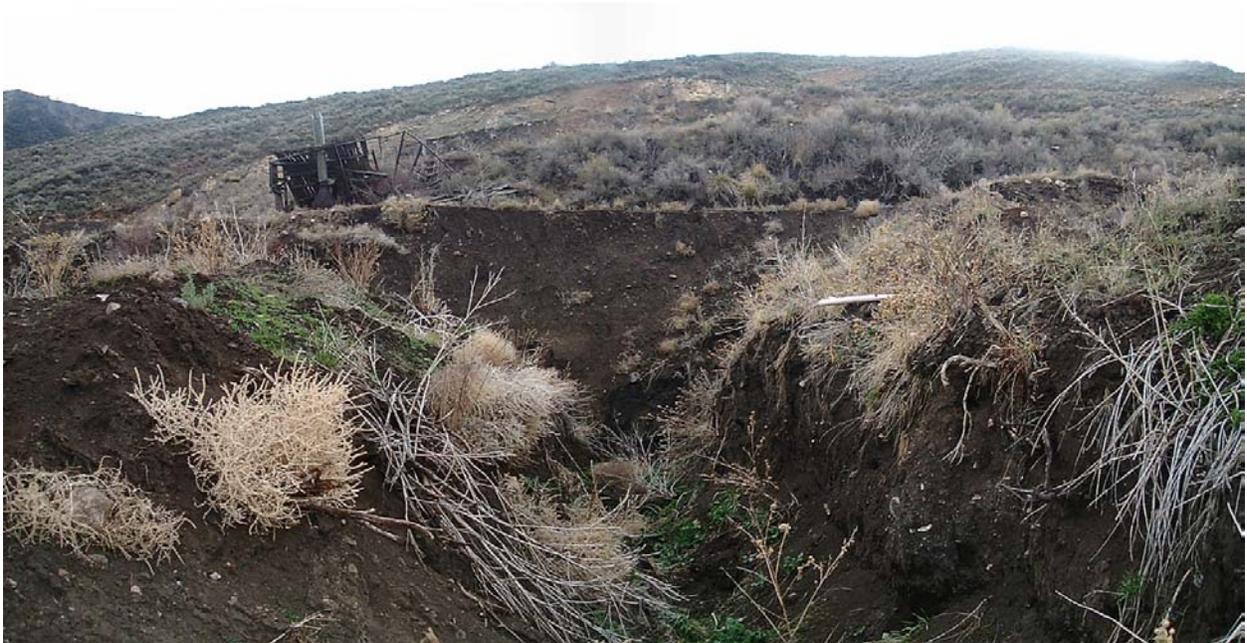
Photo 6.6

The Bennington Canyon Mine does present some concern due to potential migration to adjacent properties. There is an active seep flowing from a waste shale dump. While the surface water sample does not indicate the action level for terrestrial receptor and domestic animal exposures, the surrounding soils and vegetation do exceed action levels. It also appears that the dump soils are eroding onto an adjacent field resulting in exceedances of soil action levels at the confluence of the field and adit seep flow. High levels of selenium were observed in the vegetation on the central waste dump.

Bennington Canyon Mine seep dissection through black shale waste dump. White irrigation pipe in right center of photo. Pit highwall in background. Sample OS-BMS-SW-03-01 sampled the seep and OS-BMS-SO-05-01 sampled the waste dump. View to east.

Due to the completed exposure pathway to the adjacent cultivated field, the Agencies are recommending additional actions at the Bennington Canyon Mine. These actions should consist of additional waste consolidation, erosion controls, and reclamation improvements for the waste dumps to prevent deposition on developed agricultural lands, and elimination of seep waters as a potential irrigation source. The appropriate Agencies will pursue necessary funding and initiate discussions with the current site owner on these issues.

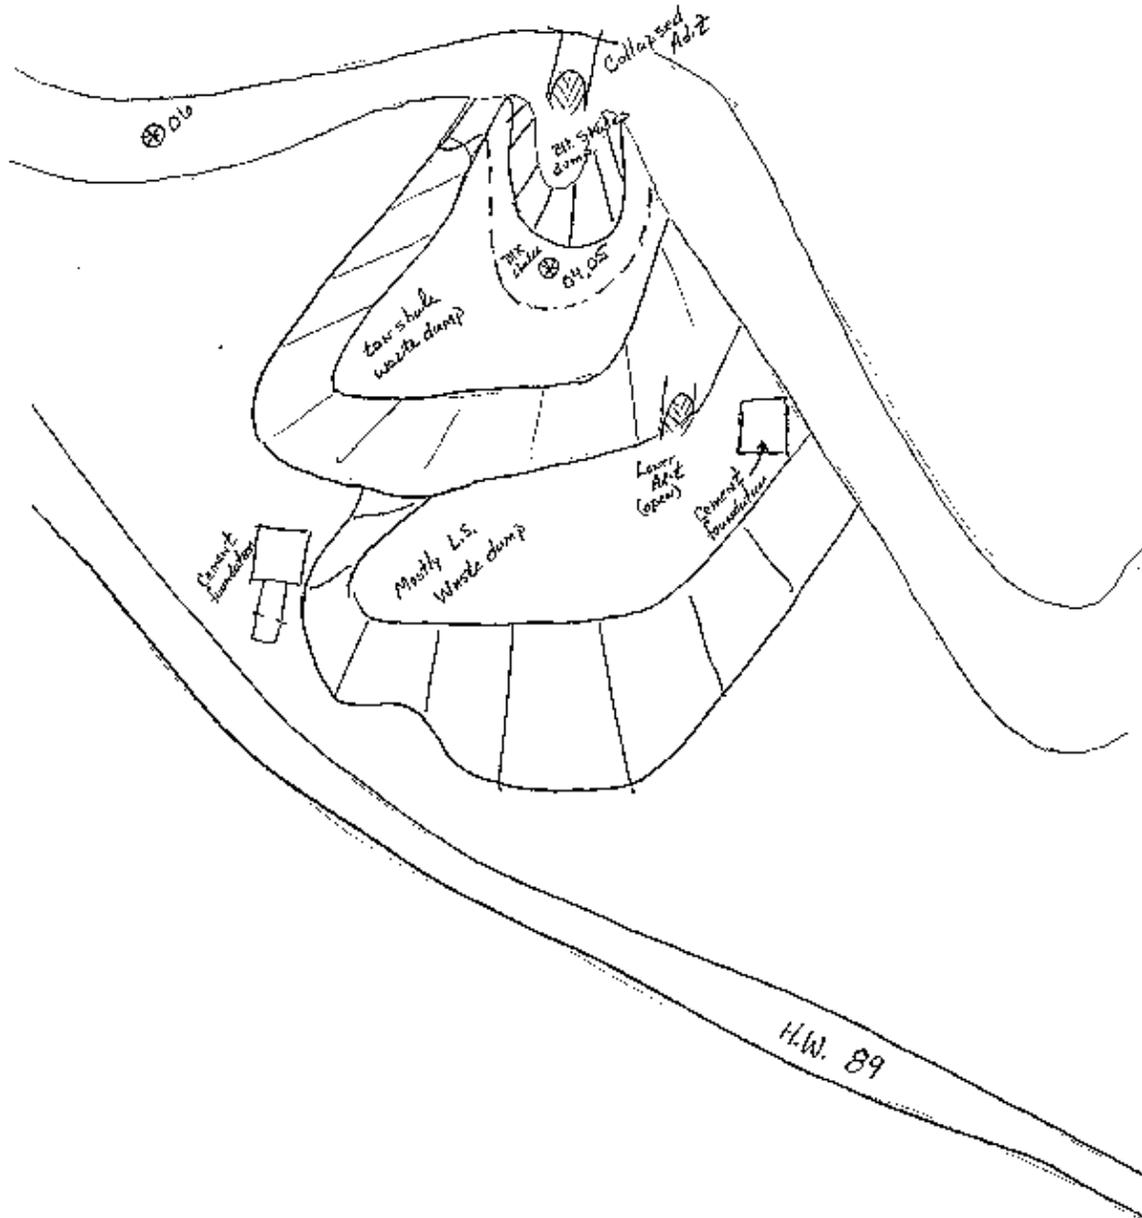
Figure 7.3
"West" Home Canyon Mine site sketch.

The west area has three tiers of waste dumps. The lowest dump, poorly visible from the road, is composed mostly of limestone. At the top surface elevation of the dump is an open adit, with a metal door in place. The door is open and allows for human access. Many of the original timbers and metal work is scattered around the area. Also, located on this elevation is a cement building foundation. Upslope from the open adit is the middle waste dump. This dump is much larger than the first, and contains moderately oxidized tan shales. On the top surface of this dump lies the third tier of waste dump. This dump is composed of black waste shales and is poorly vegetated. It is about 30 feet across and 30 feet tall. The uppermost adit is collapsed.

The Agencies will conduct additional sampling of surface waters for Montpelier Creek and the associated riparian areas during the spring of 2004. The Agencies do recommend additional activities at the Home Canyon Mine, in the form of waste consolidation, erosion controls, and reclamation improvements. The appropriate Agencies will investigate the solvency of past owners and potential for alternative funding.

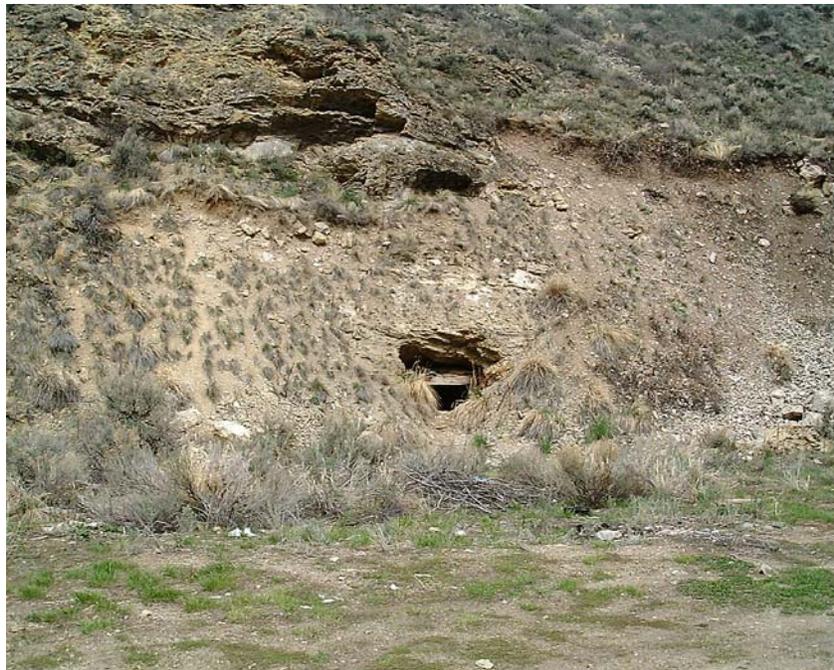
two significant areas of production referred to as the “main area” and the “west area”. The main area, located on the Cumberland lode, consists of: a partially collapsed adit; a main ramp area where the ore was shuttled to a concrete load out (still visible); and two or three adjoining waste piles. About 600 feet west, the “west area” contains two adits, three waste dumps and the remains of two cement building foundations. There is no surface water associated with the mine features; however, Montpelier Creek flows down the canyon several hundred feet to the southeast.

Photo 7.2
Home Canyon Mine, main portal, open for entry. View to northwest.

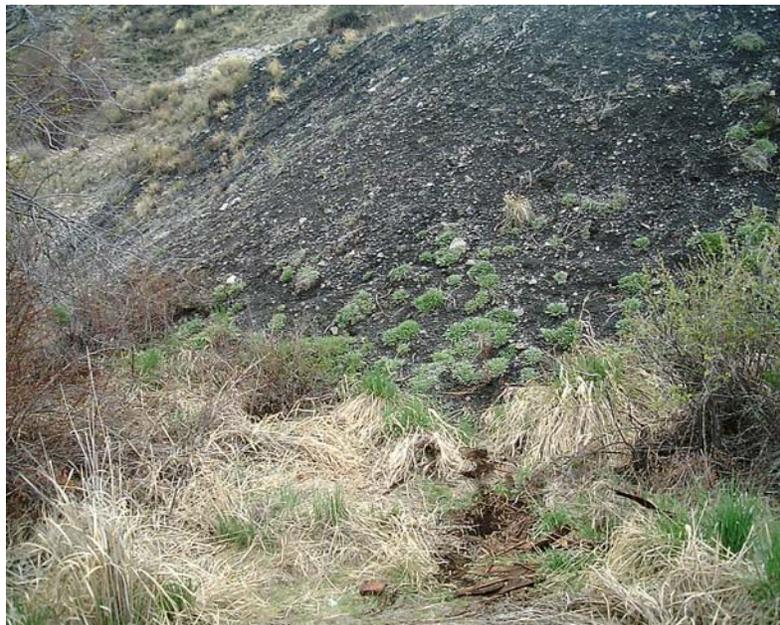
Photo 7.4
Sample location for OS-HCM-VE-02-01 and OS-HCM-SO-03-01. View to northwest. Black shale ramp in background.

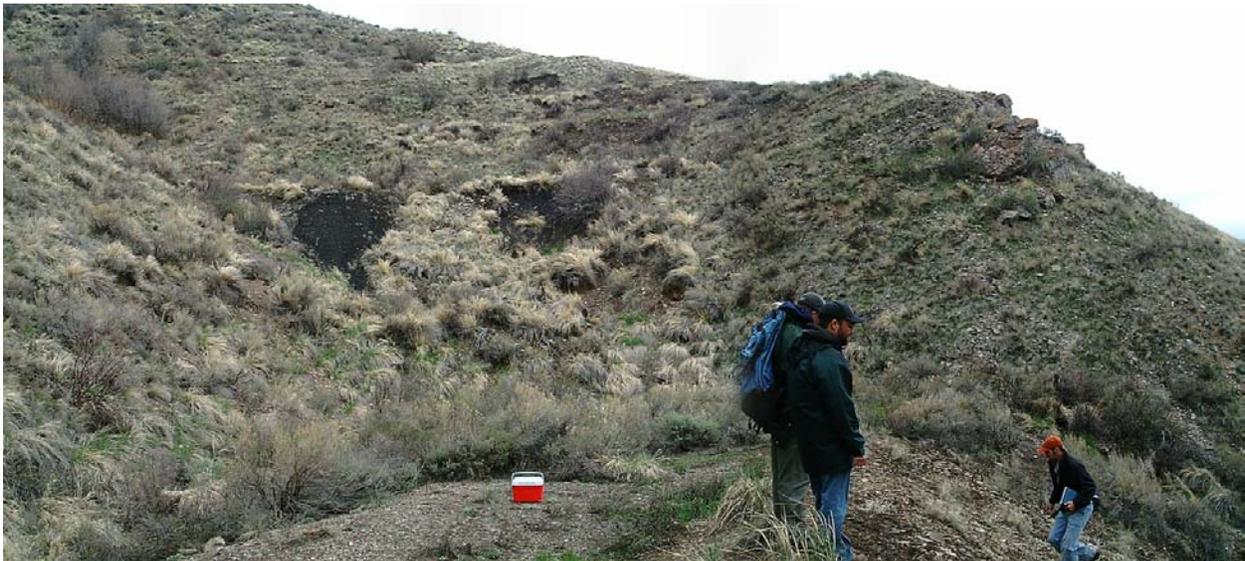
Photo 7.6
“West” Home Canyon Mine, upper tier. View to northwest. Samples OS-HCM-SO-04-01 and OS-HCM-VE-05-01 were collected between red cooler and the black shale above.

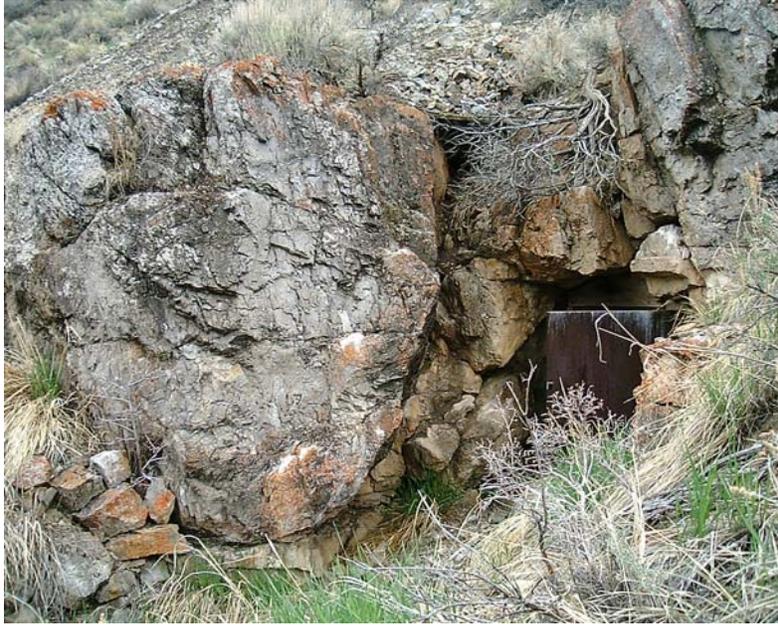
Photo 7.7

“West” Home Canyon Mine, middle tier. View to north. Adit with open metal door.

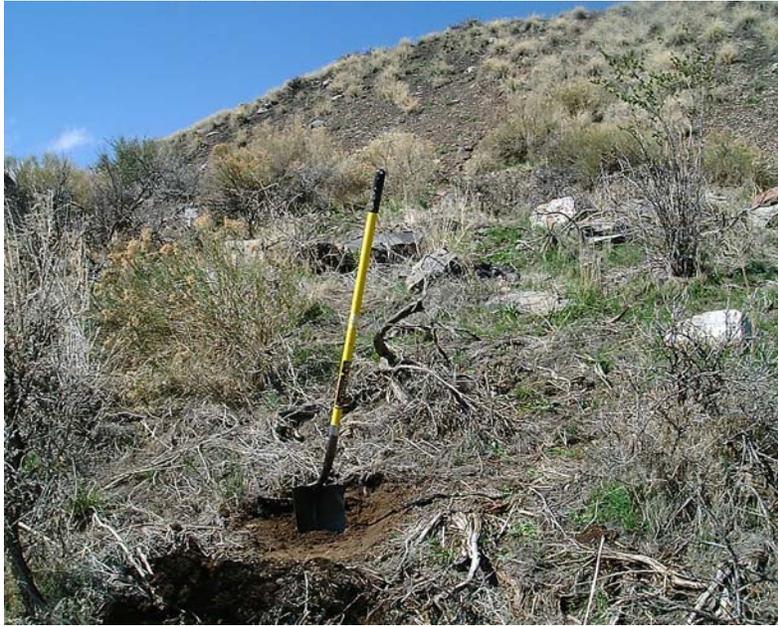
Photo 8.2

Waterloo Mine, sample location OS-WLM-SO-02-01 and OS-WLM-VE-03-01. View to north. Sample on stable slope, partially vegetated waste dump above.

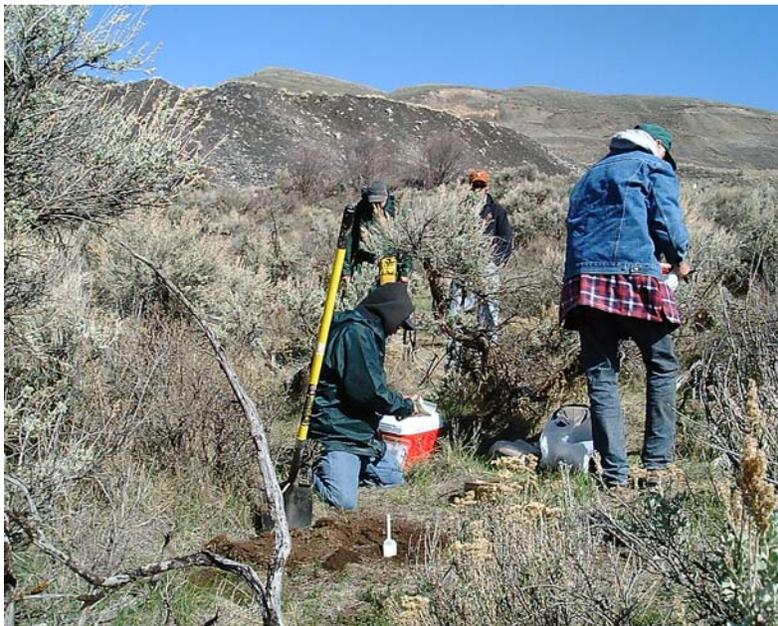
Photo 8.3

Waterloo Mine, sample site OS-WLM-SO-04-01. View to southeast. Stable slope with poorly vegetated waste dump in background.

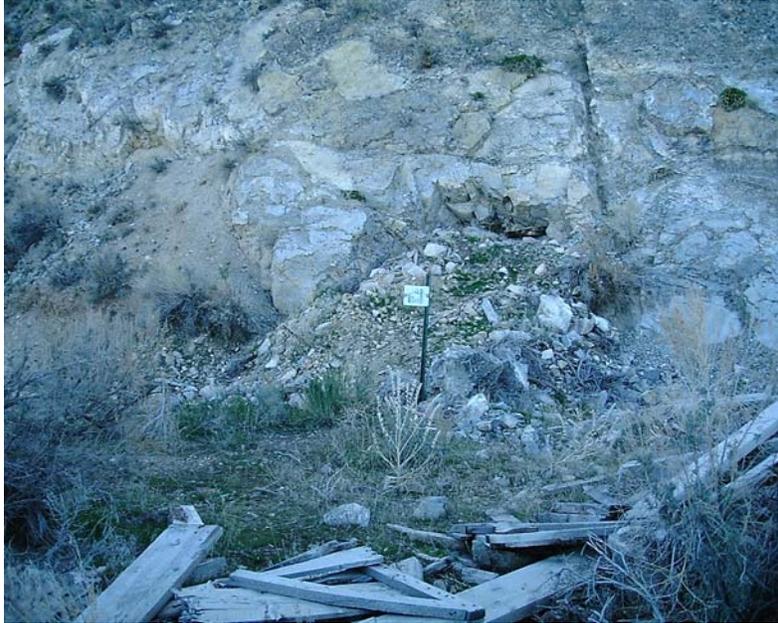
Photo 9.1
Hot Springs Mine, partially open North Lake Tunnel. View to east.

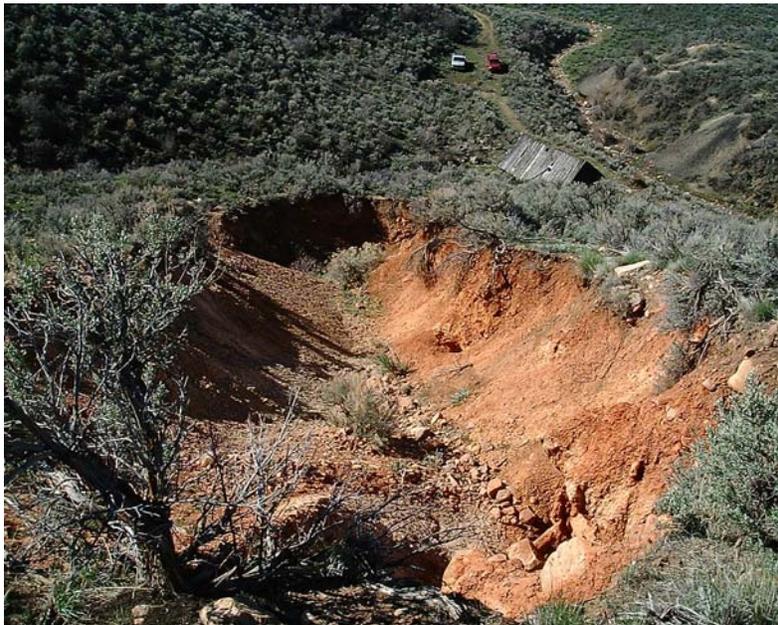
Photo 10.2
Excavated area below main portal. View to south.

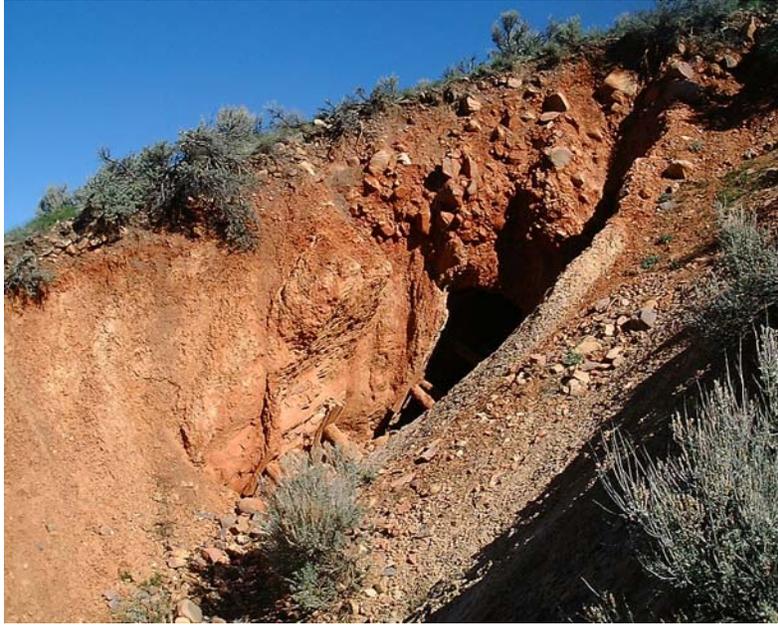
Photo 10.3
Consolidated Mine, main portal, open. View to north.

The Agencies will conduct surface water sampling of Little Canyon Creek and Bloomington Creek during the spring of 2004 to evaluate site releases. The Agencies are recommending additional actions at the site in the form of further site investigation, waste consolidation, erosion controls, and reclamation improvements. The appropriate mineral extraction Agency will investigate funding mechanisms for implementing further actions.

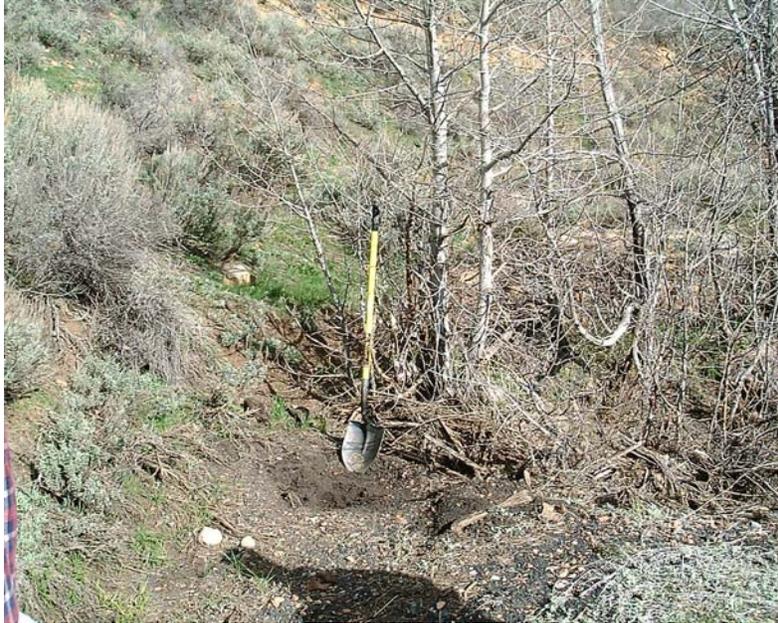
Photo 10.7

Consolidated Mine, sample location for OS-CMS-SO-03-01 and OS-CMS-VE-04-01.
Considerable black shale in stream channel. View to south.

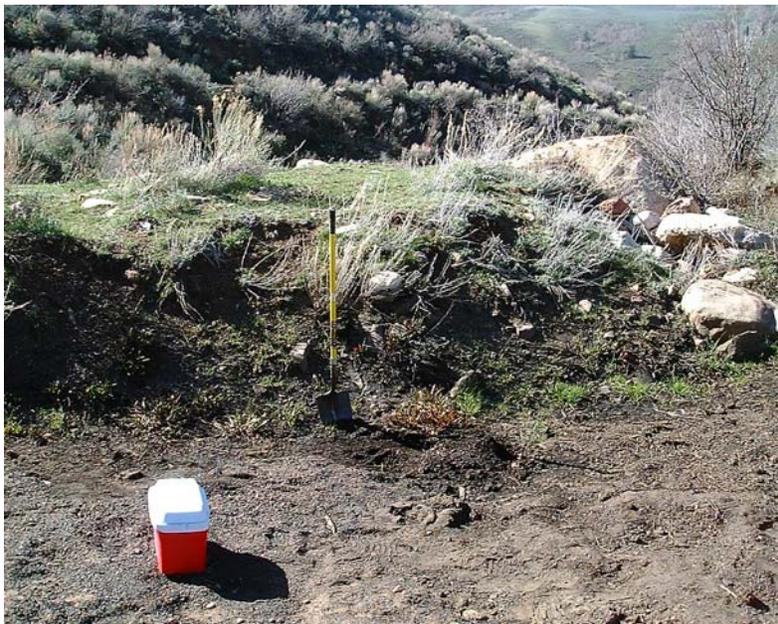
Photo 10.8

Consolidated Mine, sample OS-CMS-SO-05-01. Upstream side of sediment dam. Majority of
rock material is black shale. View to south.

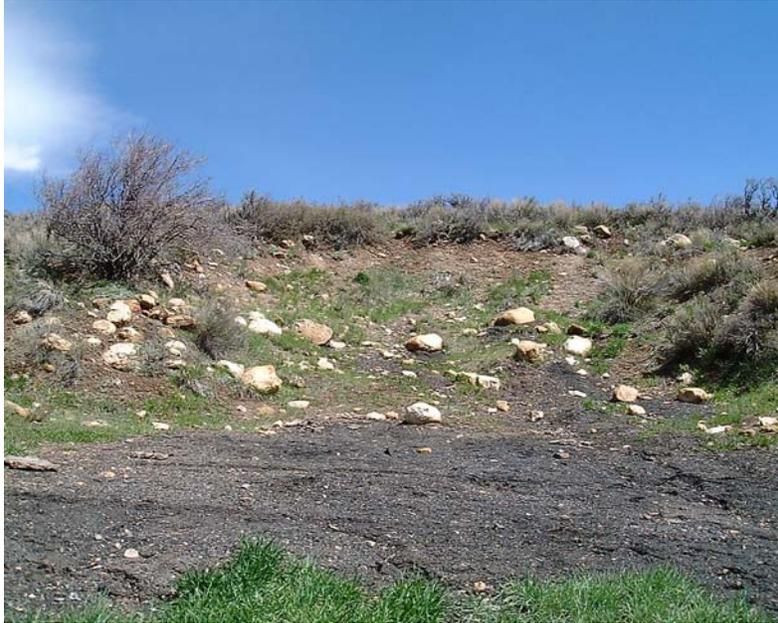
Photo 11.3
Bloomington Canyon Mine, T14S (Wyodak) Tunnel dozed closed. View to north.

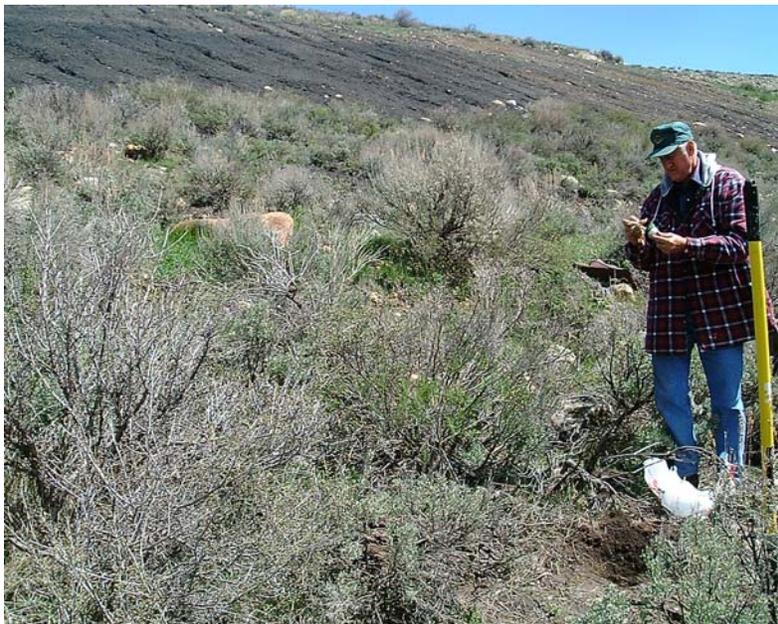
Photo 11.6
Bloomington Canyon Mine, sample location for OS-BLO-SO-03-01 and OS-BLO-VE-04-01.
Erosion of black shale at the top of photo. View to northeast

The Agencies will conduct surface water sampling of Bloomington Creek during the Spring of 2004 to evaluate site releases. The Agencies are recommending additional actions at the site in the form of waste consolidation, erosion controls, and reclamation improvements. The appropriate mineral extraction Agency will contact the site owners and investigate funding mechanisms for implementing further actions. Bloomington Canyon also has two open adits that may present public risks and should be addressed by the appropriate land management agency.

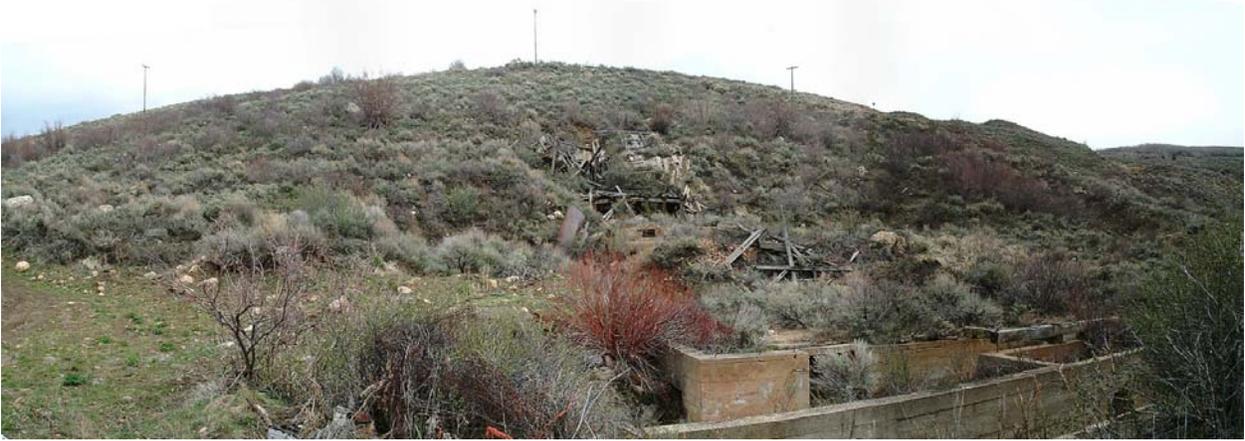
The mine consists of: two production adits, one north of Paris Creek and one to the south; approximately five waste dumps; and a large complex of platforms and foundations. Both adits are still open to entry. The south portal/adit is approximately thirty feet up slope from the canyon road. Brickwork and concrete foundation material abound just below the portal. Historically there was a large mill and tram system in this location. Approximately 15 feet down slope from the adit is the largest waste dump. The toe of the dump runs almost to the east bank of the Paris Creek, stopping approximately three feet short. It is composed of various Phosphoria Formation lithologies.

Photo 12.1
Paris Canyon Mine, south portal. View to south.

The Agencies will conduct surface water sampling of Paris Creek during the Spring of 2004 to evaluate site releases. The Agencies are recommending additional actions at the site in the form of waste consolidation, erosion controls, and reclamation improvements. The appropriate mineral extraction Agency will contact the current owner and investigate funding mechanisms for implementing further actions.

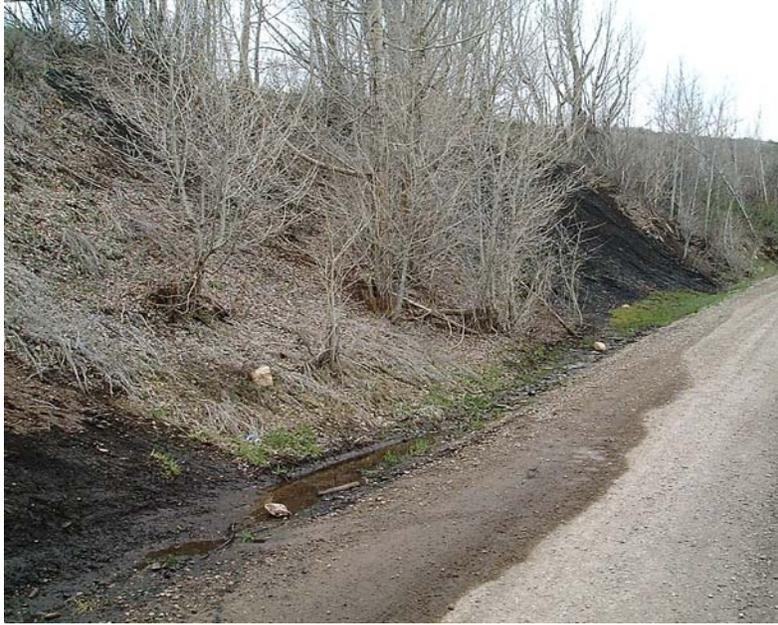
Photo 12.5
Paris Canyon Mine, sample OS-PAR-SW-02-01. Pondered runoff in the lower center of photo.
View to southwest.

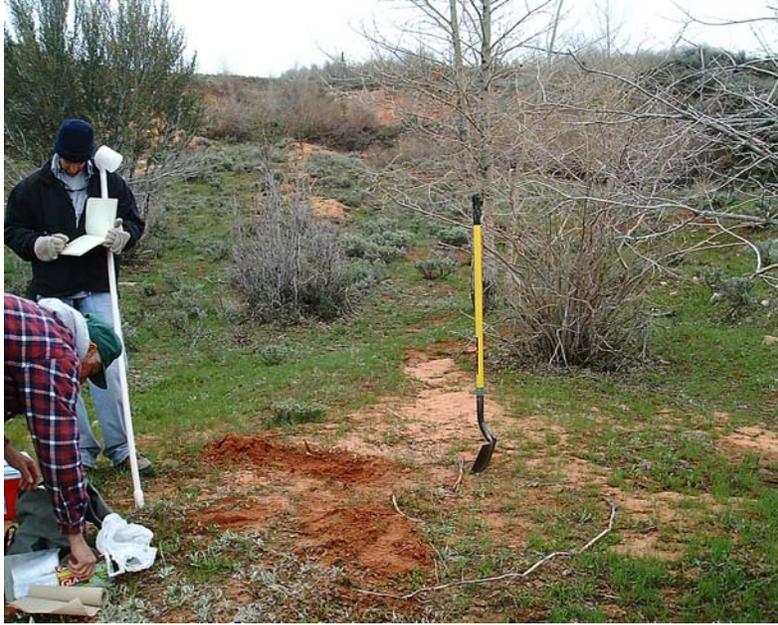
Photo 13.3

Wyodak Coal Exploration, sample local for OS-WYO-SO-02-01. Note oxidized sandy soil.

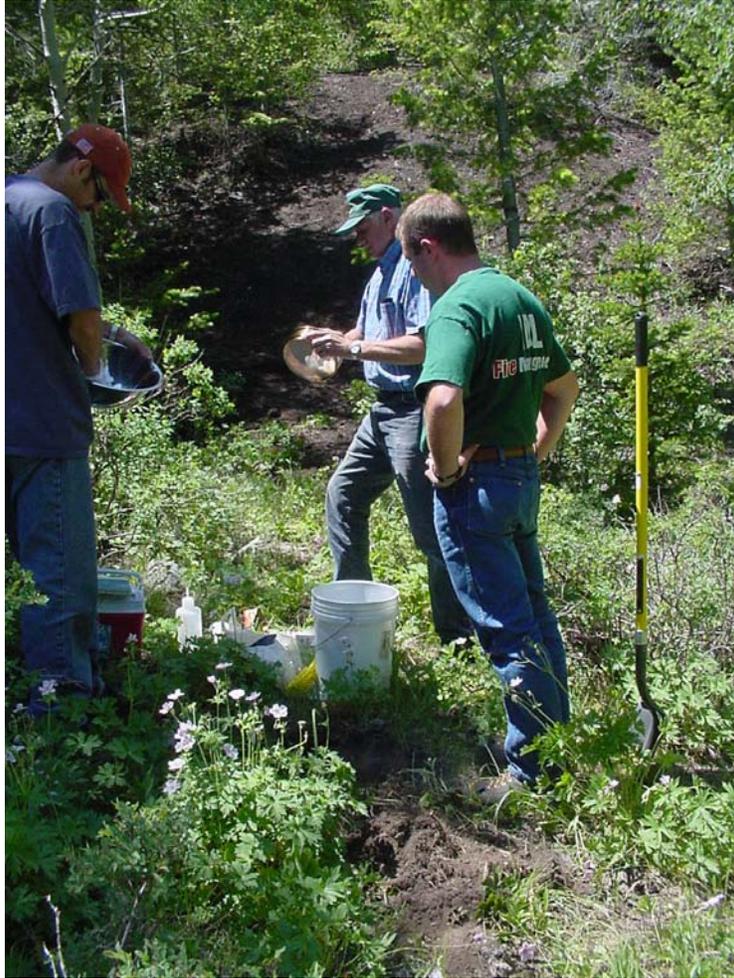
Photo 14.5

Sample location for OS-GCM-SO-02-01 and OS-GCM-VE-03-01. Waste dump in background.
View to northwest.
