# **Paymaster & Ironclad Mine Claims**

## **Preliminary Assessment Report**

Blaine County  
State of Idaho

### **Idaho Department of Environmental Quality**

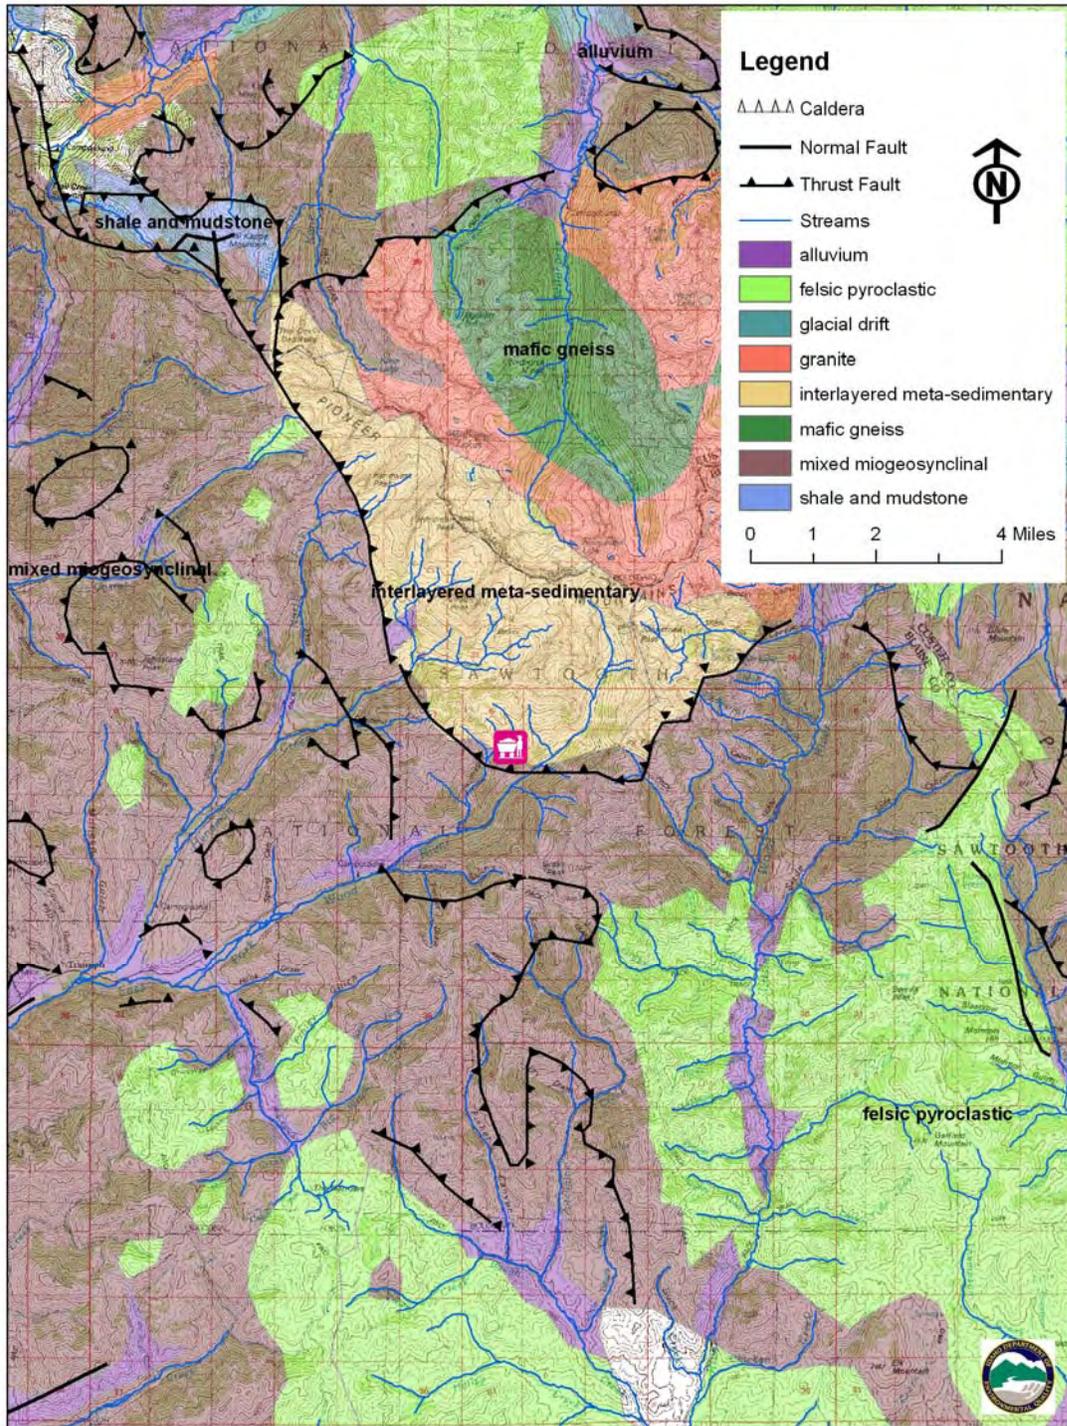
In the open cuts on the Iron Clad and Mars claims and in outcrops and cuts on near-by claims there are masses of rusty material which appear to represent replacement of limestone and quartzite of the East Fork formation by magnetite, arsenopyrite, quartz, siderite, and probably other minerals. Some of the limestone near the Iron Clad deposit has been almost completely altered to actinolite, and this mineral is probably associated with the iron ore on the P K group. The presence of gold in the iron ore from both places has already been mentioned.

The old Paymaster workings are shallow cuts and irregular burrows on the crest of the ridge...There are several rather poorly defined deposits, and the early miners merely gouged out the readily accessible more or less oxidized material near the surface and then ceased their activities. The minerals noted in the workings are limonite, smithsonite, and other oxidization products, galena, quartz, and calcite. The smithsonite was presumably derived from sphalerite (ibid, p. 200).

Figure 3. Geologic Map of Paymaster Patented Claim Area. (Source: USGS 7.5 Minute Quads)

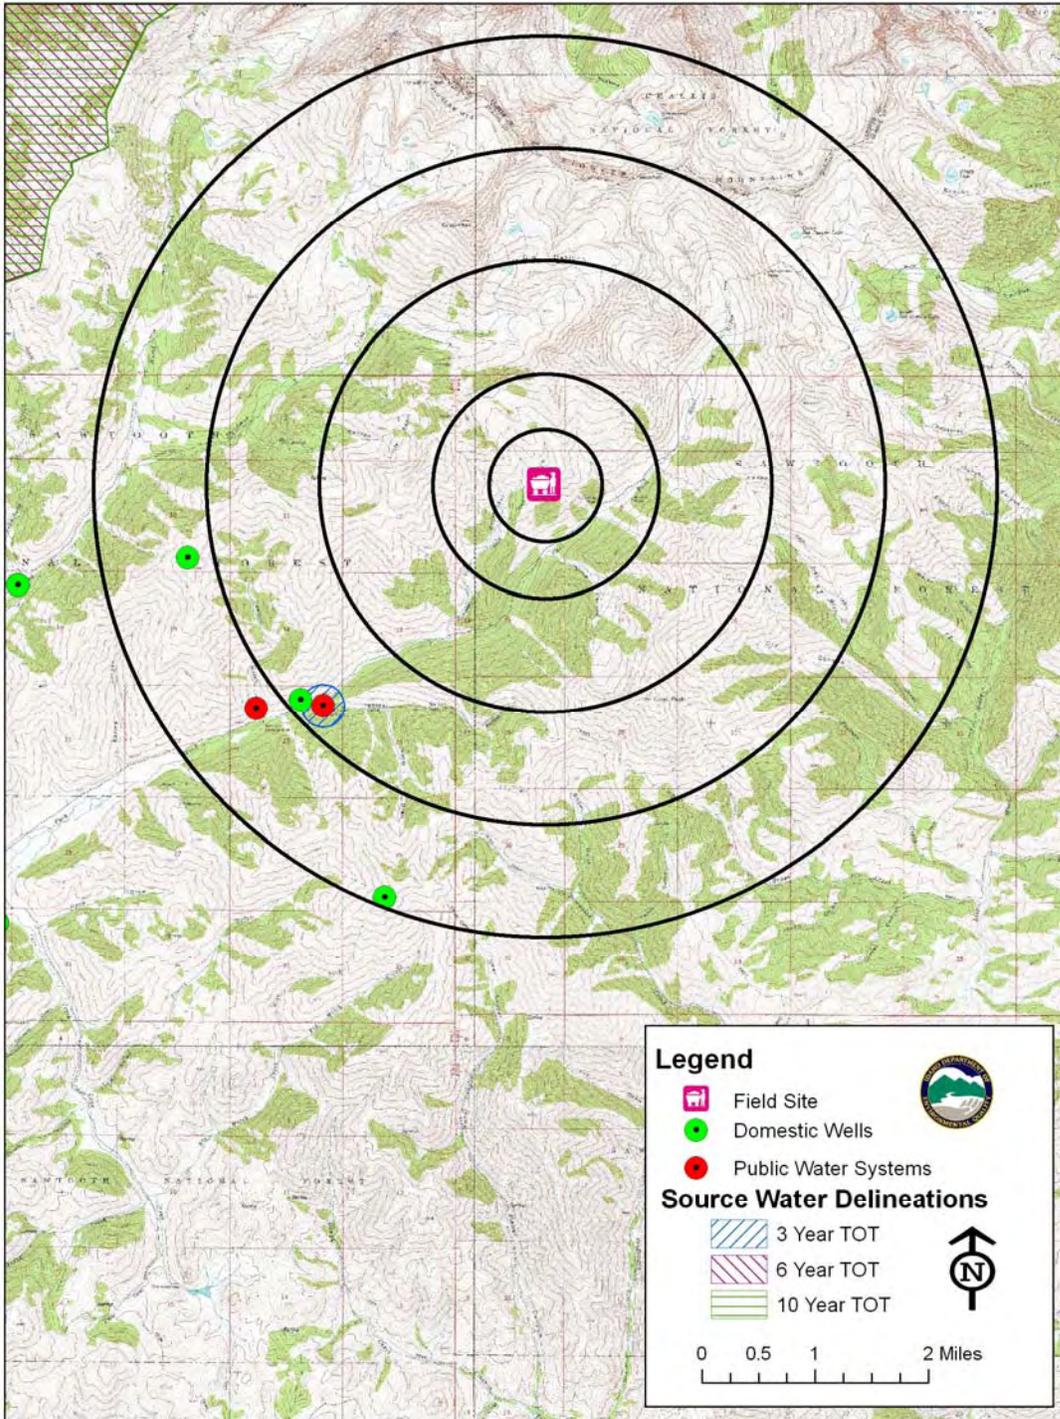
**Figure 5. Domestic wells and public water system wells located within a 4-mile radius of the Paymaster Claim. (Source: USGS 7.5 Minute Quads)**

Generally speaking, public drinking water systems in the Big Wood River Valley are rated as moderate to high (IDEQ 2000). Multiple factors affect the likelihood of movement of contaminants from the sources to the aquifer, which lead to this moderate to high score. Soils in the area are poorly to moderately drained. The vadose zone is predominantly gravel, which increases the score. On the valley floors the average depth to ground water is twenty to fifty feet.

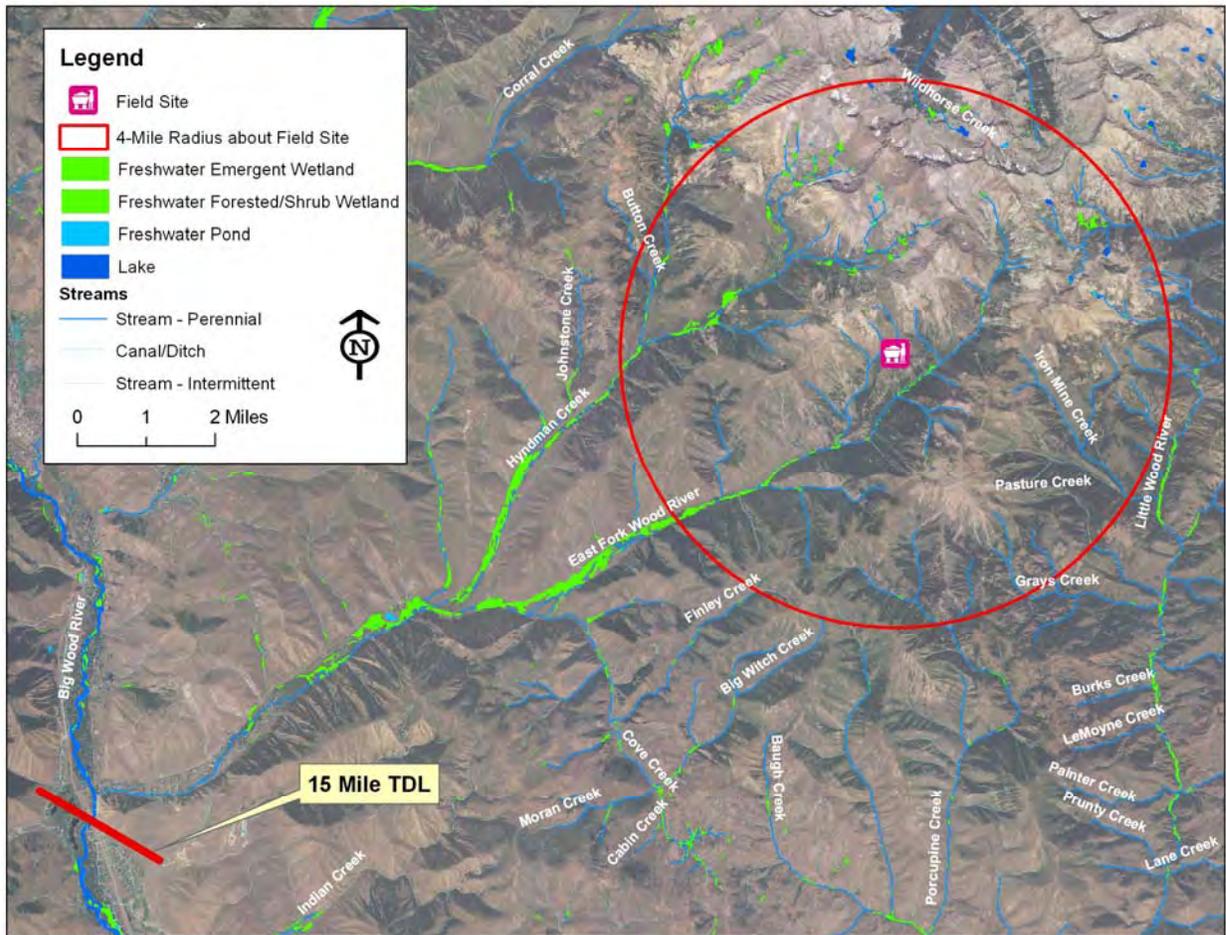
Most of the Paymaster's workings lie on the east side of a high ridge overlooking the perennial East Fork of the Big Wood River. The inclined shaft and associated waste dump lie in Paymaster Gulch, an ephemeral drain. None of the collapsed mine workings showed evidence of drainage. However, a seep or spring was emanating in Paymaster Gulch, approximately 0.25 miles west of the inclined shaft. The surface water flows for a few hundred meters before infiltrating into the alluvium and gravels. IDEQ collected a water sample [PM SW 1] from this surface water expression. The water sample did not exceed any primary or secondary water quality standards.

**Figure 6. Surface water 15-mile Target Distance Limit (TDL) from the preliminary assessment site. (Source NAIP 2004)**

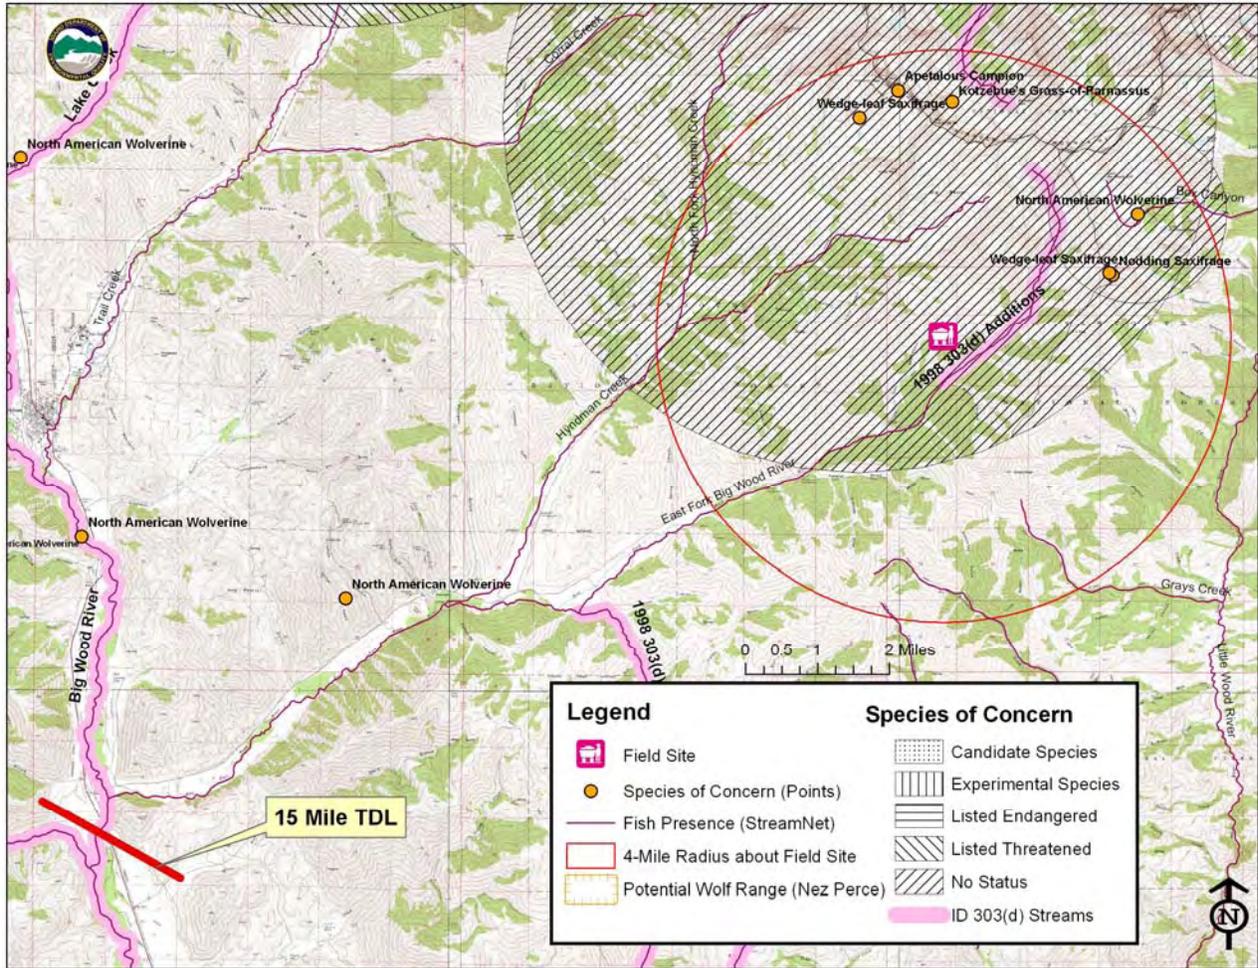
Several species of concern are documented within the 4-mile radius (see Figure 7), including the North American Wolverine. The site is also within the potential Gray Wolf range. Since wolves range over a wide area, exposure to heavy metals at the site and potentially within the adjacent stream/pond may be limited, thus minimizing any dose. Therefore, it does not appear as though the site could cause adverse affects to this sensitive species.

Figure 7. Sensitive species identified in the vicinity of the preliminary assessment site. (Source NAIP 2004)
