2011 Performance and Progress Report

State of Idaho Nonpoint Source Management Program

**State of Idaho
Department of Environmental Quality**

March 2012

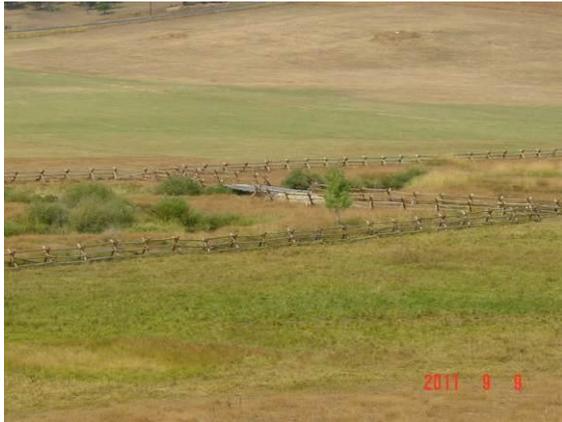
Figure 5. Approximately 2.5 miles of jack-pole fencing and a bridge installation are part of the work accomplished. Local labor harvested the trees for the fence. Note the lush vegetation within the fenced cattle exclusion area along Elk Creek.

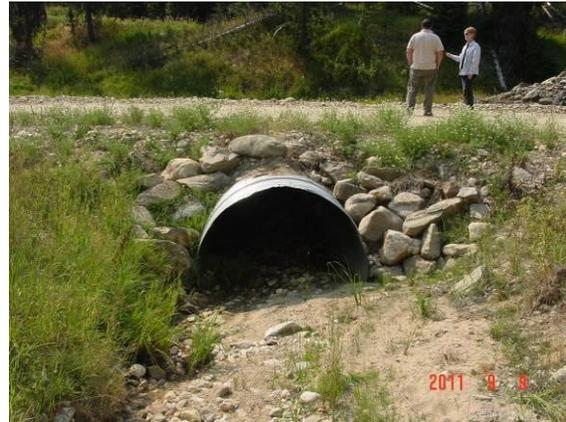
Figure 6. Another BMP, this new culvert near the mouth of Telephone Creek, handles heavy spring runoff in the area and reduces sediment transport to American River.

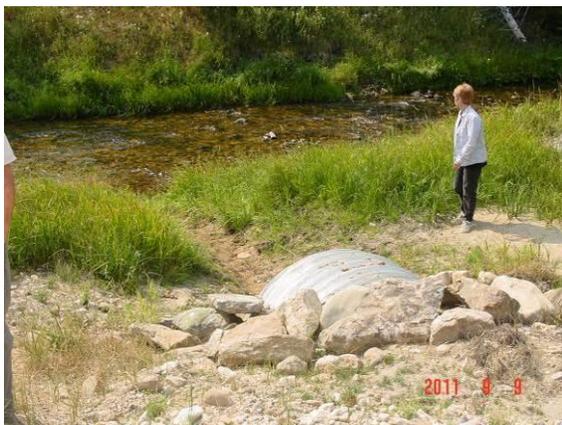
Figure 7. This is the confluence of Telephone Creek at American River. Framing Our Communities Executive Director Joyce Dearstyne is explaining that Telephone Creek only flows during summer storms and spring runoff, but prior to culvert installation and additional channel work further upstream; it was a major contributor of sediment to American River.

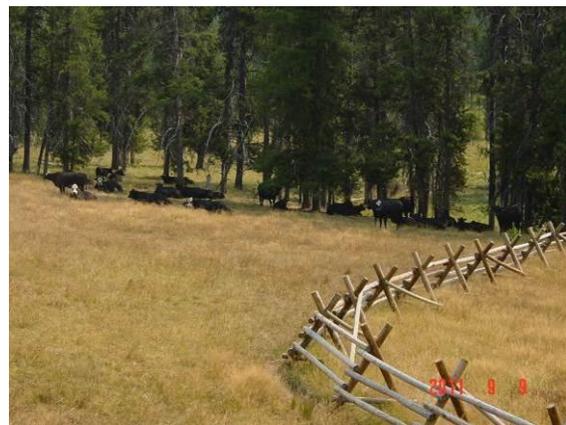
Figure 8. With all of the fencing in place, cattle are excluded from Elk Creek.

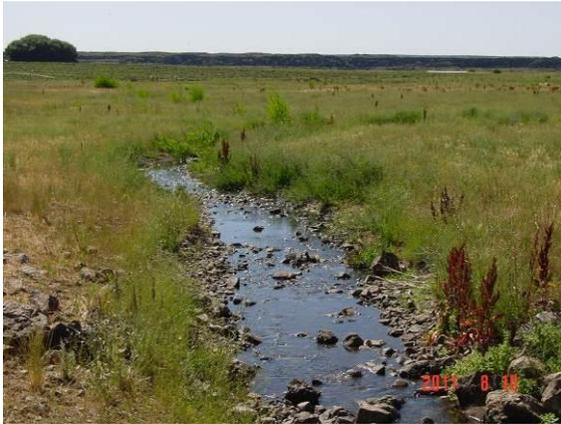
Figure 9. A section of Copper Creek restored 2 years ago was formerly cluttered with debris from an illegal landfill. Now there is a meandering channel and floodplain planted with bitterbrush, chokecherry, willow, alfalfa, currant, silver sage, big sage, and a variety of grasses.

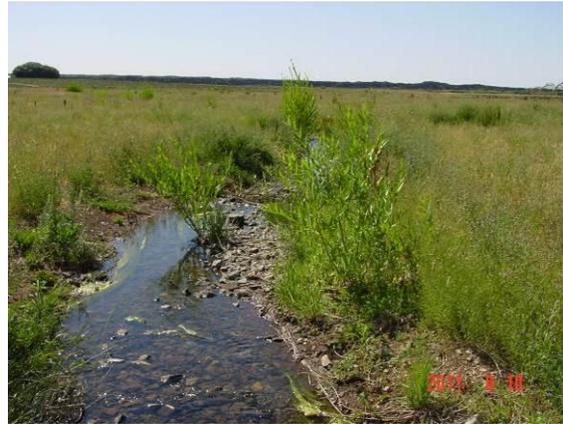
Figure 10. Willow canes planted deep with the help of a hydraulic stinger along Copper Creek are resulting in a very high survival rate.

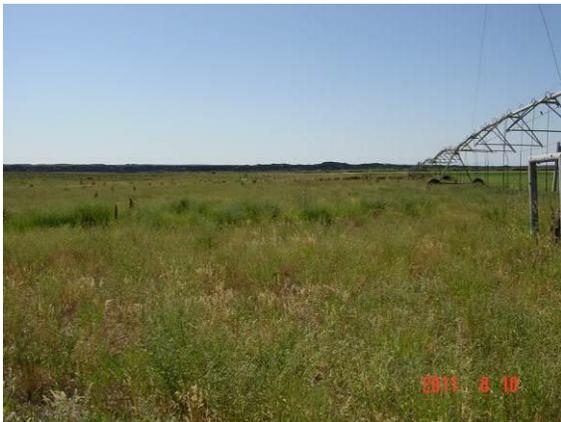
Figure 11. The constructed floodplain along Copper Creek also acts as a filter strip between the creek and the sprinkler-irrigated field.

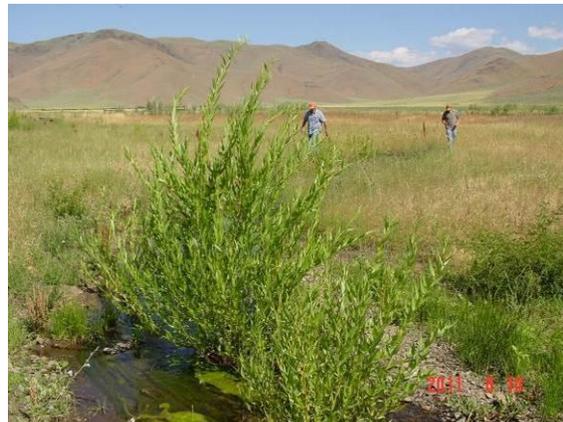
Figure 12. In a few more years, the willows and other plantings along Copper Creek will provide excellent streambank stability and shading for the creek.

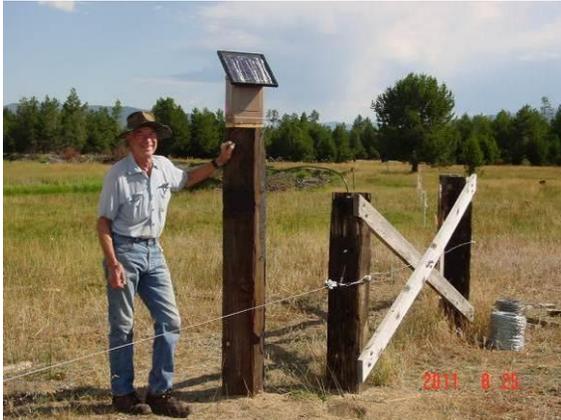
Figure 13. Landowner Harry Adams stands beside his solar-powered electric fence. A mile of fencing keeps cattle from the riverbank. Section 319 funding paid for the materials; Harry and his son supplied the labor.

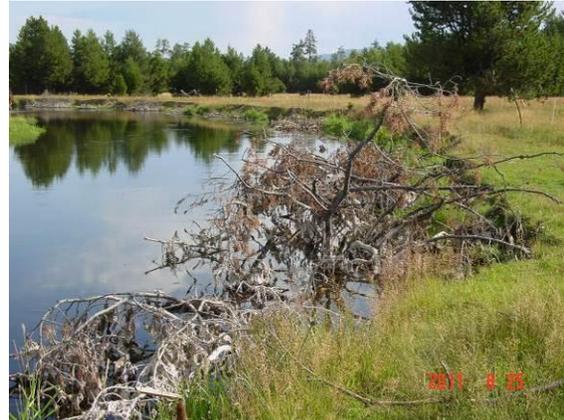
Figure 14. The other part of this project involved installation of dead trees to capture sediment and encourage vegetation along the riverbank. The trees came from downed timber from a recent windstorm on the landowner's ranchland.

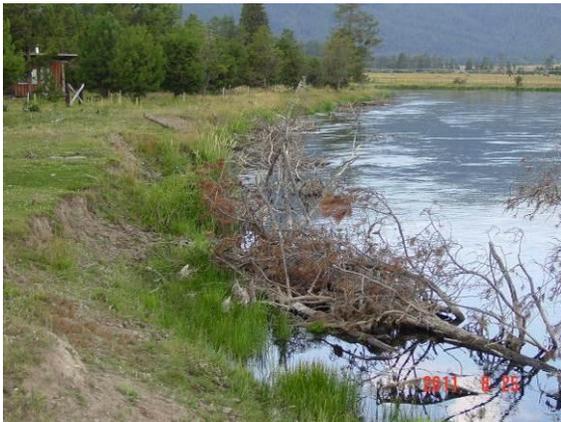
Figure 15. Dead trees were initially anchored to the shore with cable, which lasted for a couple of years, during which time the trees became permanently encased with tons of sediment.

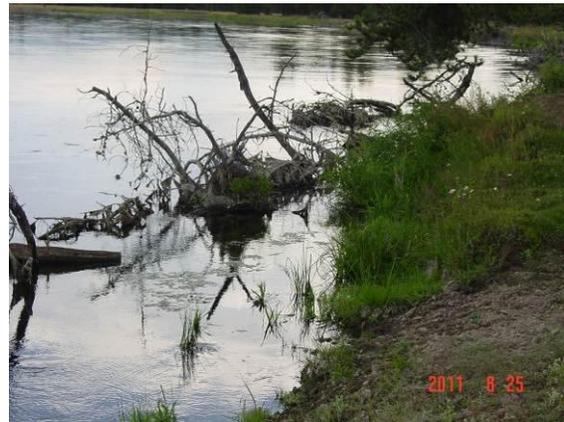
Figure 16. These BMPs may not be aesthetically pleasing, but they slow down the current and encourage deposition of sediment. The trees also offer good habitat for fish.

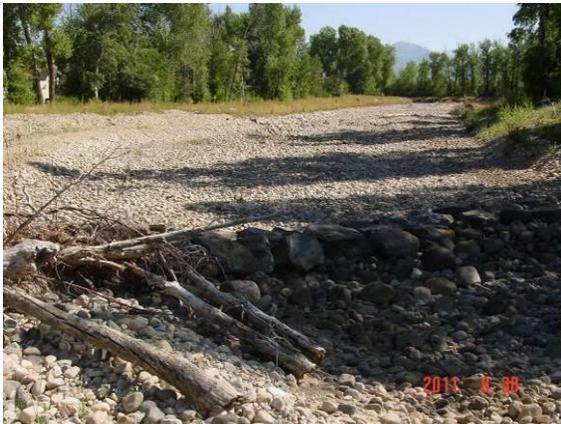
Figure 17. This rock weir has been in place for several spring runoff periods and has successfully trapped about 2.5 feet of gravel in an area that formerly experienced extreme down cutting.

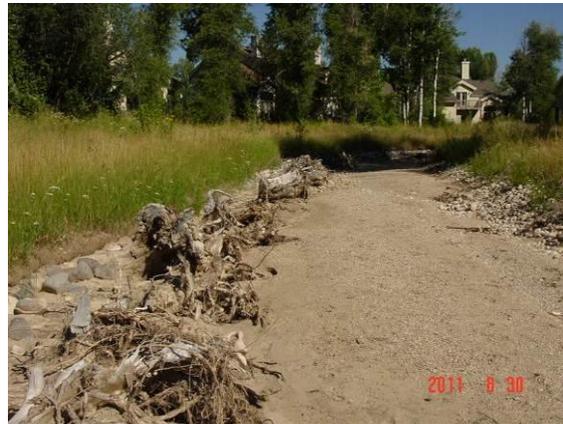
Figure 18. An exceptionally good example of rootwads installation: the trees are located on less than 5-foot centers, and about 20 feet of tree trunk is keyed into the bank for each tree.

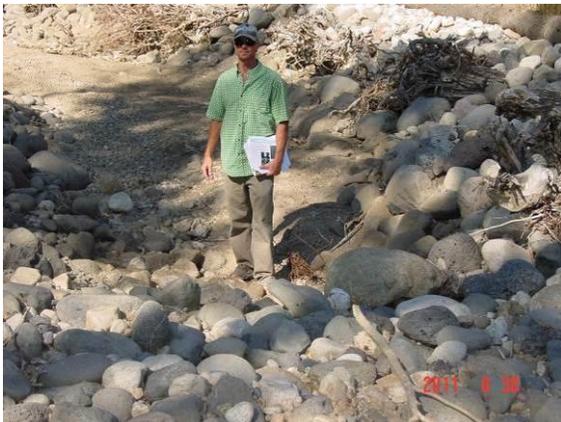
Figure 19. Project Manager Mike Lien is standing in a scourer pool that naturally formed below a rock weir after just one spring runoff.

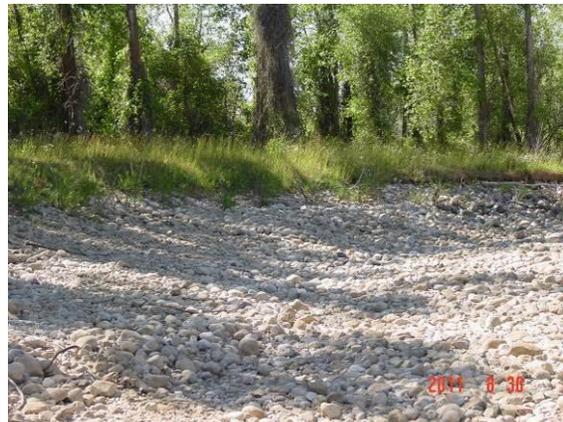
Figure 20. Vegetation is flourishing along the floodplain.

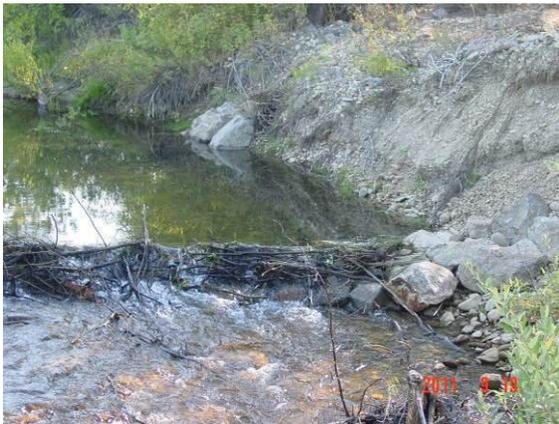
Figure 21. Beaver have taken advantage of a rock barb installed to deflect high velocity water away from an unstable bank. In this case, the beaver dam should help stabilize the bank.

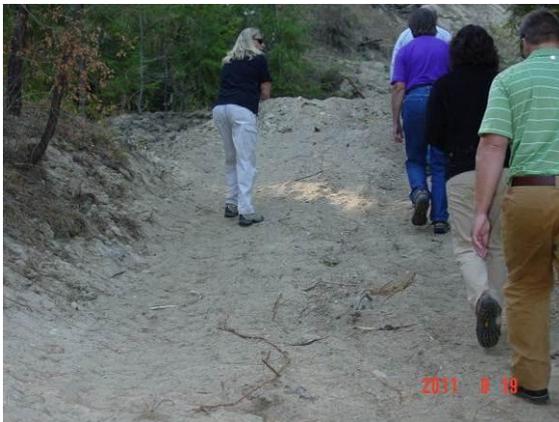
Figure 23. This unnecessary section of dirt road was unstable and contributing to sedimentation of Mores Creek. It has been closed and reseeded.

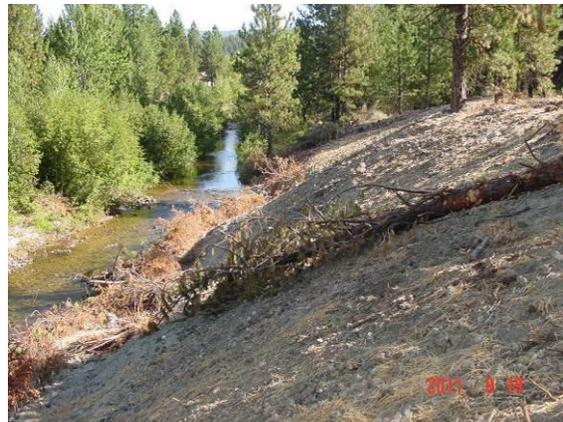
Figure 24. The streambank here was nearly vertical and was a major contributor of sediment to Mores Creek. It was resloped and reseeded and rock toe armor was added to the slope base. The work held up well during the high spring runoff.

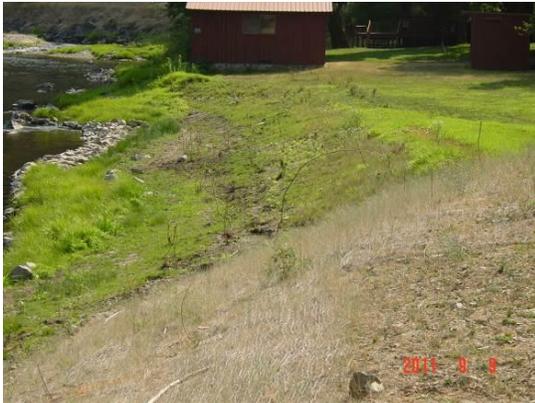
Figure 25. Prior to this project, this section of streambank was nearly vertical, unstable, and a major source of sediment to the river.

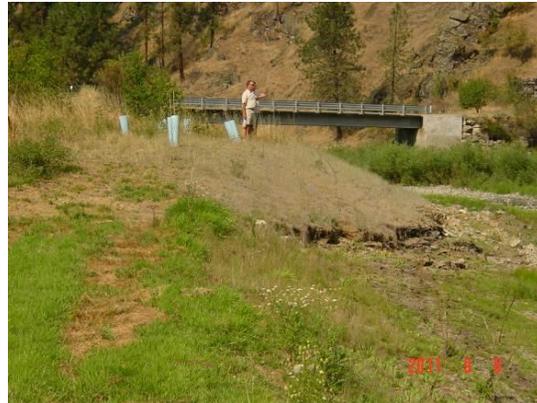
Figure 26. Although some minor erosion has occurred during high flows, most of the bank is now stable.

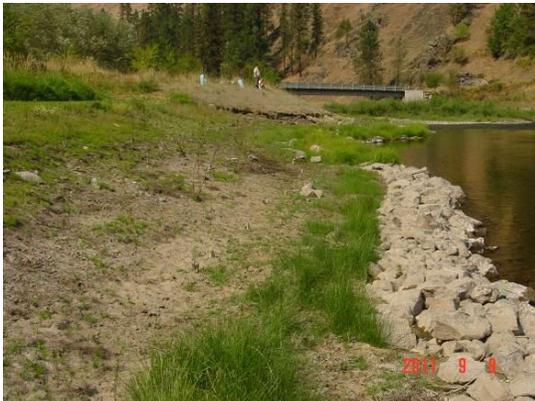
Figure 27. Large, angular rock toe armor remains in place and is allowing some of the grass planted and some natural vegetation to take hold. Funding (\$1,150–\$1,900) will soon be obtained from S394 to replant woody vegetation destroyed during last spring's very high flows.

The work was completed on schedule, and this subgrant is closed as of 1/31/2011. Some follow-up work will involve replacing plants destroyed after last spring's heavy runoff using funds from subgrant S394.

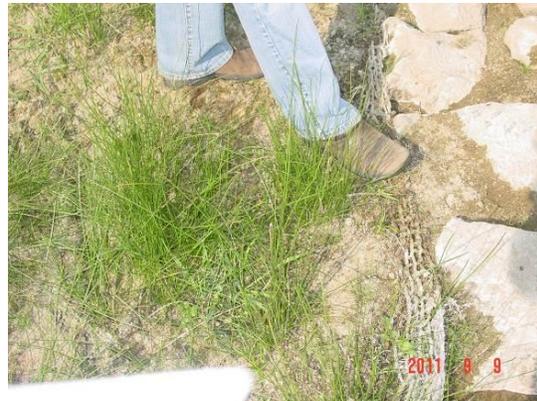
Figure 28. Coconut fiber fabric is still in place reducing erosion while helping the vegetation become established.

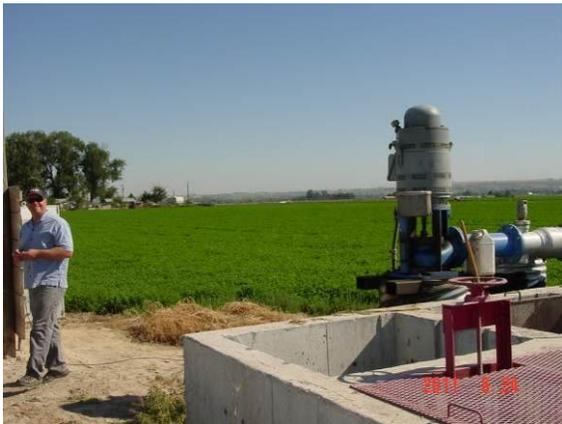
Figure 29. DEQ’s Lance Holloway is looking at the A-8 Lateral project, where a new efficient sprinkler and piped pumping system replaced a wasteful flood irrigation system that caused massive irrigation return flow to the Snake River. With the new system, there is seldom any irrigation return flow to the river.

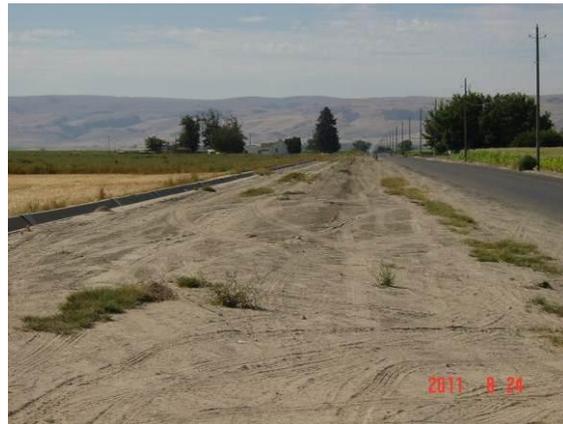
Figure 30. This photograph shows where the pipeline is buried.

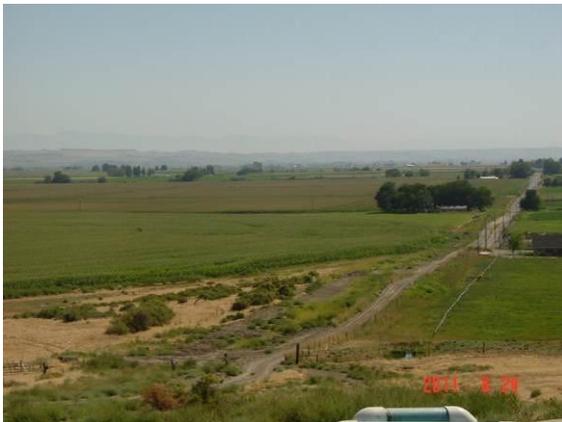
Figure 31. This is a view of a portion of the 800 acres of farmland that previously discharged thousands of gallons of contaminated irrigation return flow to the Snake River when it was flood irrigated.

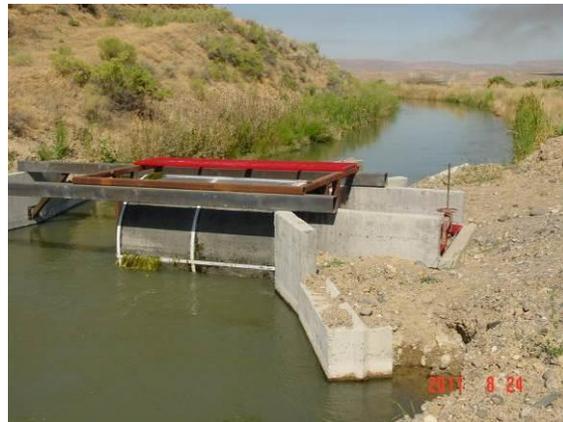
Figure 32. To prevent sprinkler system clogging, the head gate required this filter screen to keep out moss and other debris.

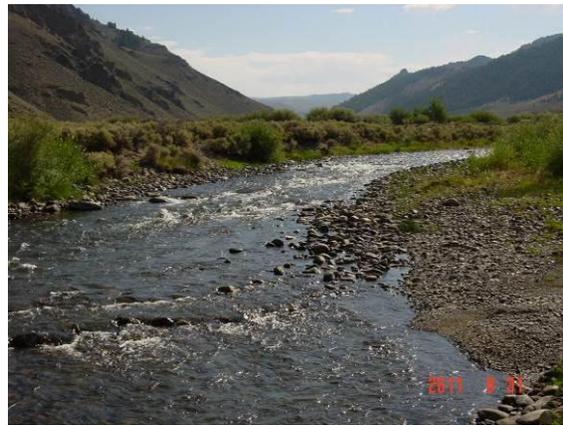
Figure 34. This section of the river adjacent to the toppled fence was cattle free during our evaluation.

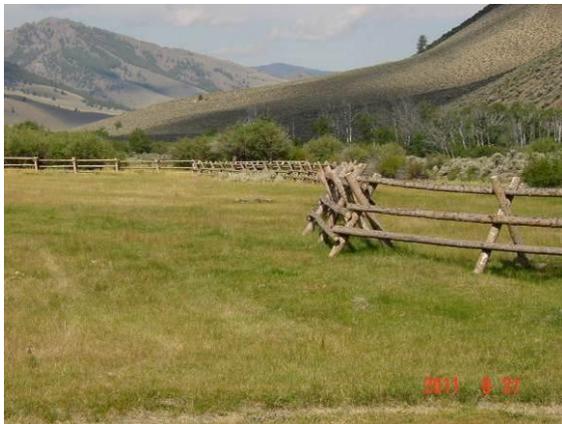
Figure 35. Most of the thousands of feet of fencing are in good shape. Jack-pole fencing is preferred in areas of Idaho where severe winter conditions combined with bear, elk, and moose traffic routinely destroy metal fencing.

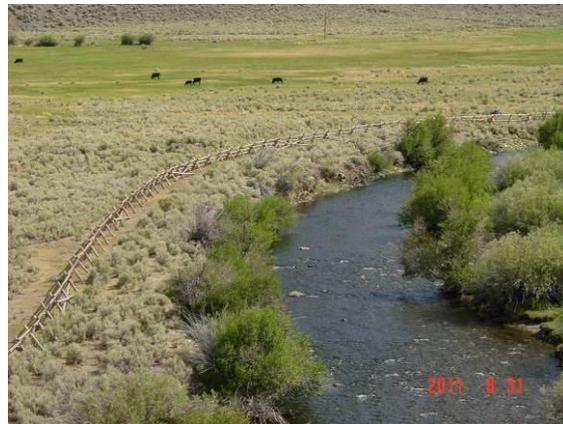
Figure 36. The fencing is doing its intended job of keeping cattle (seen in the distance) out of the river.

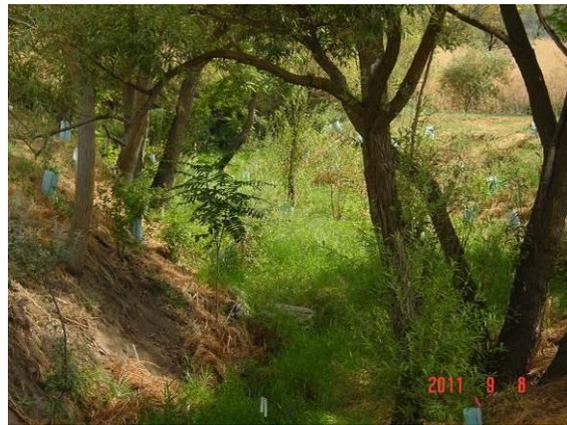
Figure 38. Work on the Cowger property includes livestock exclusion and vegetative plantings. This work is creating a much more stable riparian environment.

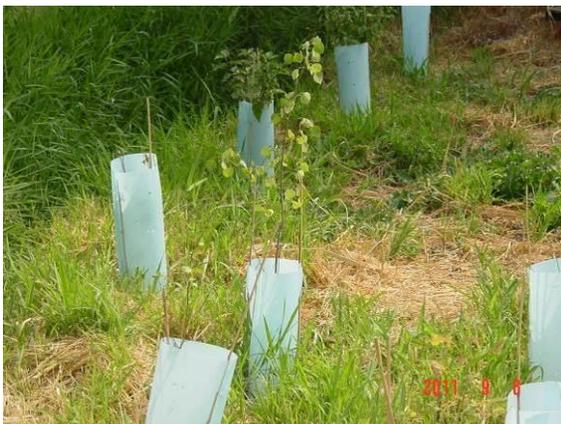
Figure 39. After several more growing seasons, these trees will contribute to shading along Lindsay Creek.

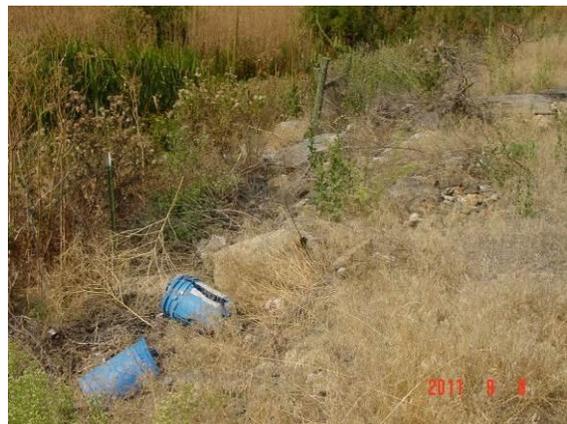
Figure 40. This proposed subproject on the Rodgers property would clean up some illegal dumping along Lindsay Creek. Work would also include some minor resloping of the streambanks and removal of weeds.

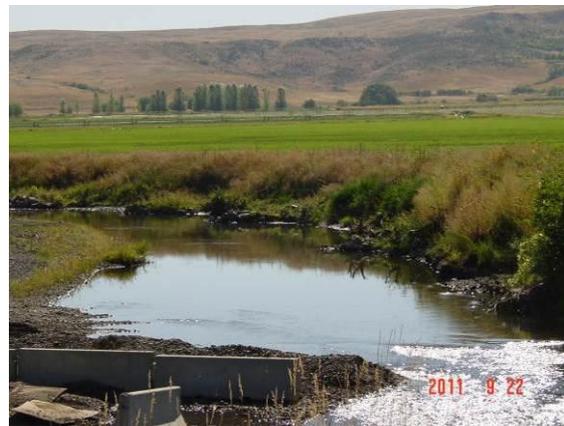
Figure 42. This span of the Little Weiser River was resloped and planted with vegetation. Rip-rap at the toe of the bank is holding up, even during very high spring runoff. Temporary concrete barriers in the foreground will be replaced with a permanent diversion.

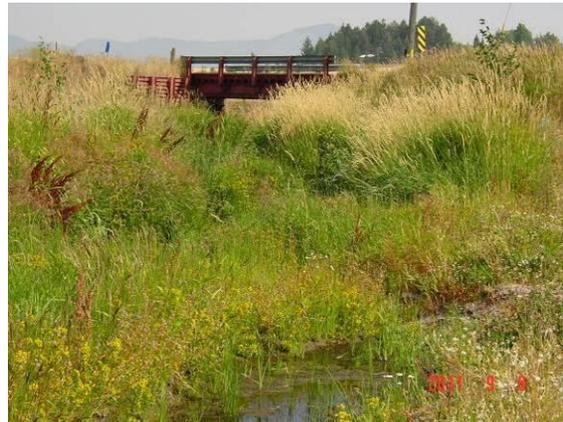
The hardscape resloping held up but some of the woody riparian plantings were destroyed during the exceptionally heavy spring runoff of 2011. Additional woody plantings are being replaced this summer.

Figure 46. Sedges and rushes have taken over since the vertical banks were knocked down, re-sloped, and planted.

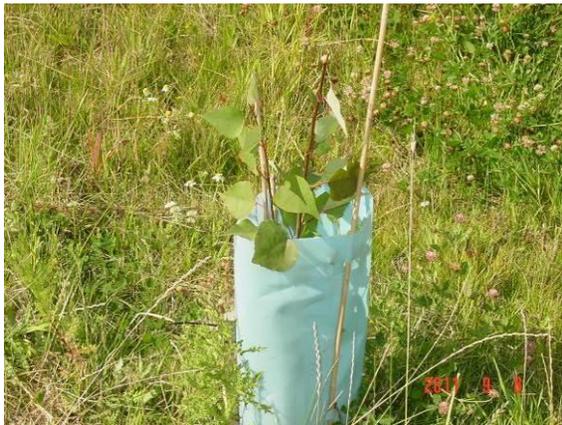
Figure 47. Blue plastic collars protect plants from browsing deer and elk and allow easy identification as weed control crews work in the area.

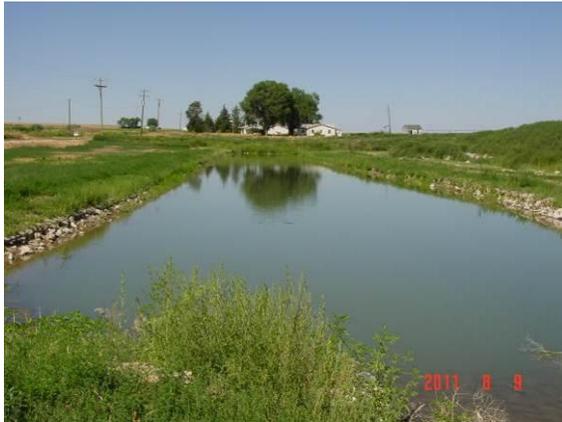
The settling ponds and finishing pond that were evaluated during the first visit to this project continue to function as designed, but the first pond was near its holding capacity for sediment. DEQ's regional staff will notify the canal company that it is time to clean the pond out (Figures 49–52).

Figure 49. The first in a series of three settling ponds that handle irrigation return flow from cultivated farmland.

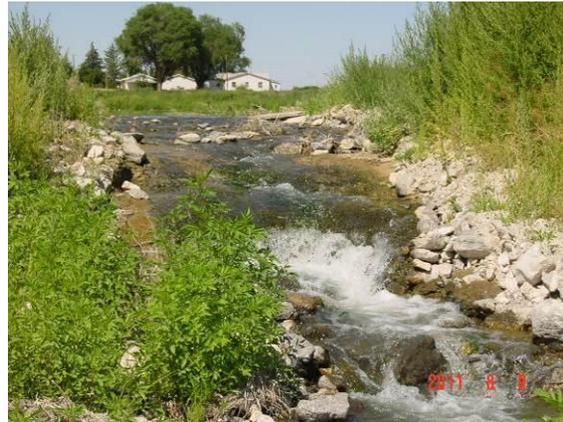
Figure 50. Partially treated water from the first pond flows to the second settling/wetland pond.

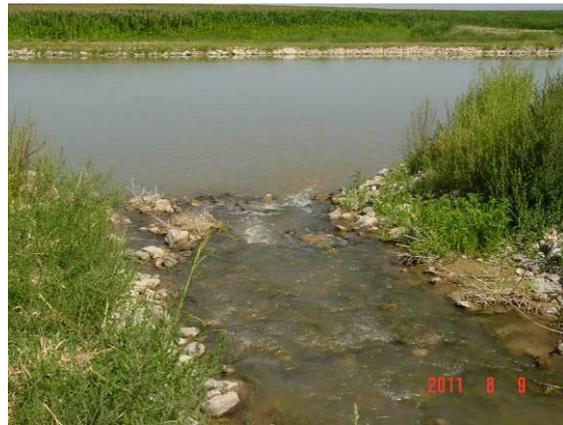
Figure 52. Irrigation return flow leaving the second settling/wetland pond is shown flowing to the final wetland pond for final treatment prior to release to the Snake River.

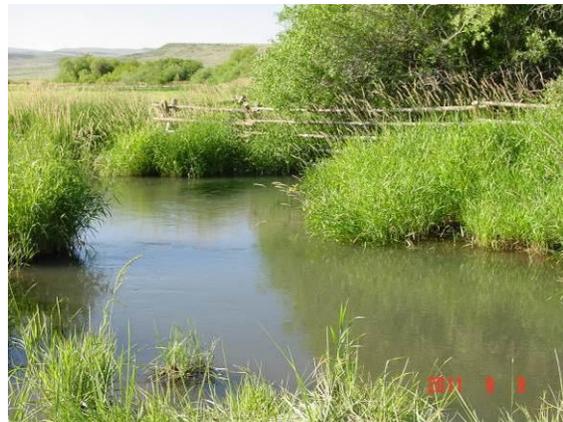
The work was completed on schedule except for the water gap rocking, which was held up due to unusually high and late spring runoff. The rocking was stockpiled on-site and was installed in October 2011.

Figure 72. This is one of five watering gaps installed along House Creek. The bottom and shore along the watering gap still need a rock lining to reduce the impact of cattle.

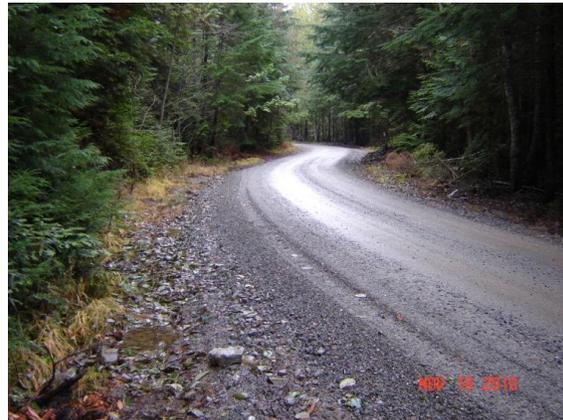
Figure 74. After: the road is now crowned to improve drainage and can be maintained by grading.

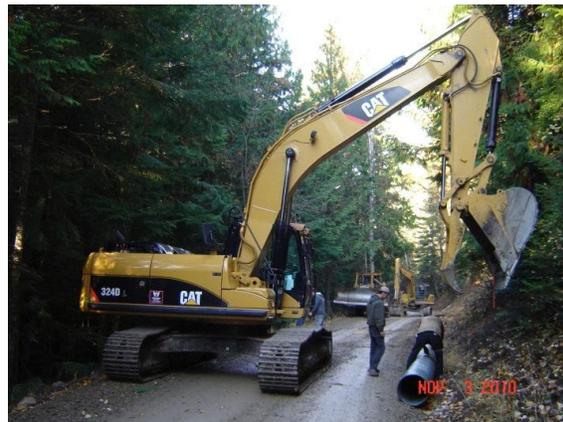
Figure 76. The crew installed new culverts to improve drainage and reduce erosion. Adding more drains distributes runoff over a larger area, greatly reducing sediment deposition to Twentymile Creek.

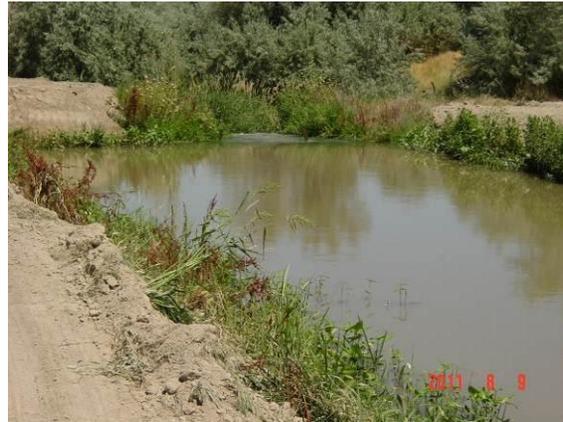
Figure 78. The first pond was already largely complete, but its dike is being raised to create more capacity.

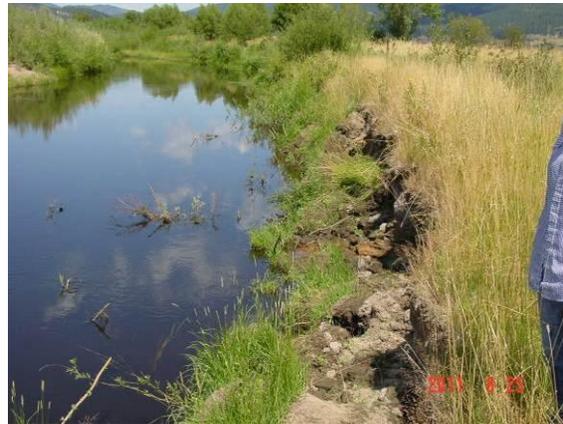
Figure 82. This bank is just beginning to recover now that cattle are restricted and vegetation has been planted. The irregular surface of the streambank will fill in with sediment during high-flow events.

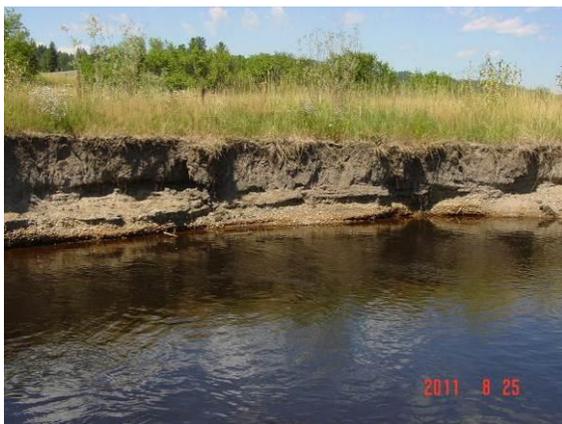
Figure 83. This unstable vertical bank is the result of uncontrolled cattle grazing. Prior to this project, much of the shoreline along the Little Salmon River looked like this.

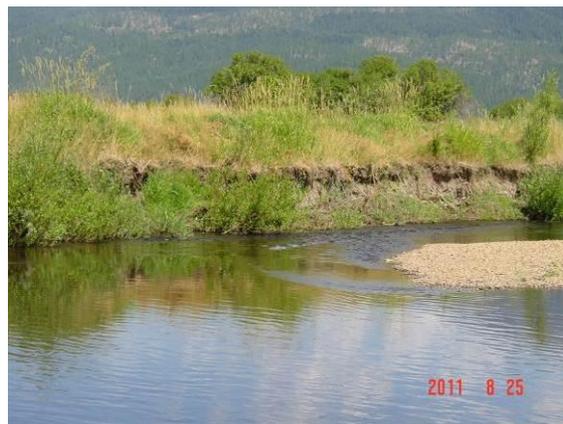
Figure 84. After one season of excluding cattle and installing willow weavings, the improvement is noticeable.

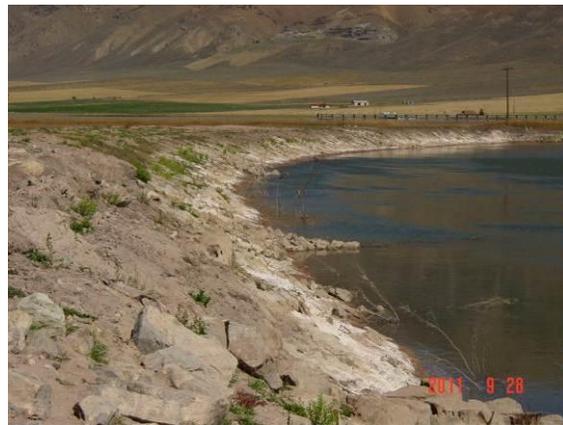
The evaluation covered a 1,000-foot span along Bear River listed in the work plan for reclamation. Although the newly planted vegetation was largely destroyed by the exceptionally high spring runoff on Bear River, all of the hardscape—including the resloped and rip-rap-armored streambank and the well-keyed-in rock barbs—held up and are functioning as intended (Figures 85–88).

Figure 86. In addition to the resloped bank, rock barbs were keyed into the bank. These structures force high-velocity water toward the center of the channel and away from the bank.

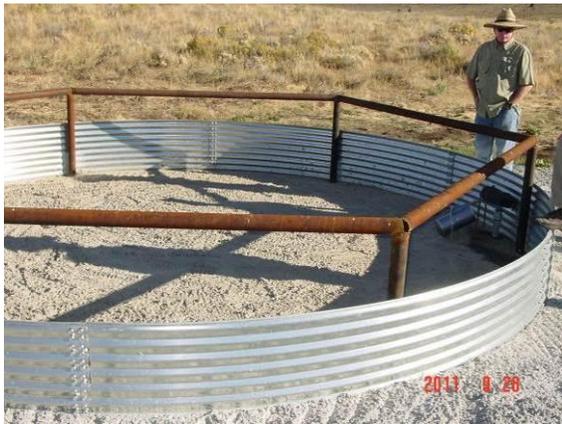
Figure 89. This new water trough is high tech: the concrete floor is heavily scored to help cattle get traction as they approach with muddy feet. The steel guardrail keeps cattle from entering the trough. A float valve shuts off the water flow at a defined level.

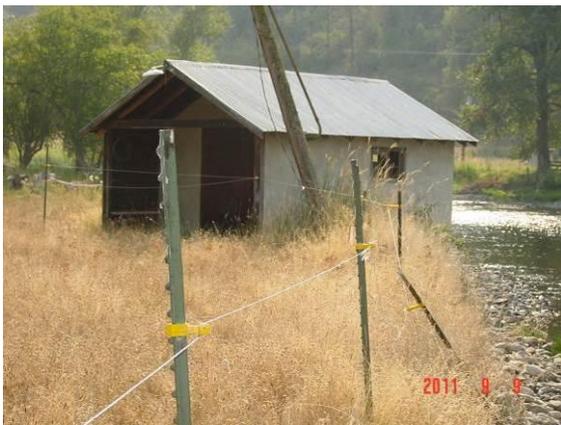
Figure 95. Temporary electric fencing is keeping livestock away from the unstable bank.

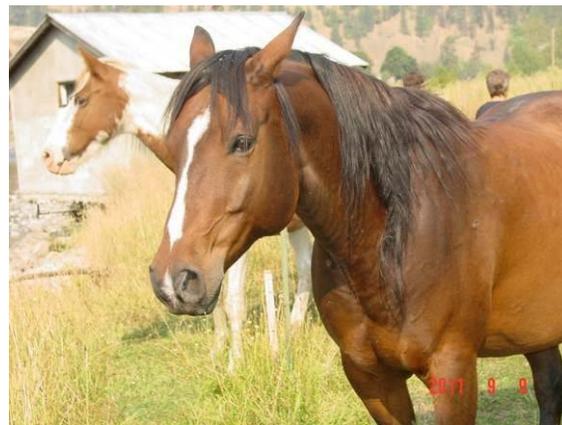
Figure 96. These friendly residents would appreciate it if we could halt further erosion of their prime pasture and send less sediment into the South Fork Clearwater River.

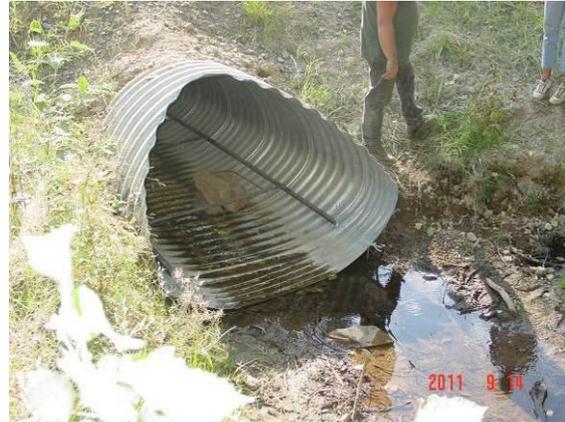
Figure 98. This tributary to Hangman Creek contains bull trout, so the culvert selected is more fish friendly than a conventional culvert. Note that the culvert is located at a grade below water level to enhance fish passage.

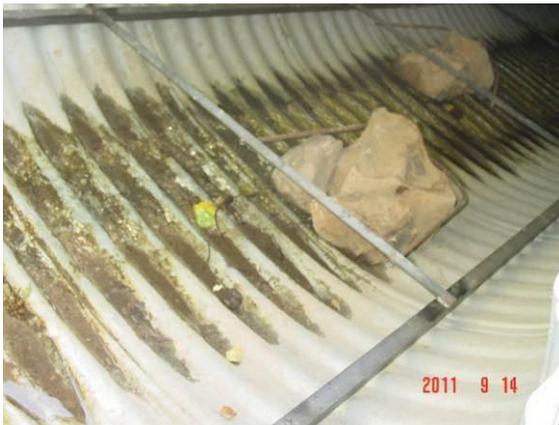
Figure 99. An additional fish-friendly feature is a custom-made steel ladder to keep large rocks in place within the culvert. These large rocks offer safe refuge for fish as they migrate upstream during their spawning season, which coincides with spring runoff high flows.

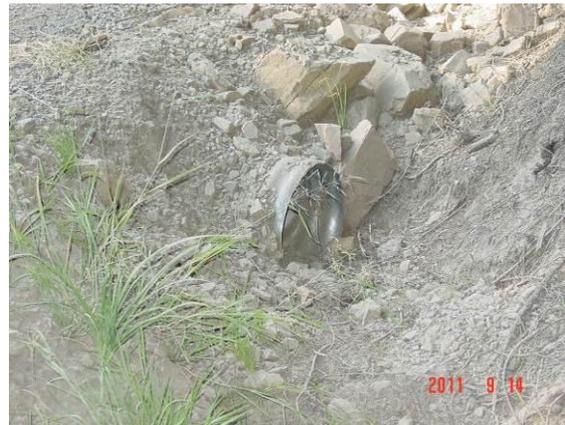
Figure 100. One small ditch culvert conveys water from a short span of road barrow ditch to a wooded area.

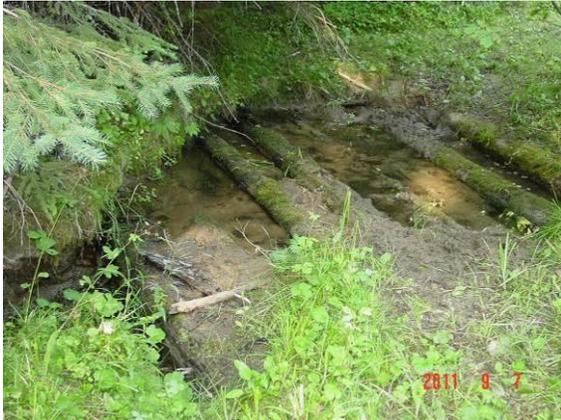
Figure 101. This old logging road crossing is contributing to erosional head cutting on a tributary to the East Fork Potlatch River and will be removed as this stretch of logging road is closed out.

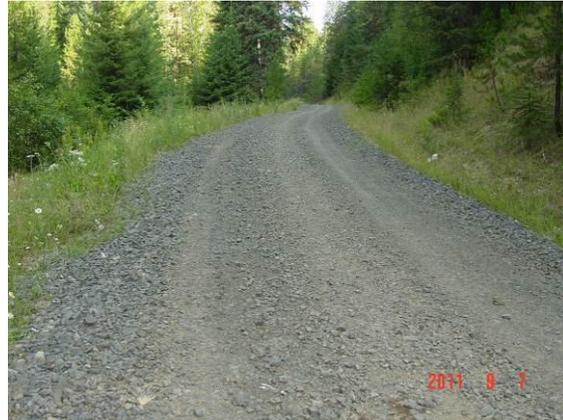
Figure 102. A logging road that will remain open has just received new gravel and ditches over a 4.5-mile stretch. Roadwork of this nature is effective in reducing sedimentation to surface water.

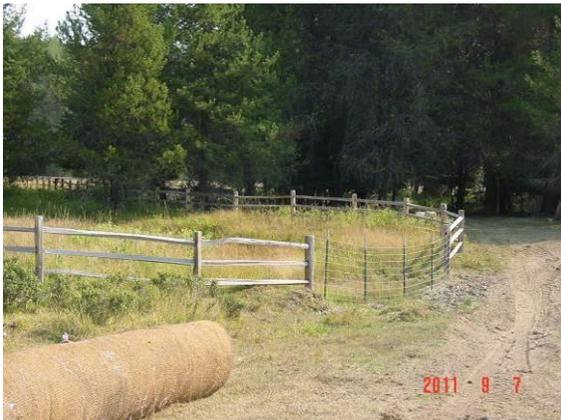
Figure 103. About 20,000 feet of exclusionary split rail fencing has been installed along Corral Creek, another tributary to the Potlatch River. This locally produced fencing, which created local jobs, holds up better than barbwire in heavy snow areas with cattle, elk, and moose traffic.

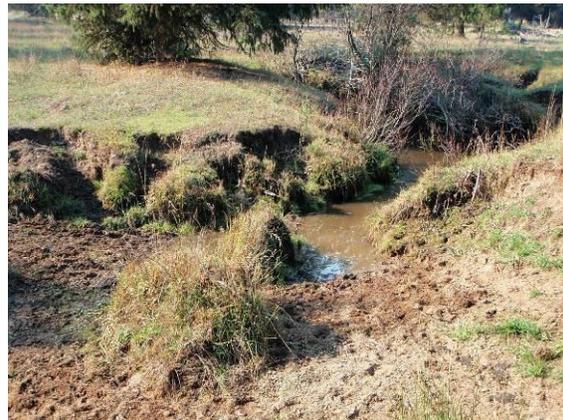
Figure 104. Prior to this project, uncontrolled grazing resulted in mass erosion and high levels of bacteria in Corral Creek. Ken Stinson took this photograph last summer.

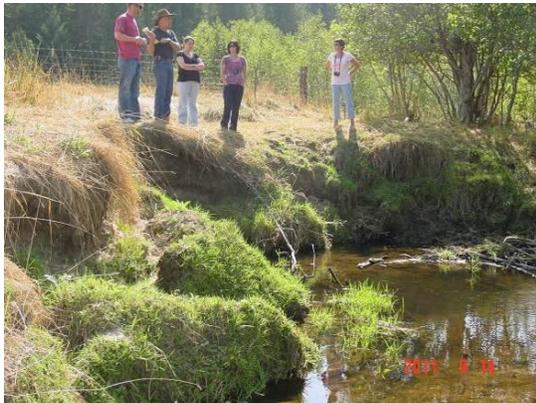
Figure 105. Decades ago, Highway 95 construction pushed the channel to one side of the valley, thereby shortening and increasing the stream gradient. This action resulted in a steeper gradient, channel down cutting, and bank instability. Uncontrolled cattle grazing further aggravated the problems.

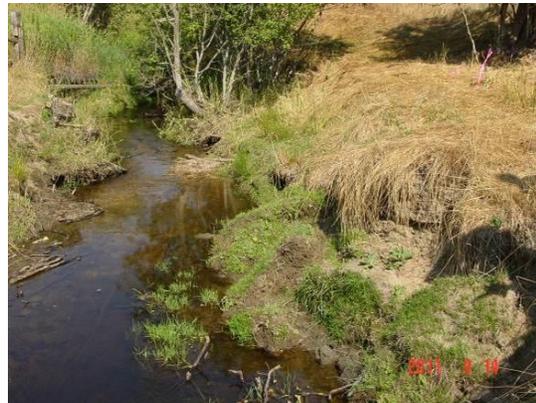
Figure 106. After just one season of cattle exclusion, the grass is already coming back. However, the problem will not be fully corrected until fragile vegetation becomes more established since spring runoff can be quite destructive to fragile vegetation.

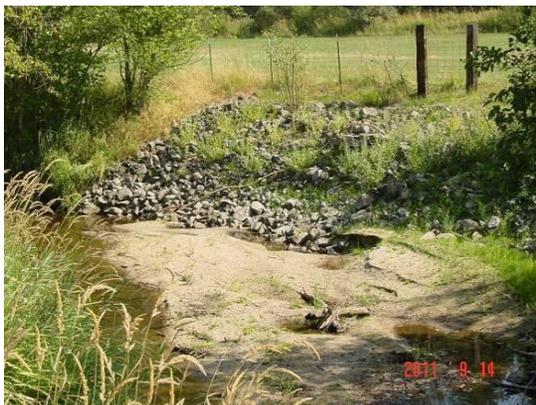
Figure 107. Spring runoff from this field enters Mica Creek at a low point, where an old meander scar naturally exists. The point of entry has been fortified with rip-rap to prevent head cutting into the bank. A beneficial sand bar is now naturally forming along Mica Creek immediately upstream from the rip-rap.

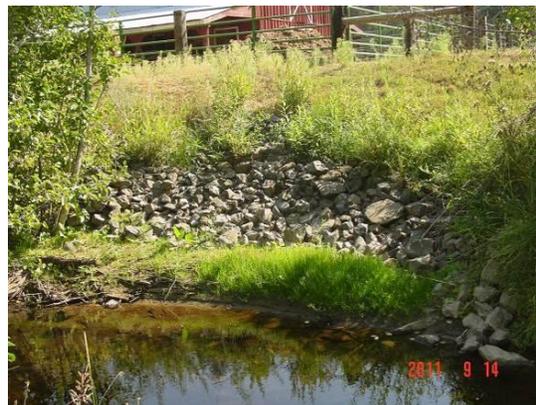
Figure 108. A soft touch was required here, where established trees were about to become destabilized as the bank was gradually receding. Rip-rap, combined with a rock barb (bottom right), should protect the trees and the grassy sand bar.

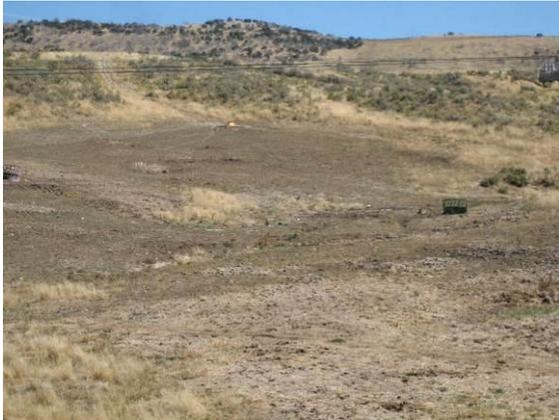
Figure 109. This AFO will routinely handle 400 head of cattle. The addition of berms will soon keep stormwater runoff from passing through it to Marsh Creek.

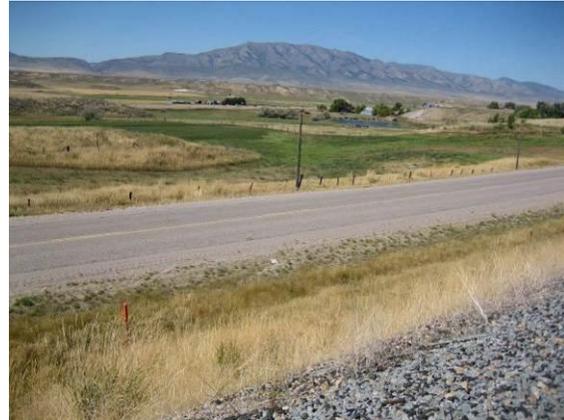
Figure 110. A culvert conveys contaminated stormwater under the railroad and highway right-of-way to Marsh Creek, which meanders through the valley.

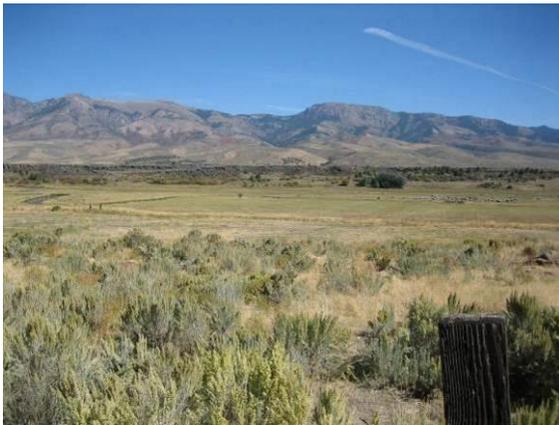
Figure 111. Decades of uncontrolled cattle grazing have had a negative impact on Marsh Creek. Exclusionary fencing will soon protect 2,600 feet of Marsh Creek as this BMP annually excludes 300 to 500 head of cattle. Watering troughs will encourage cattle to remain in the pastures where their feed is, rather than congregate along the creek.

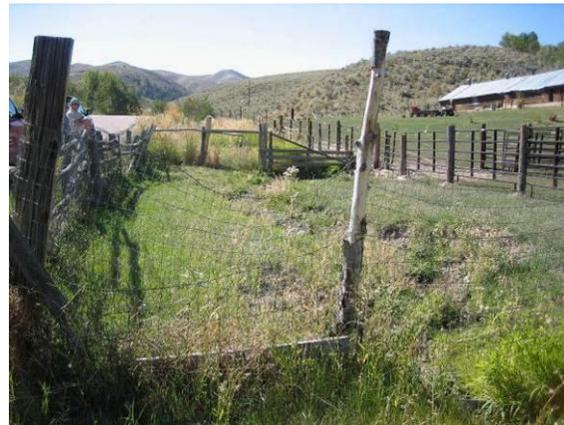
Figure 112. The steel fence panels (upper right) exclude cattle from this tributary to Marsh Creek. Many small projects like this one add up to substantial reductions of nutrients, bacteria, and sediment deposition in Marsh Creek. After part of one growing season, this formerly denuded section of the creek is already beginning to stabilize.

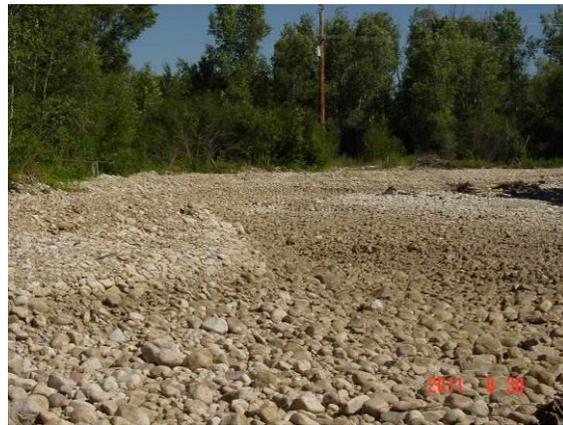
Figure 114. Weeks prior to this photograph, about 900 cubic feet per second of spring runoff flowed down this channel. At the date of this photograph, all of the streamflow was diverted for irrigation.

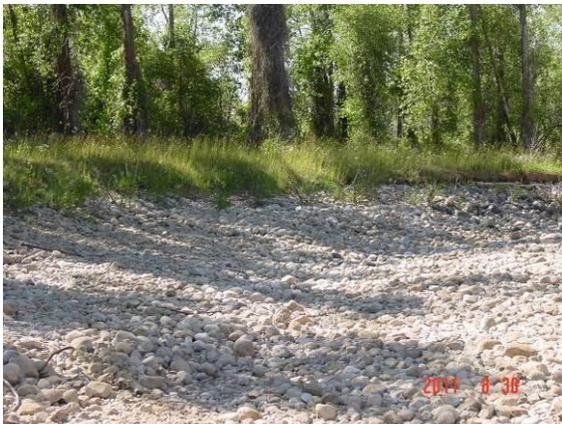
Figure 115. Temporary irrigation waters the vegetation planted along the floodplain–channel interface, which is doing well.

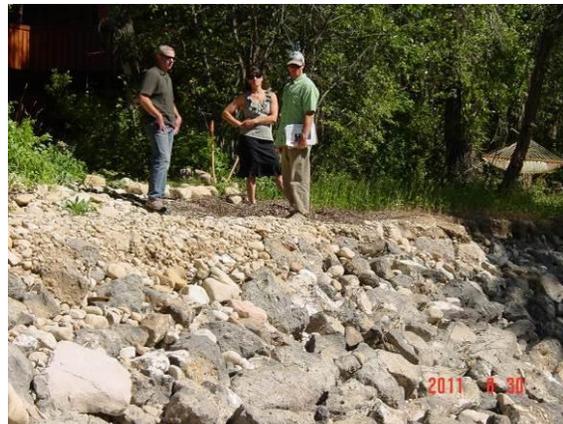
Figure 116. In this particular section, angular basalt boulders are excellent for buried rock toe protection because they are heavier and less apt to be rolled downstream during flood events than the granitic round river rocks that are native here.

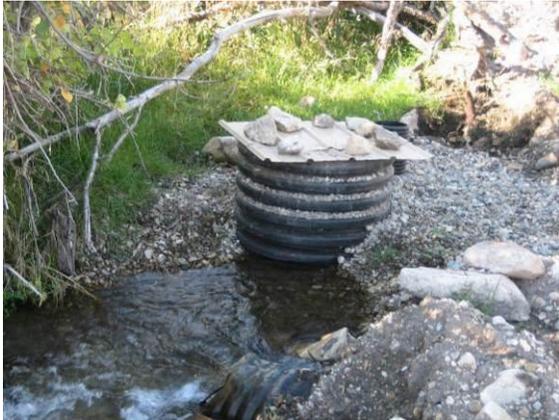
Figure 117. For generations, Indian Creek has been heavily grazed without exclusion of cattle for watering. With the installation of two collection boxes, like this one, water is piped to watering troughs out in pastures.

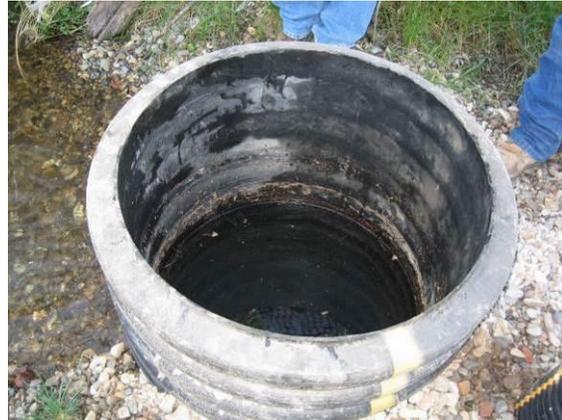
Figure 118. The collection box filters debris and transfers water to 8 miles of buried pipeline that feeds 12 watering troughs spread over 2,500 acres of grazing land.

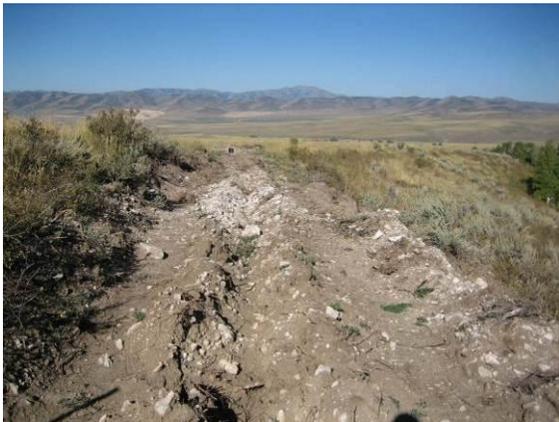
Figure 119. The beginning of a buried pipeline that conveys water to watering troughs.

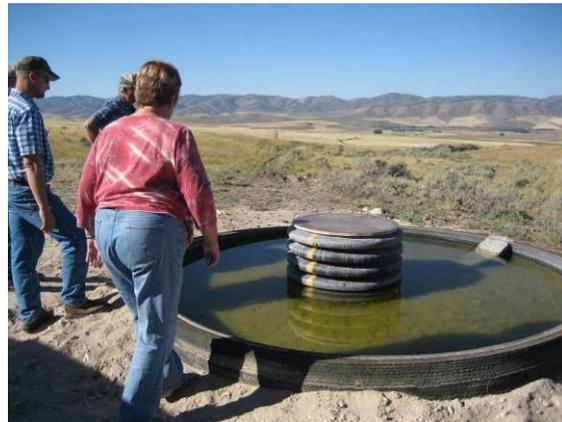
Figure 120. Watering troughs are made from used heavy-equipment tires that have been sliced in half and mounted in concrete. The small ramp in back allows birds to escape.

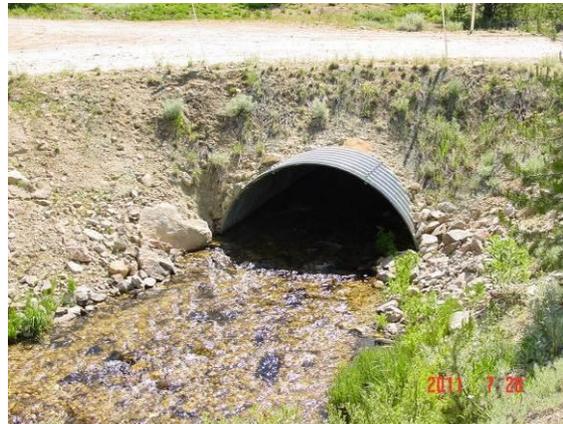
Figure 122. This recently installed fish-friendly culvert was not paid for with \$319 funding but is essential to the success of the project. The old culvert would not allow fish to pass.

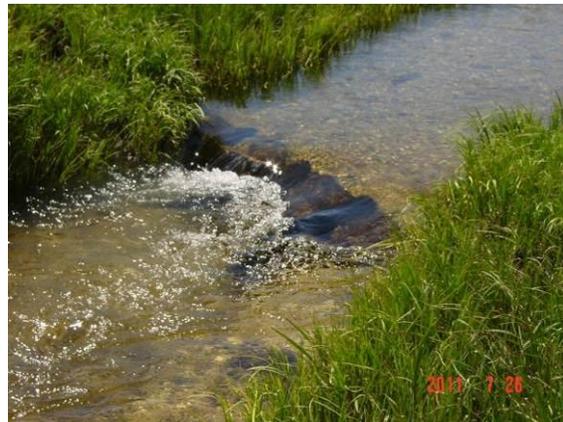
Figure 124. Ten drop structures were installed at 200-foot intervals. These pliable coconut fiber bio logs are causing gravel to build up above each structure and preventing further down cutting of the stream channel.

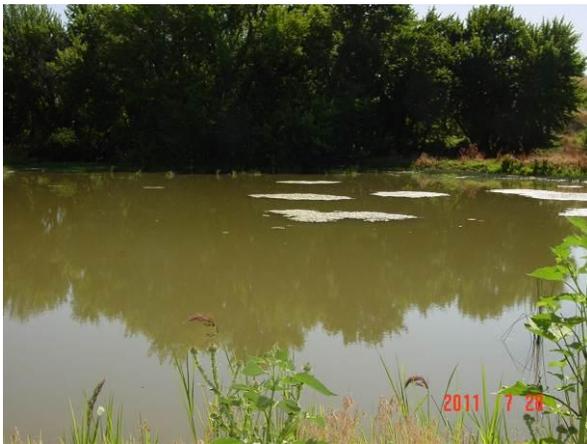
Figure 125. The top settling pond receives 3.5–4 cubic feet per second of sediment-, phosphorous-, and nitrogen-laden irrigation return flow during normal summer operations.

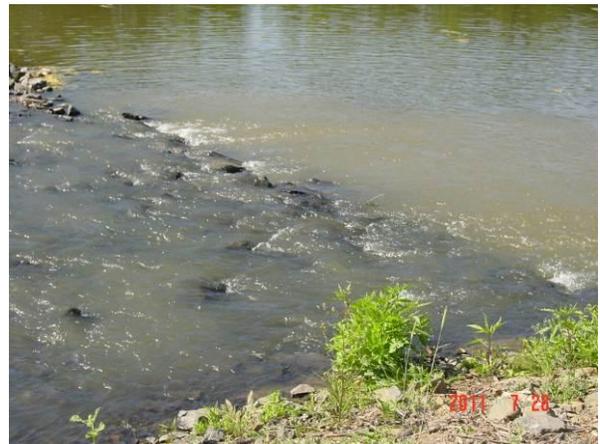
Figure 126. Partially treated irrigation return flow exits the first pond and enters the 6-acre finishing wetland, where more pollutants are removed.

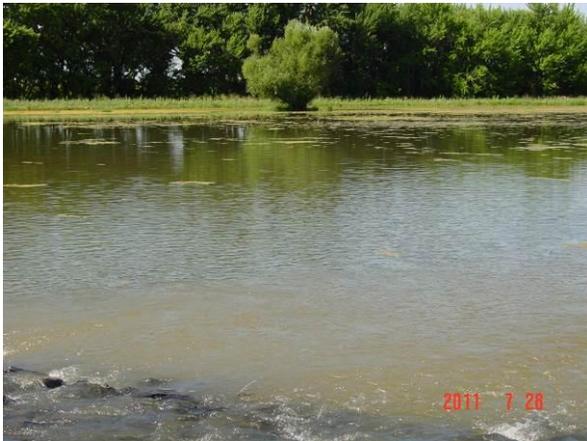
Figure 127. After several months, the finishing pond is beginning to establish vegetation on its own. Next spring, the Weiser River Soil Conservation District intends to plant willows along the shoreline.

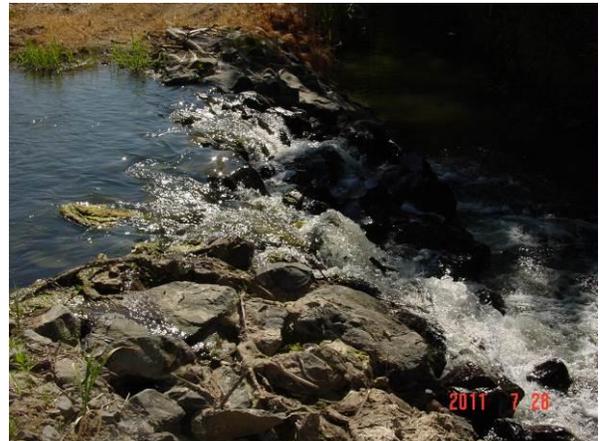
Figure 128. Treated discharge water has greatly reduced levels of pollutants. The project's monitoring program will be able to produce exact levels of reduction in the near future.
