2011 Performance and Progress Report

State of Idaho Nonpoint Source Management Program

**State of Idaho
Department of Environmental Quality**

March 2012

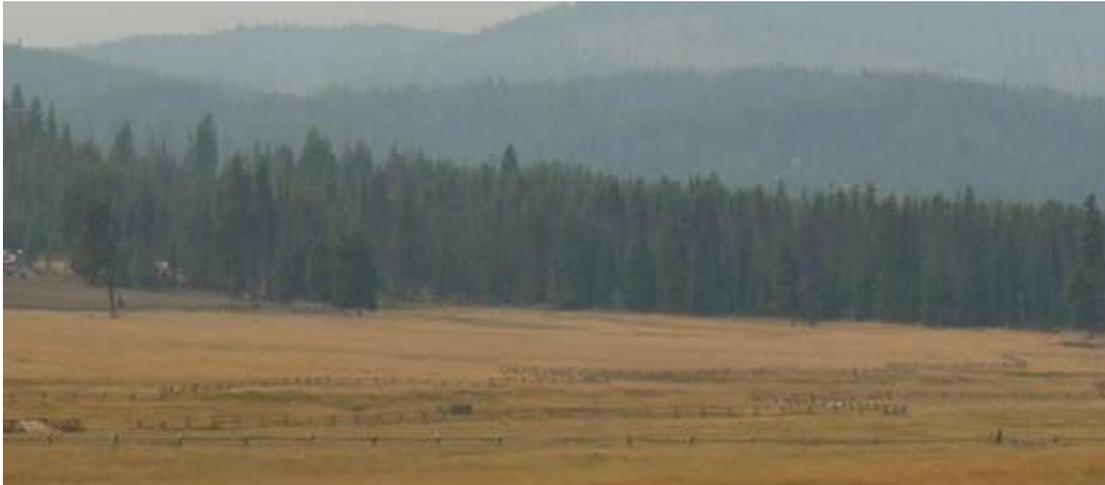
Figure 129. Big Elk Creek is now protected from grazing cattle by thousands of feet of jack-pole fencing.

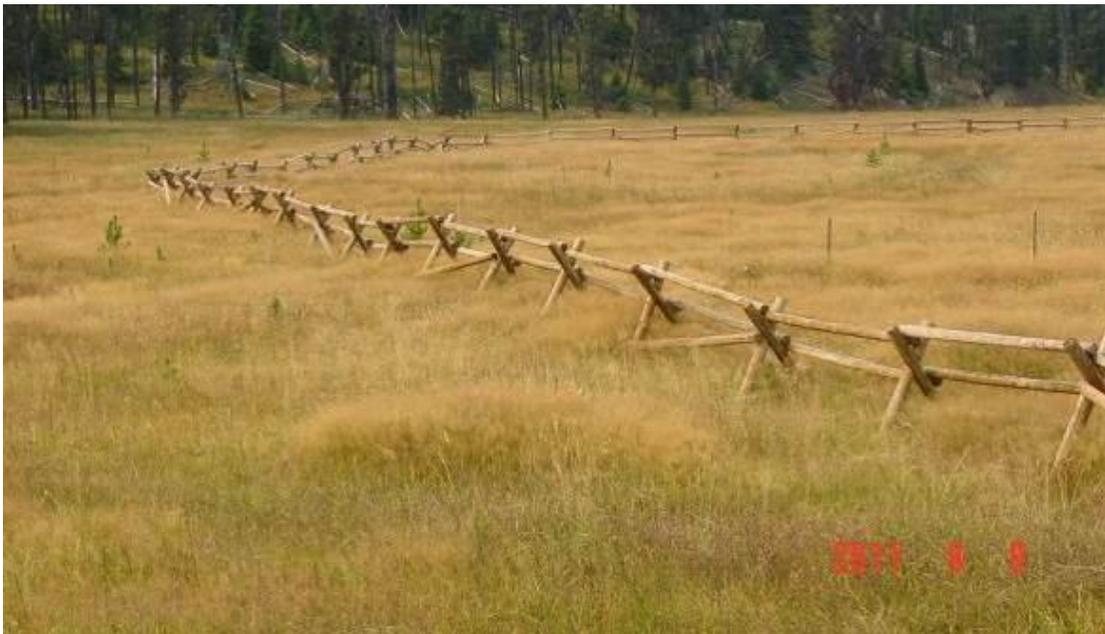
Figure 130. This is a representative example of jack-pole fencing on the southern (downstream) end of Big Elk Creek. The creek runs just to the left of this photograph.
